INSPECTION DATE - 8 SEPTEMBER 2024

# ROOF INSPECTION REPORT

8 RIVERTOP CLOSE, EMU HEIGHTS, NSW, 2750

REPORT PREPARED BY JIM MCGRATH

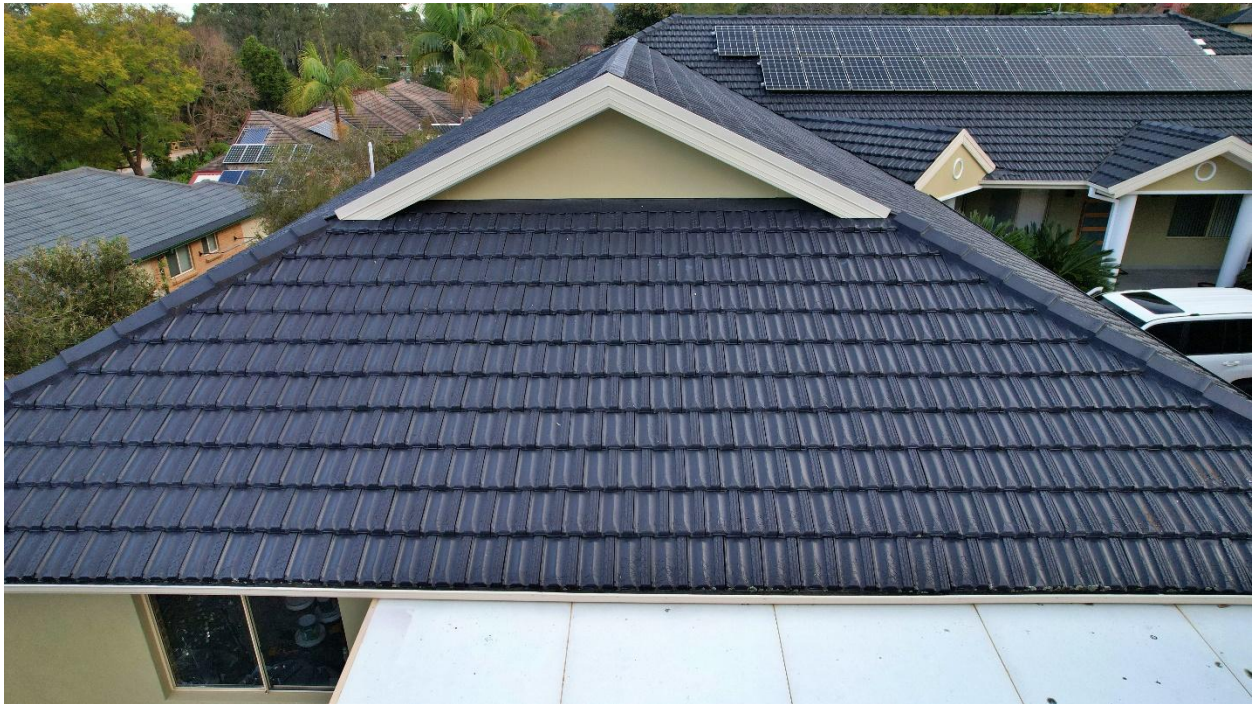
Photo 1 - Paint bubbling, peeling and cracking is present along the entire side of the roof section, from gutter to gable and ridge capping.

1. Roof Sections A–D and J present the most significant levels of deterioration across the property. Large portions of the roofing system display widespread coating failure, including bubbling, peeling, and cracking across numerous tiles. These defects indicate advanced weathering and prolonged exposure, which may compromise the protective coating and accelerate further degradation if left unaddressed.

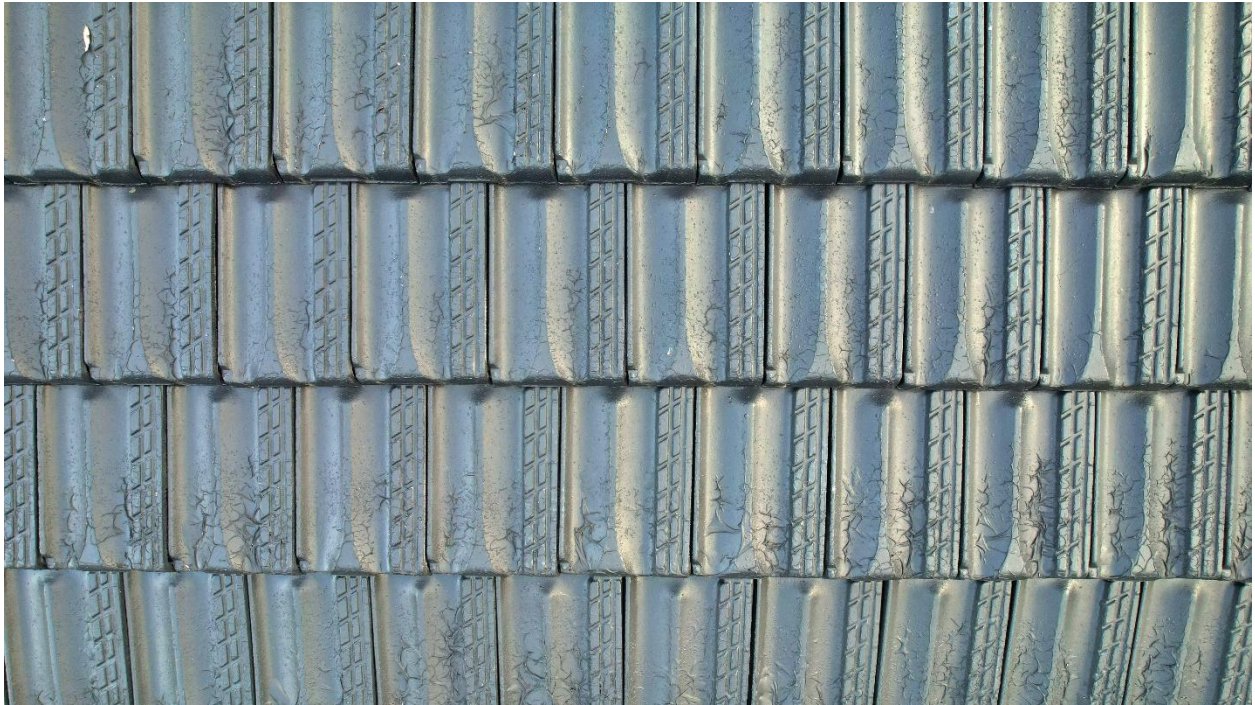
Photo 2 – Close up of roof section, showing peeling and cracking

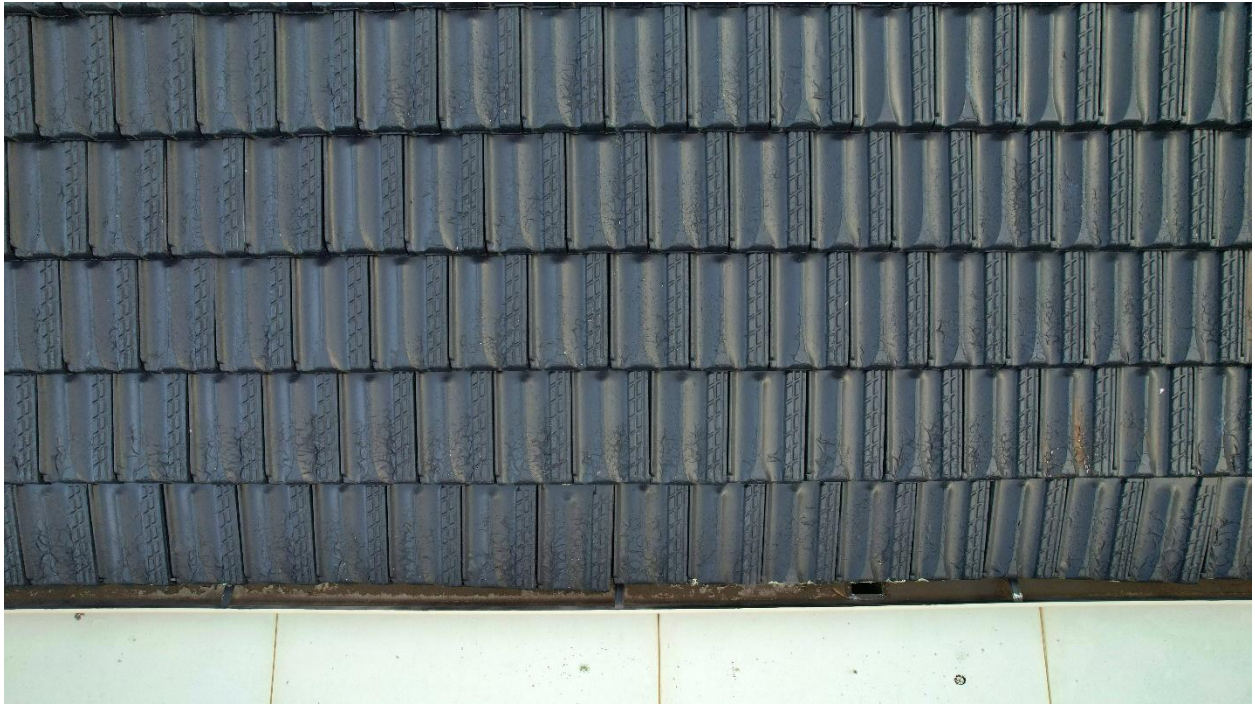
Photo 3 – Close up of roof section, showing peeling and cracking

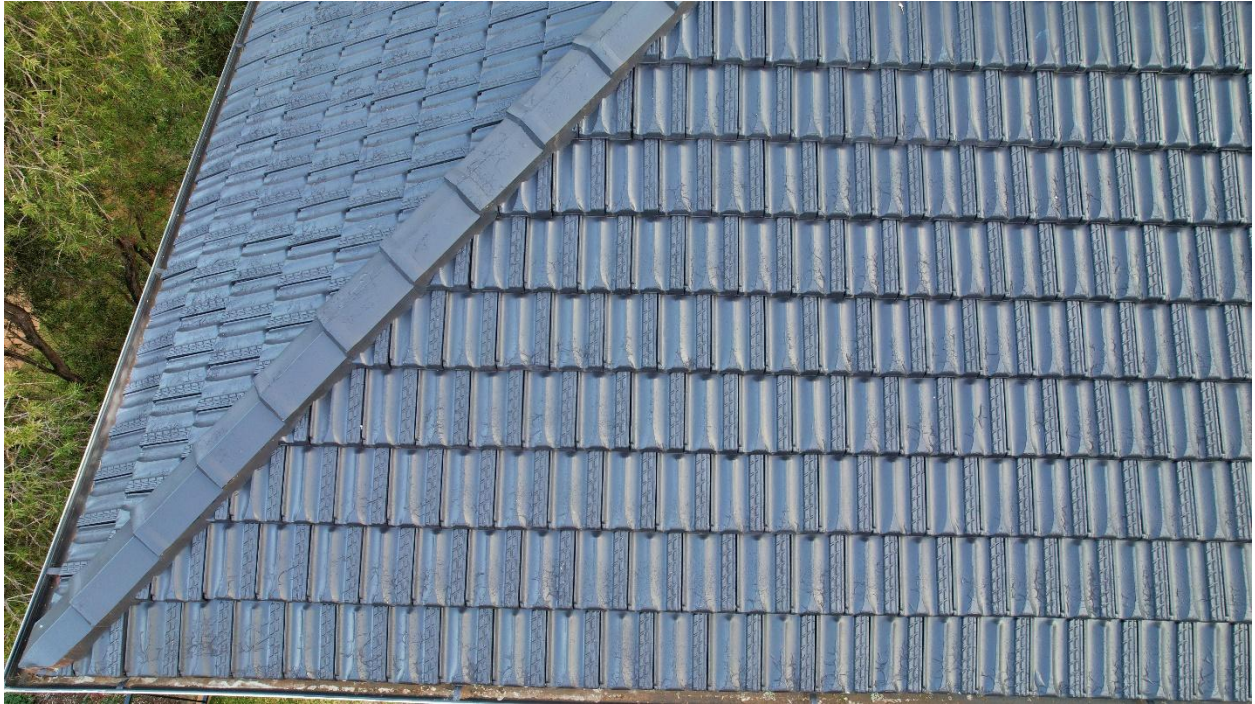
Photo 4 – Left hand side of the roof section. In the photo, the peeling, bubbling and cracking is heavily present along the gutterline to ridge cap

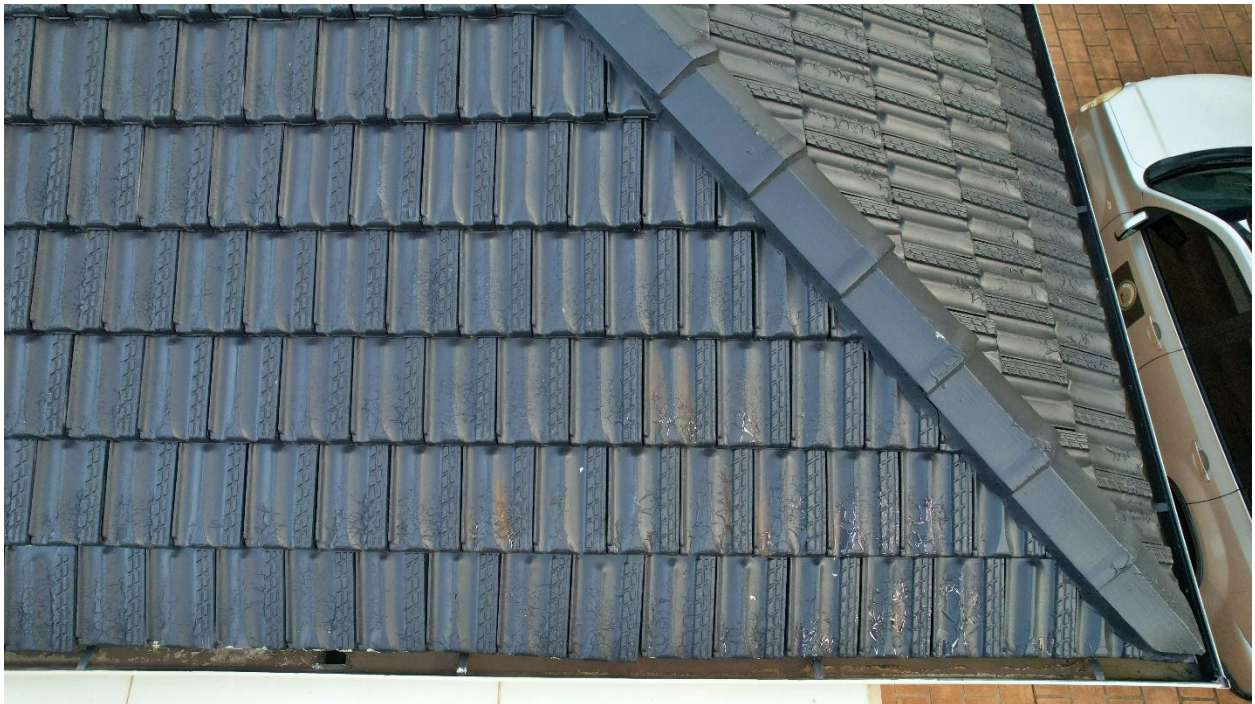
Photo 5 – Right hand side of the roof section. In the photo, the peeling and bubbling is heavily present along the gutterline to ridge cap

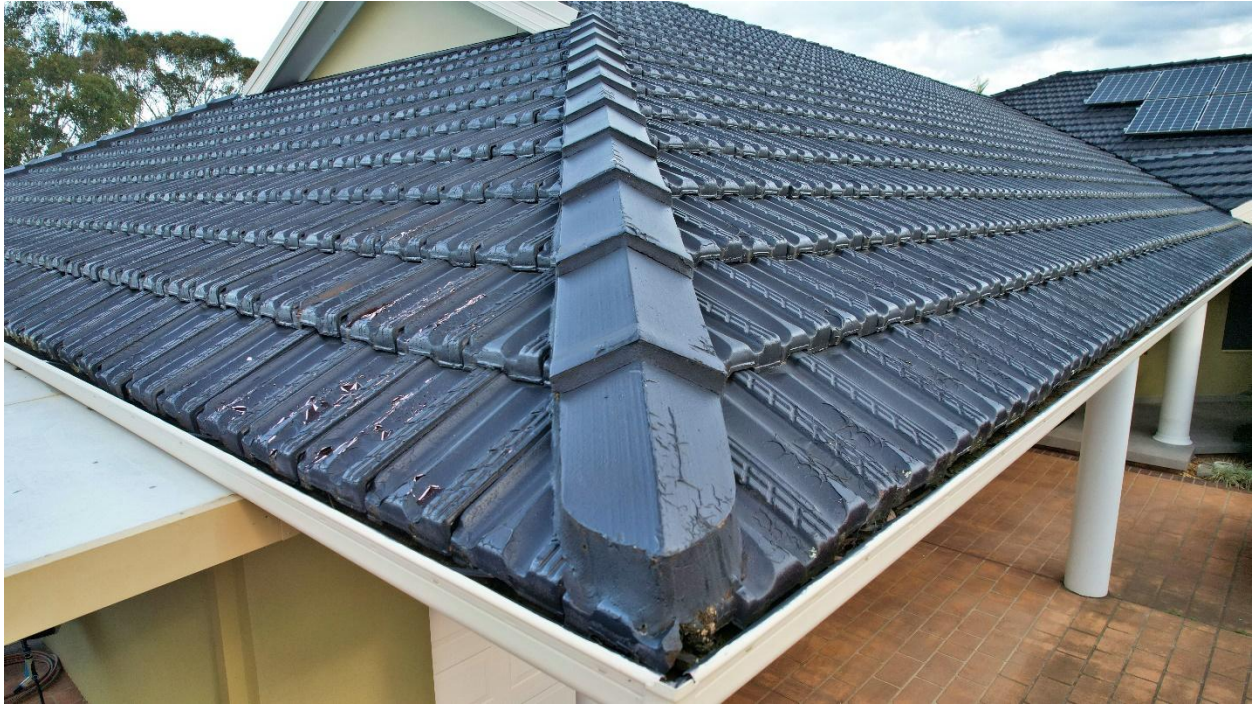
Photo 6 – Close up of the gutterline and ridge cap. Peeling and cracking is quite present of this section of the roof

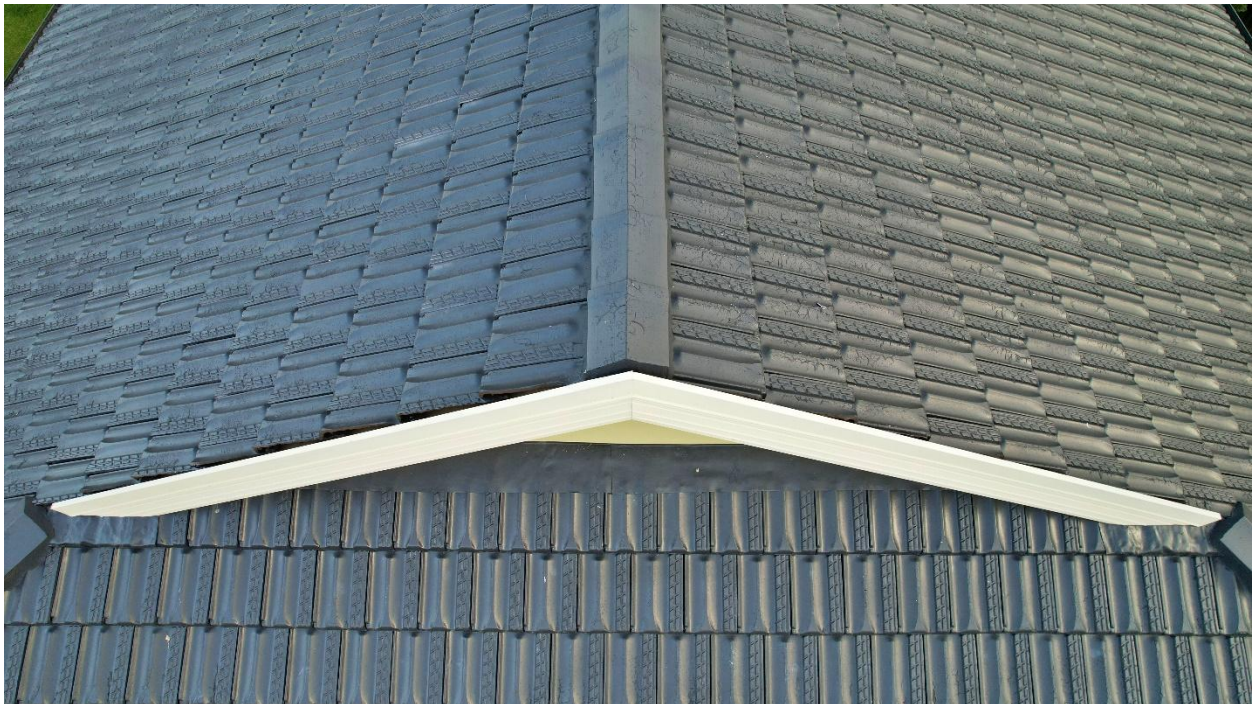
Photo 7 – Gable close up showing the paint peeling, bubbling and cracking is constant up to the gable and flashing

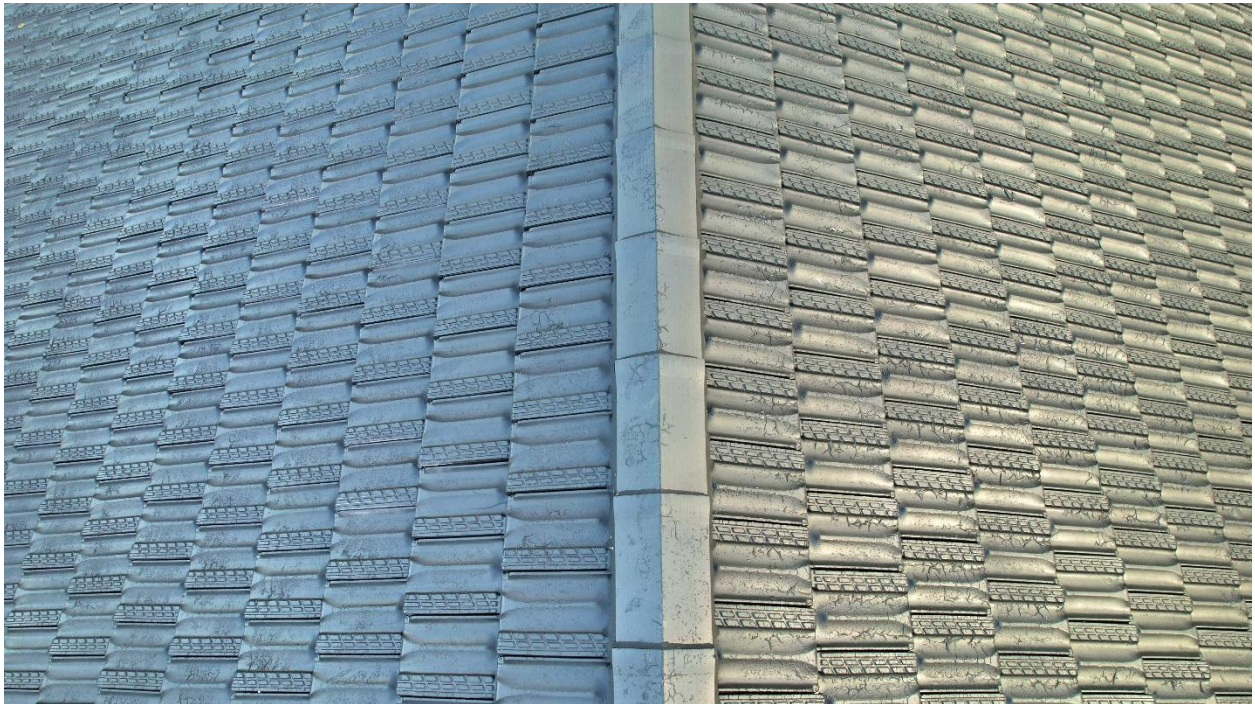
Photo 1 – Paint peeling and cracking is present along the ridge cap along this section of roof

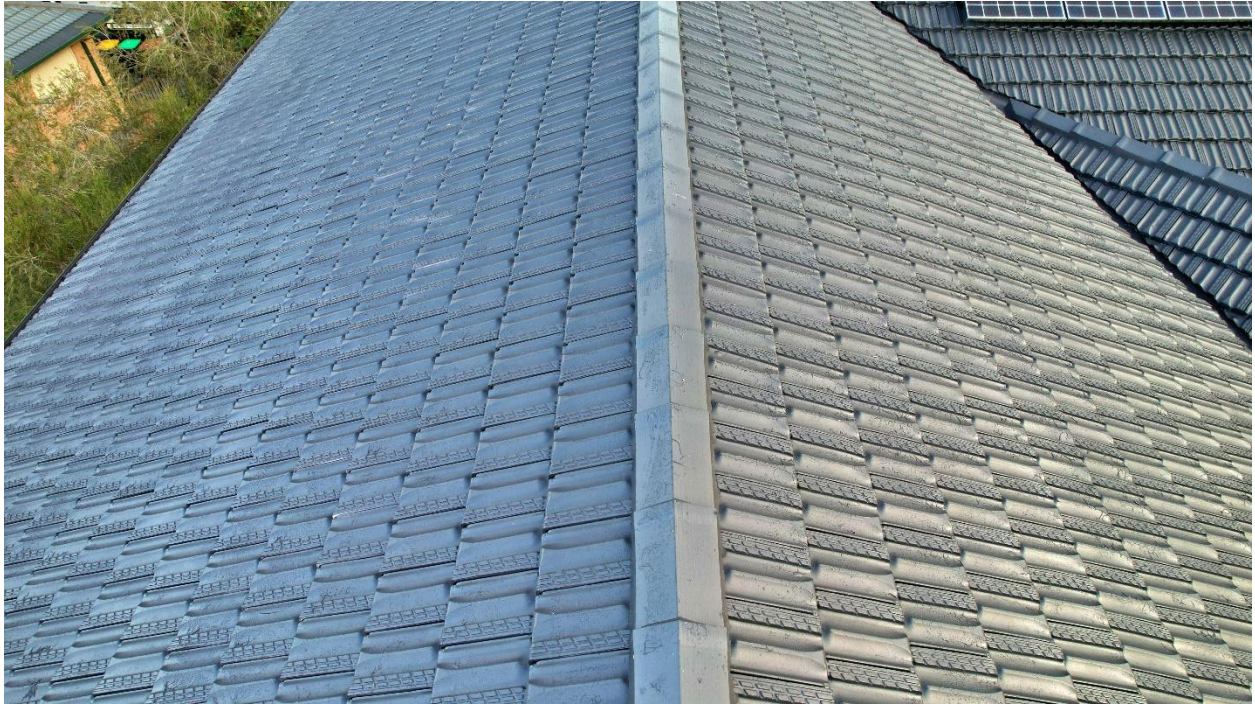
Photo 2 – Paint bubbling and cracking is present along the ridge cap along this section of roof

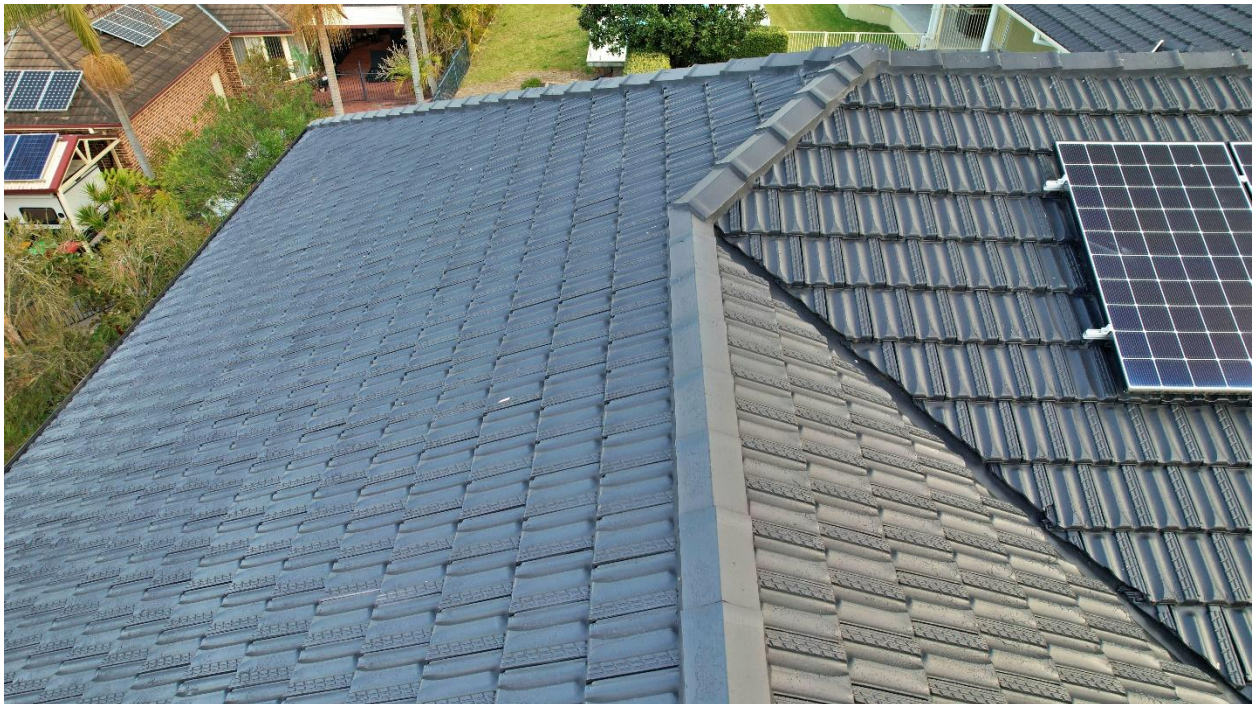
Photo 3 – Paint bubbling and cracking is present along the ridge cap along this section of roof

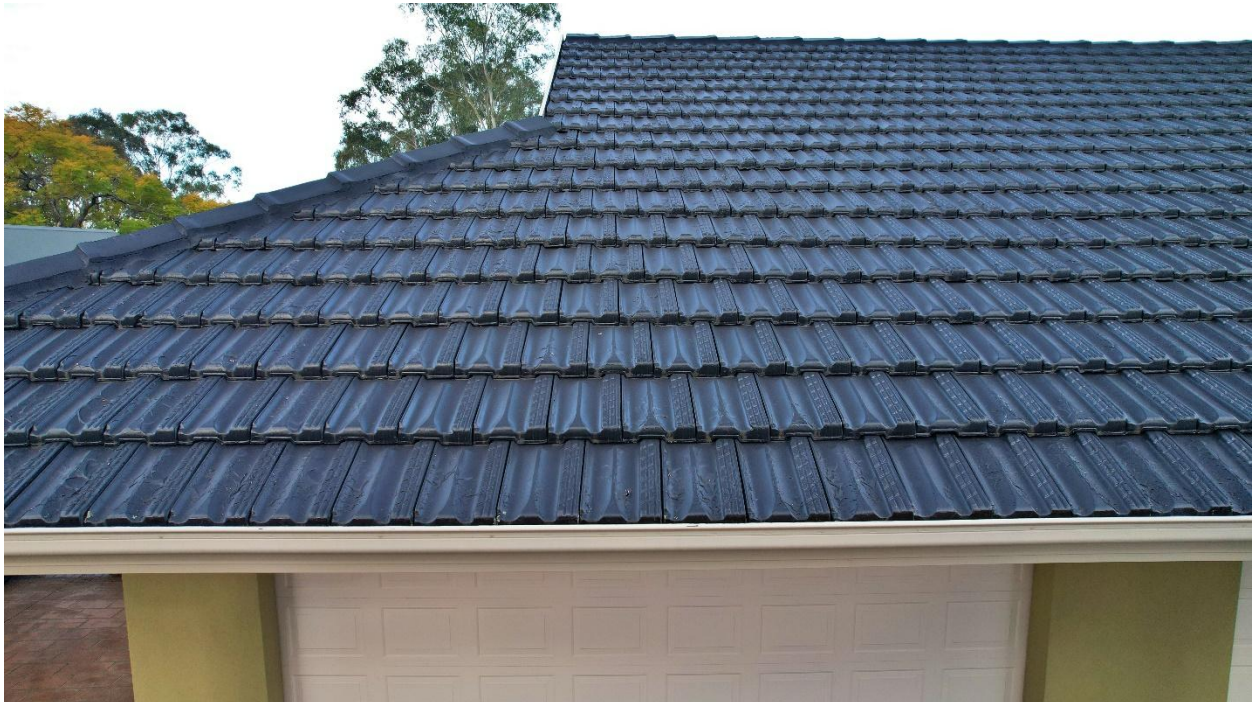
Photo 1 - Close up of roof section along the gutter line, showing peeling, bubbling and cracking paint

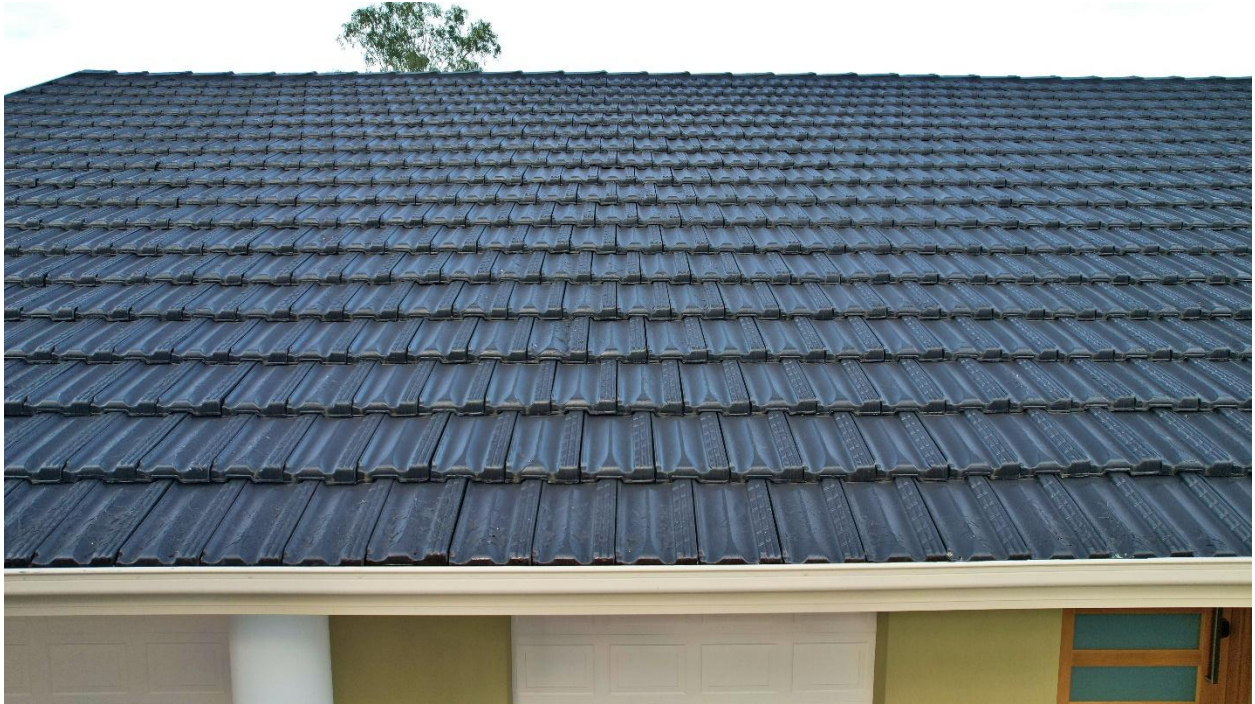
Photo 2 - Close up of roof section along the gutter line, showing peeling, bubbling and cracking paint

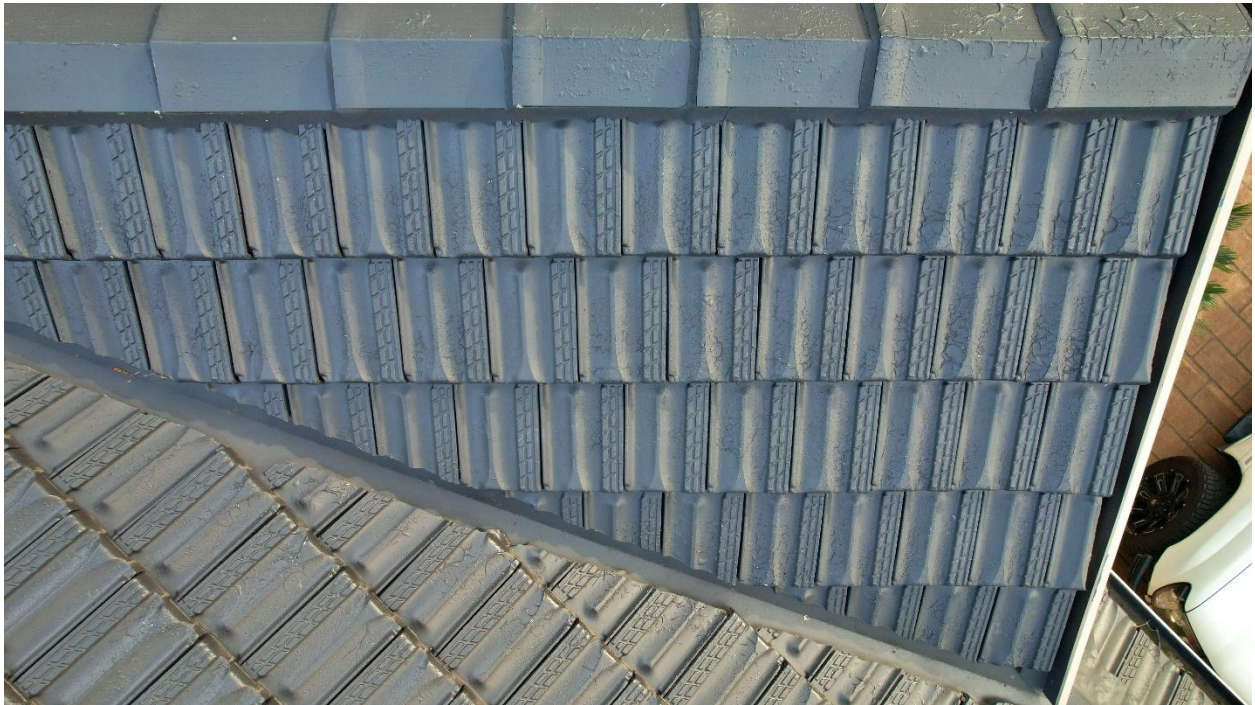
Photo 3 – Peeling and cracking paint can be observed along the ridge cap and most tiles

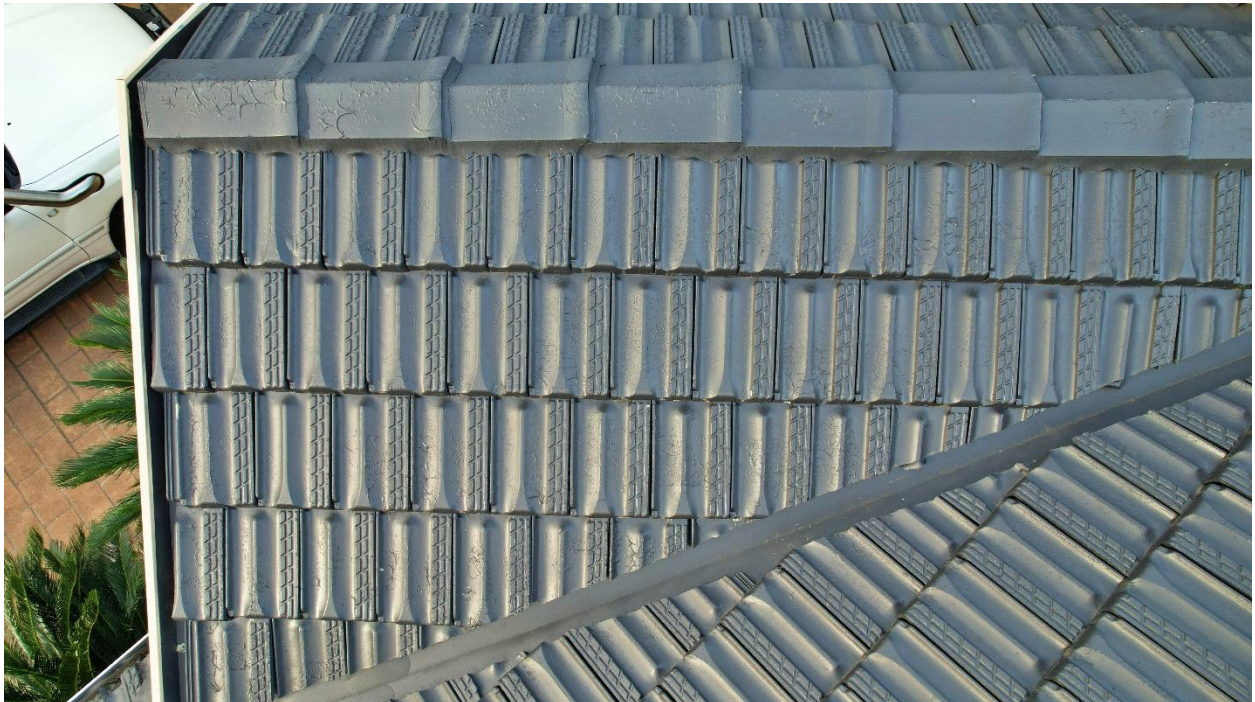
Photo 1 - Peeling, bubbling and cracking paint can be observed along the ridge cap and most tiles

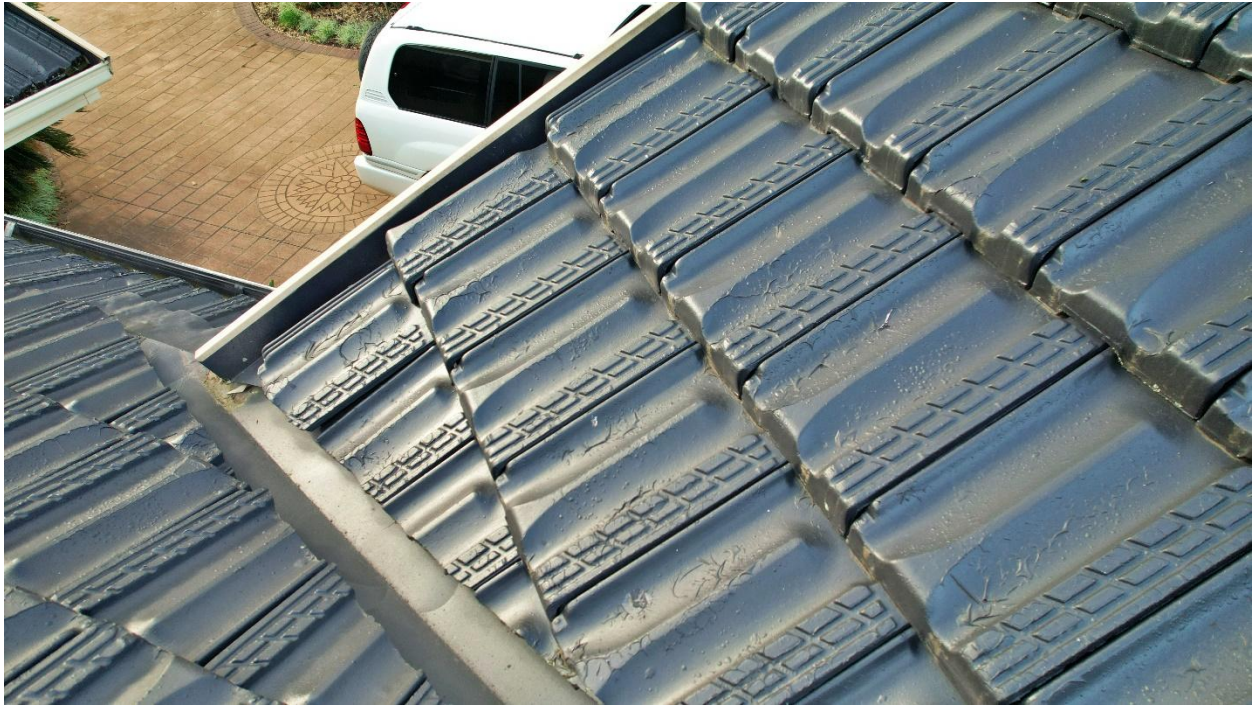
Photo 2 – Close up of bubbling and cracking can be seen

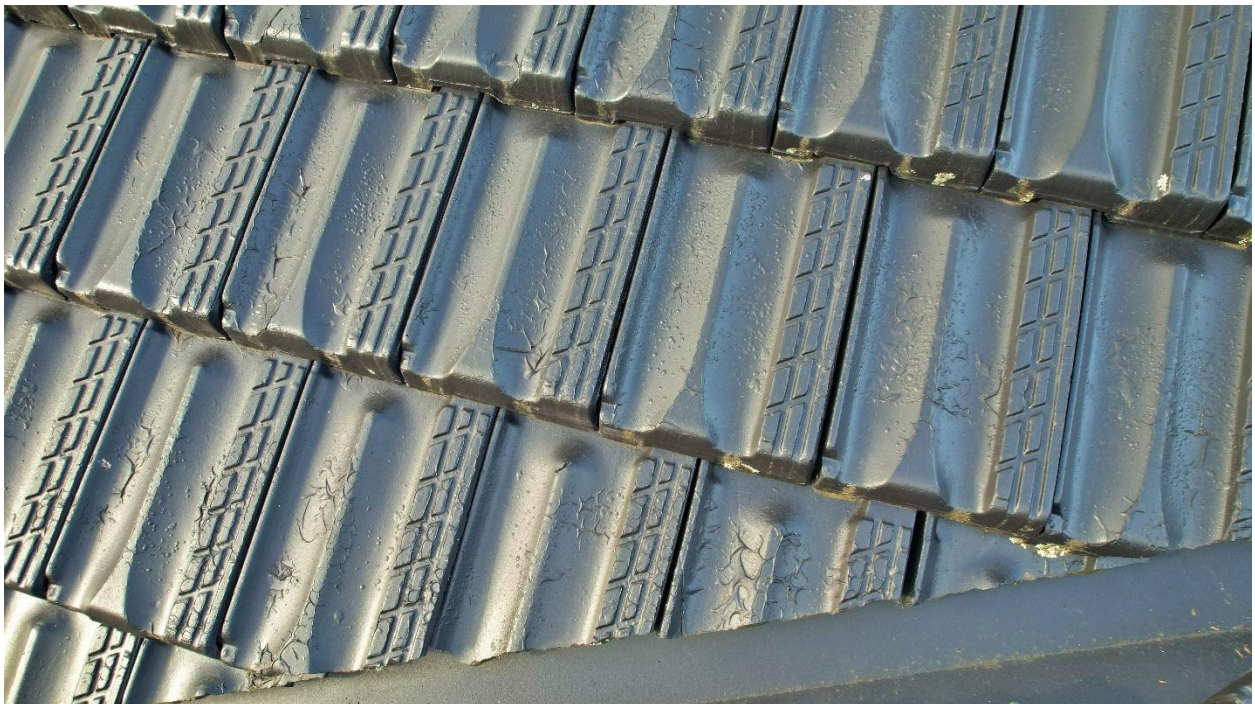
Photo 3 – Close up of bubbling and cracking can be seen

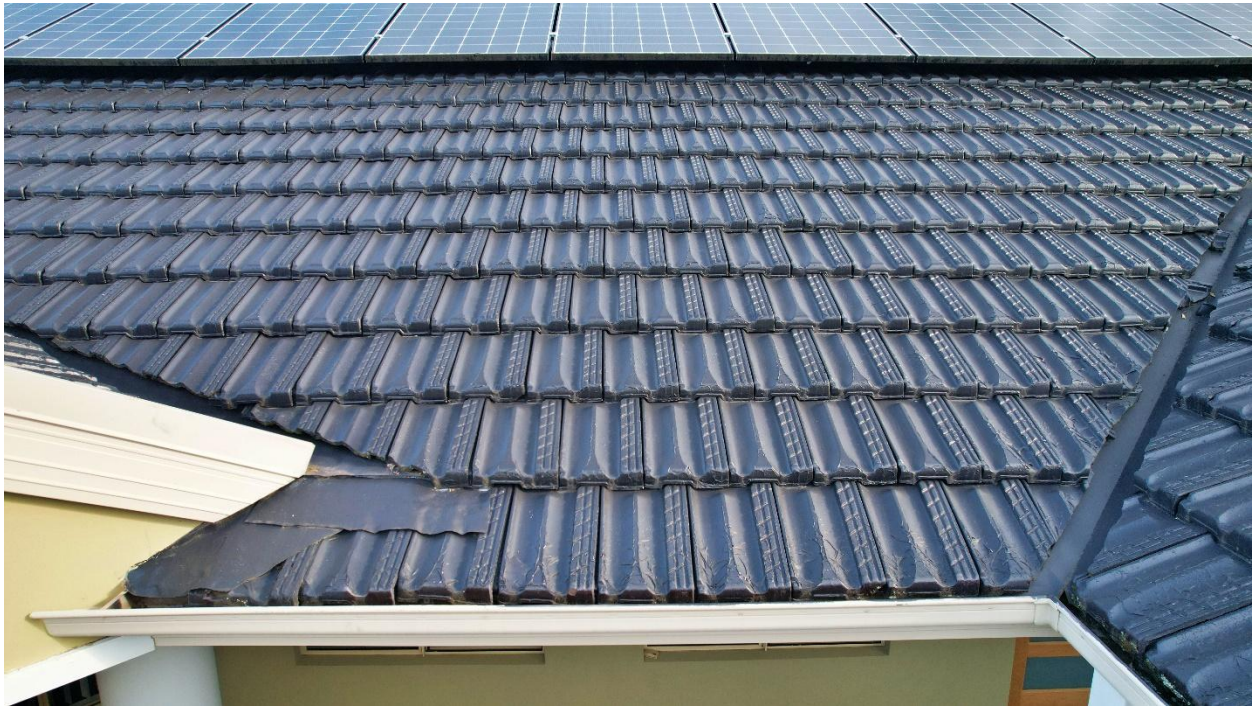
Photo 4 – Close up of roof section along the gutter line, showing peeling, bubbling and cracking paint which extends from the gutter to solar panels

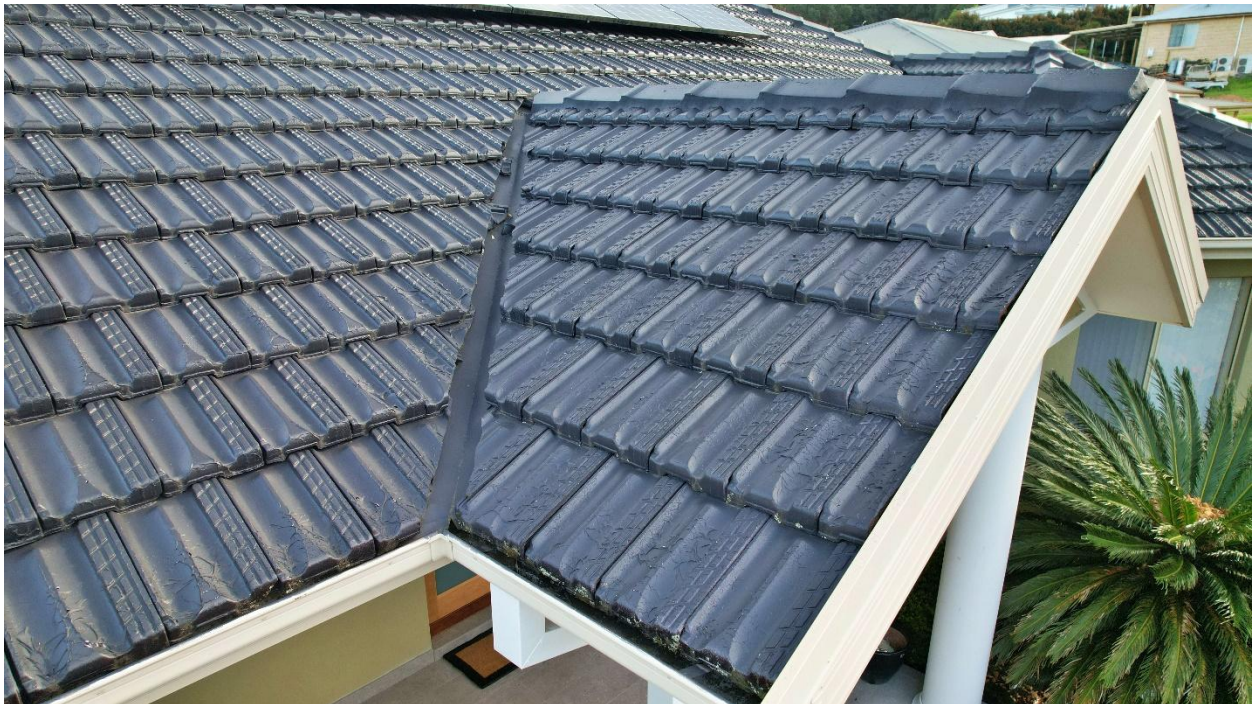
Photo 5 - Close up of roof section along the gutter line, showing peeling, bubbling and cracking paint

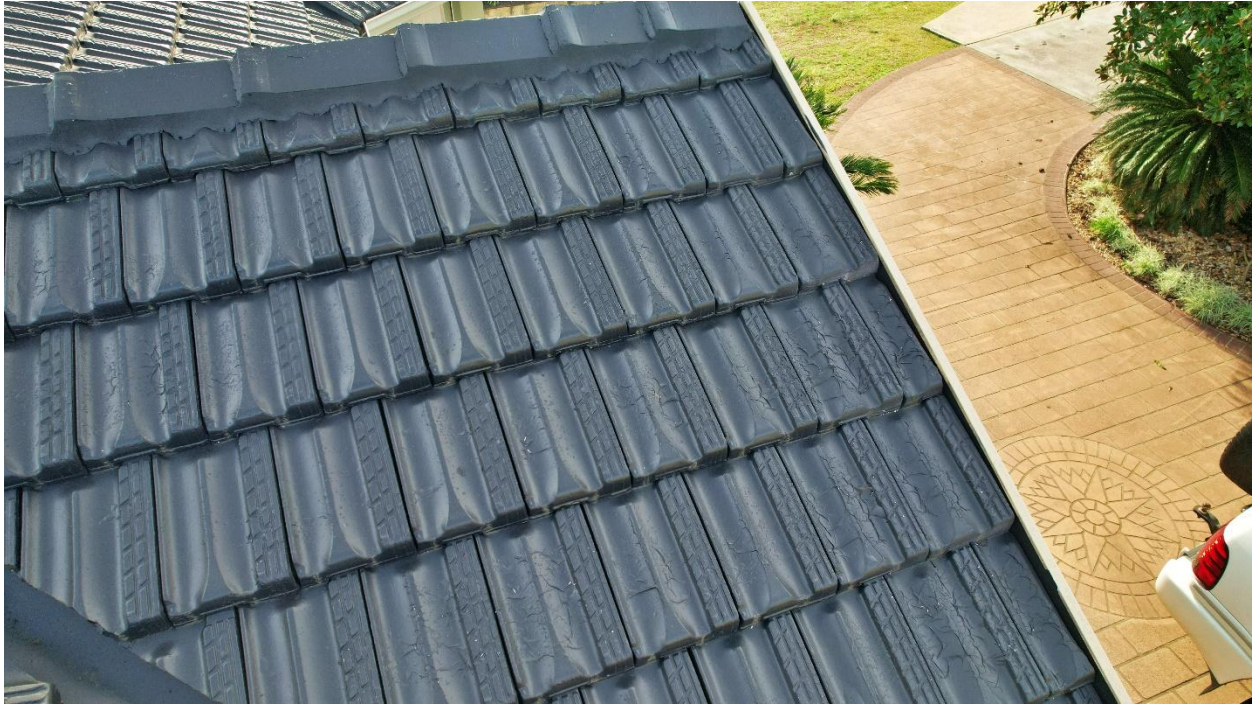
Photo 6 - Close up of roof section, showing peeling, bubbling and cracking paint

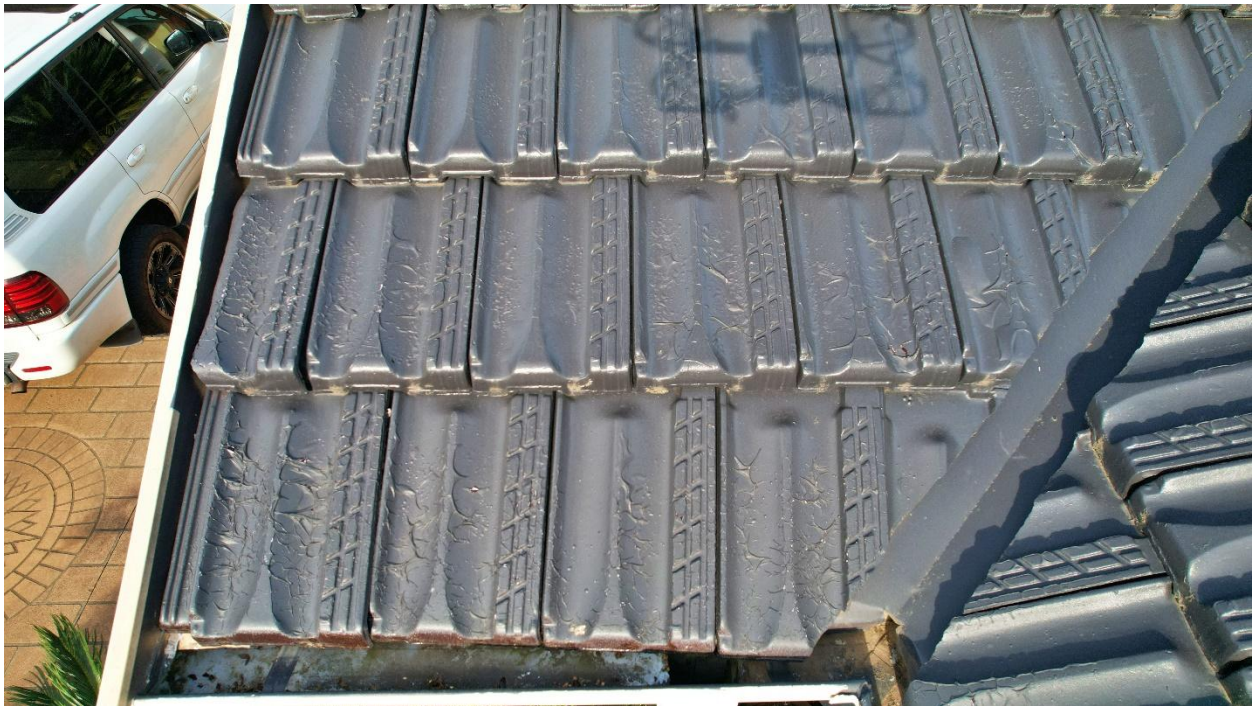
Photo 7 - Close up of roof section, showing, peeling, bubbling and cracking paint

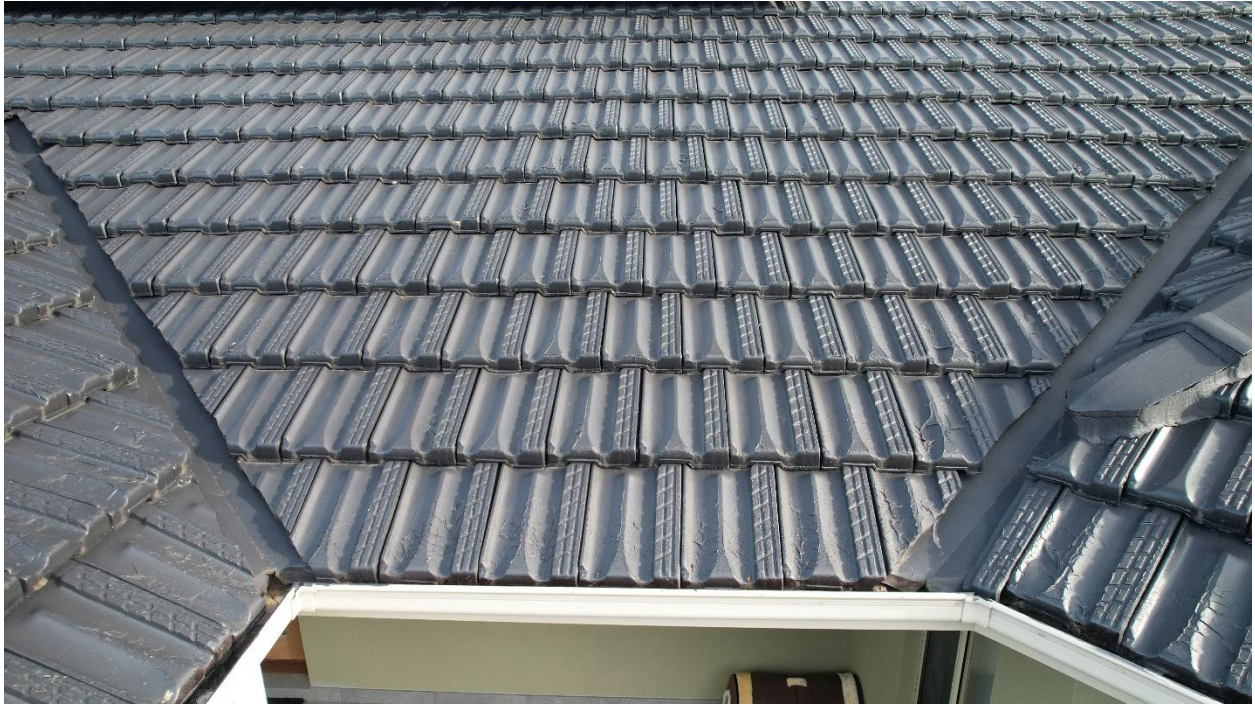
Photo 8 - Close up of roof section along the gutter line, showing peeling, bubbling and cracking paint which extends from the gutter to solar panels

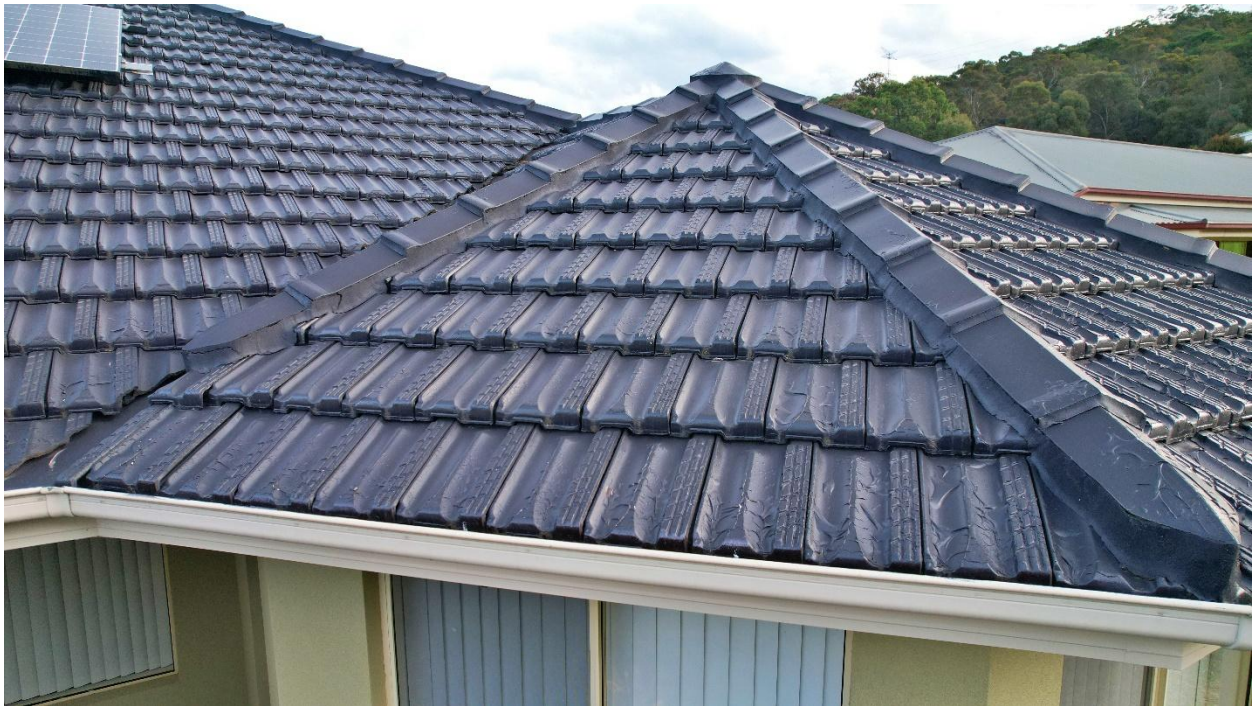
Photo 9 - Close up of roof section along the gutter line, showing peeling, bubbling and cracking paint

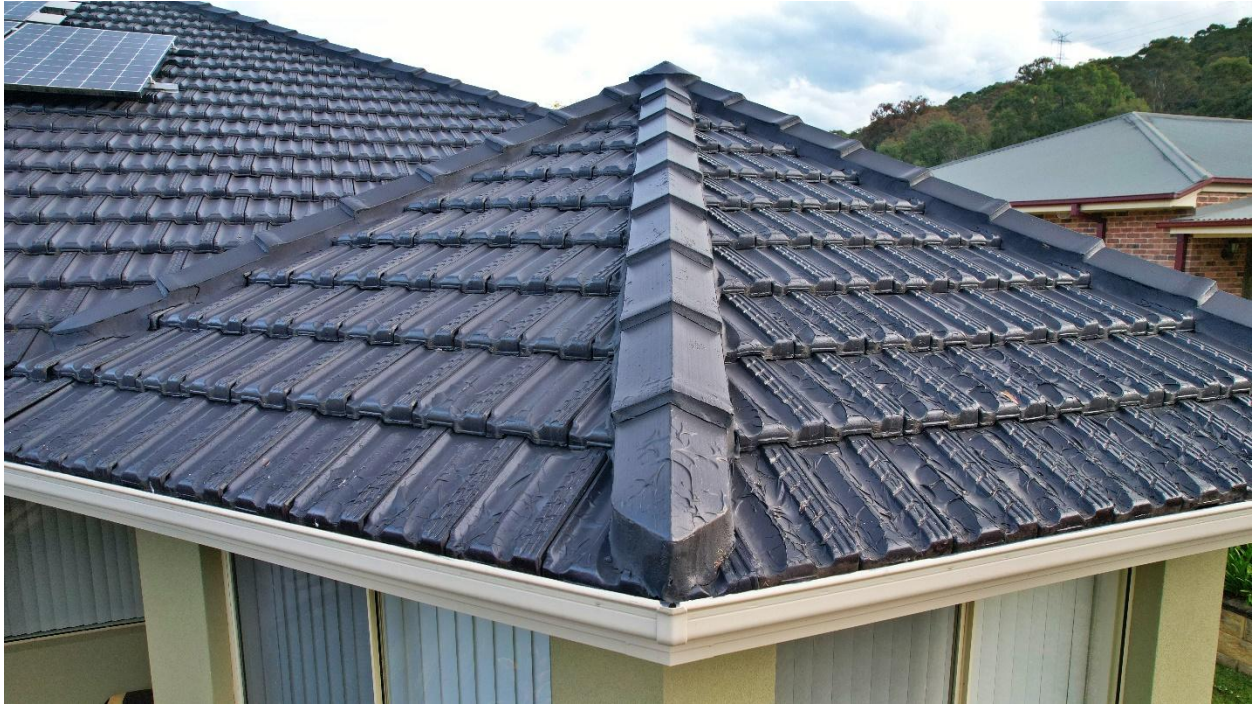
Photo 10 - Close up of the gutterline and ridge cap. Peeling, bubbling and cracking is quite present of this section of the roof

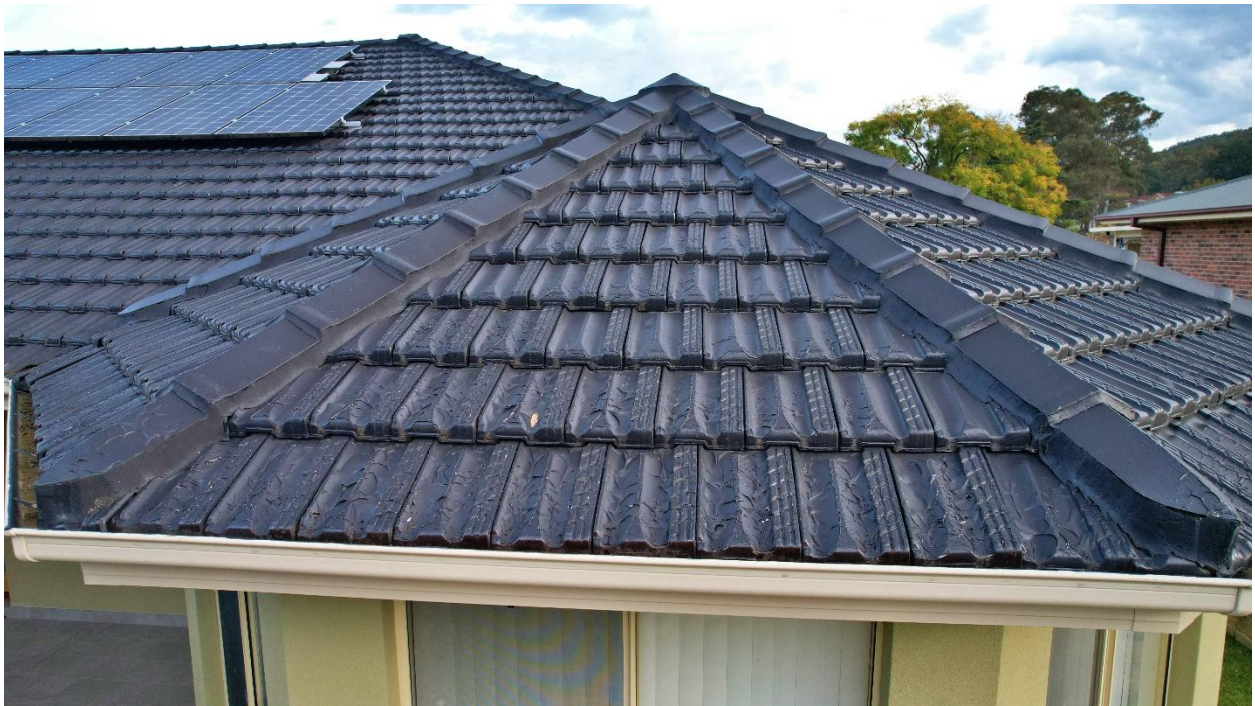
Photo 11 - Close up of the gutterline and ridge cap. Peeling, bubbling and cracking is very bad in the section of the roof

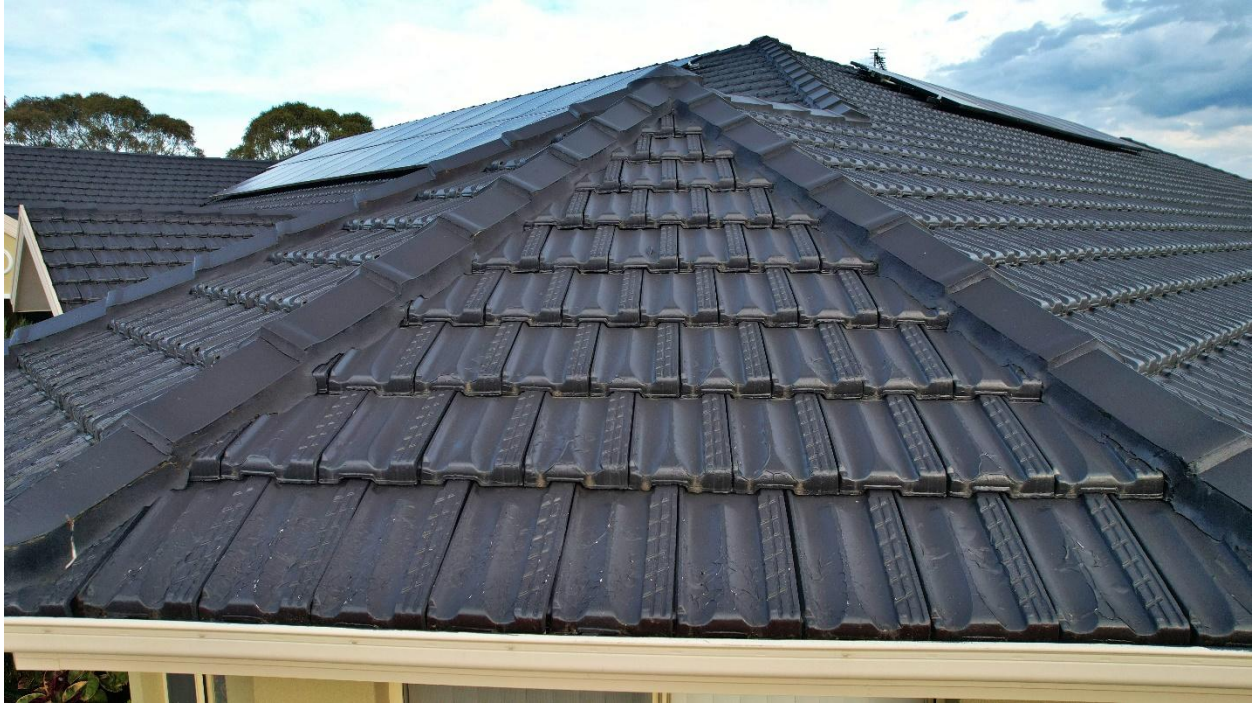
Photo 12 - Close up of the gutterline and ridge cap. Peeling, bubbling and cracking is quite present of this section of the roof
