INSPECTION DATE - 8 SEPTEMBER 2024

# ROOF INSPECTION REPORT

8 RIVERTOP CLOSE, EMU HEIGHTS, NSW, 2750

REPORT PREPARED BY JIM MCGRATH

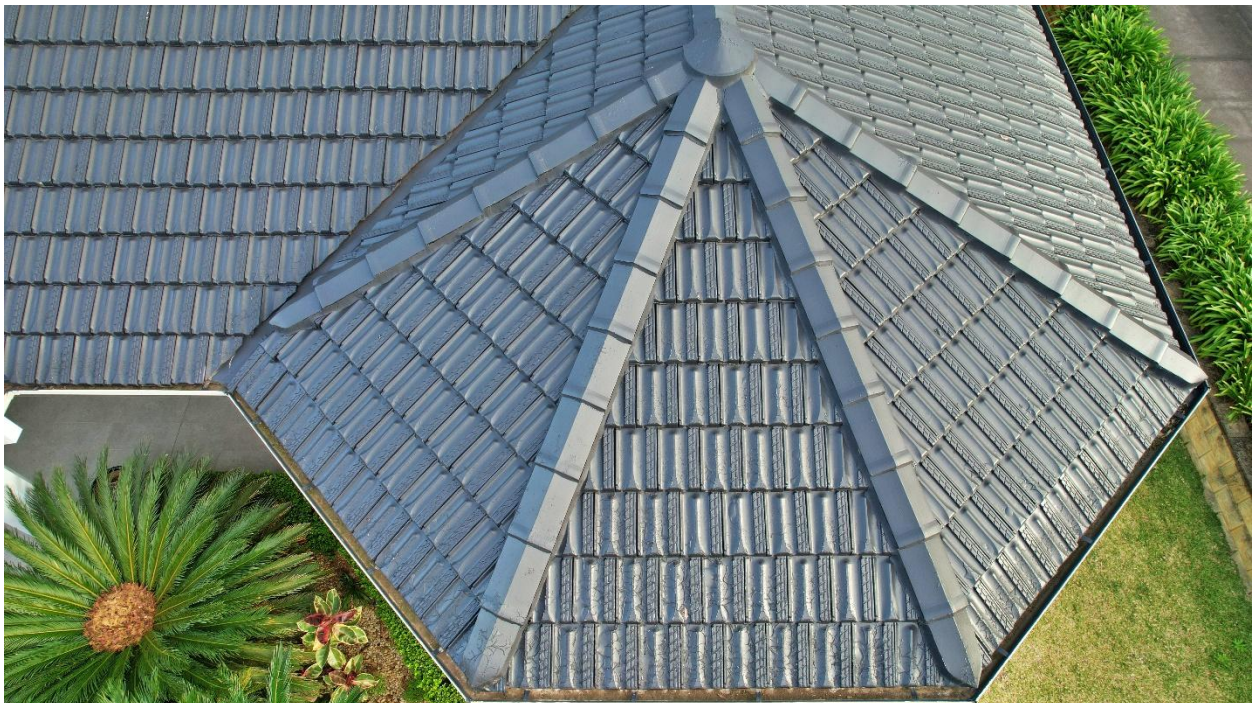
Photo 13 – Top down overview of photos 9-12 showing the extensive paint damage and degradation. This section appears to be the worst on the roof

1. Roof Sections A–D and J present the most significant levels of deterioration across the property. Large portions of the roofing system display widespread coating failure, including bubbling, peeling, and cracking across numerous tiles. These defects indicate advanced weathering and prolonged exposure, which may compromise the protective coating and accelerate further degradation if left unaddressed.

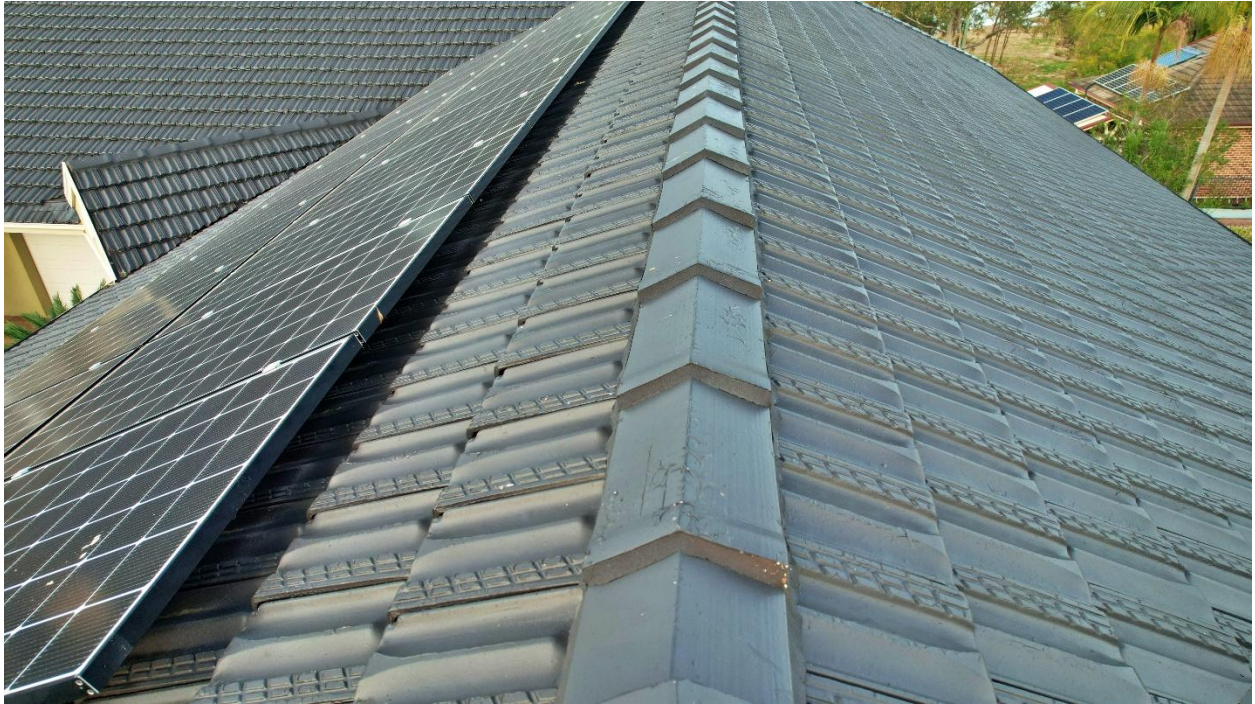
Photo 14 – Close up of roof section, showing peeling, bubbling and cracking along the ridge cap and under solar panels

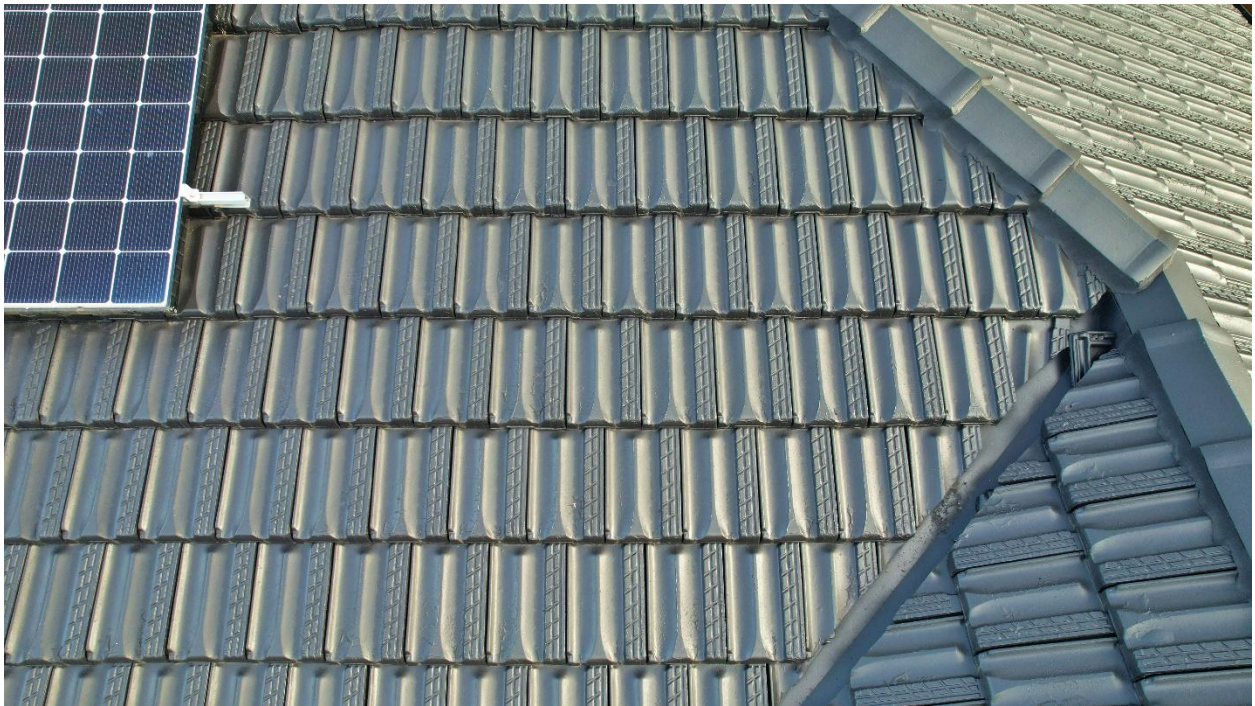
Photo 15 – Close up of roof section, showing peeling, bubbling and cracking. Extensive damage and degradations are observed around the solar .

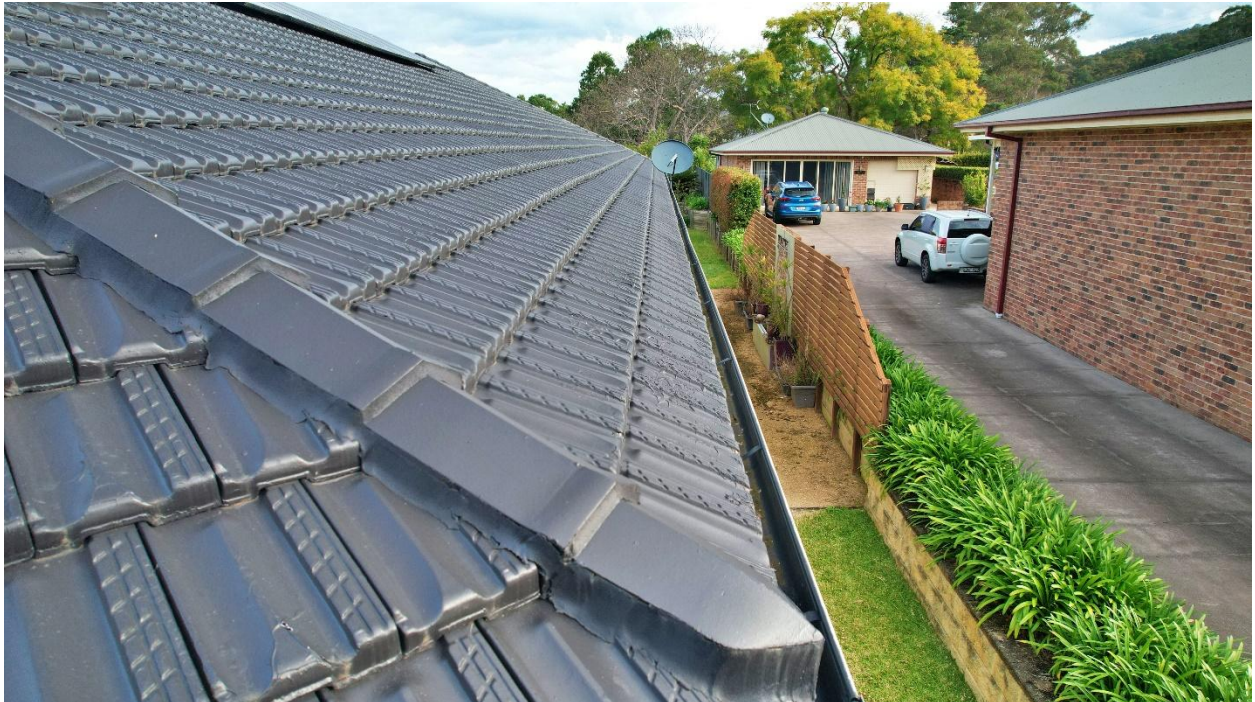
Photo 1 - Peeling, bubbling and cracking paint can be observed along part of the ridge cap and gutter line

3. Roof Sections E–I exhibit comparatively lower levels of deterioration than Sections A–D, J, and K; however, early-stage defects are clearly visible. These include minor coating breakdown, initial cracking, and localised peeling, which are developing in a similar pattern to those observed in the more affected sections and may progress over time without appropriate maintenance or intervention.

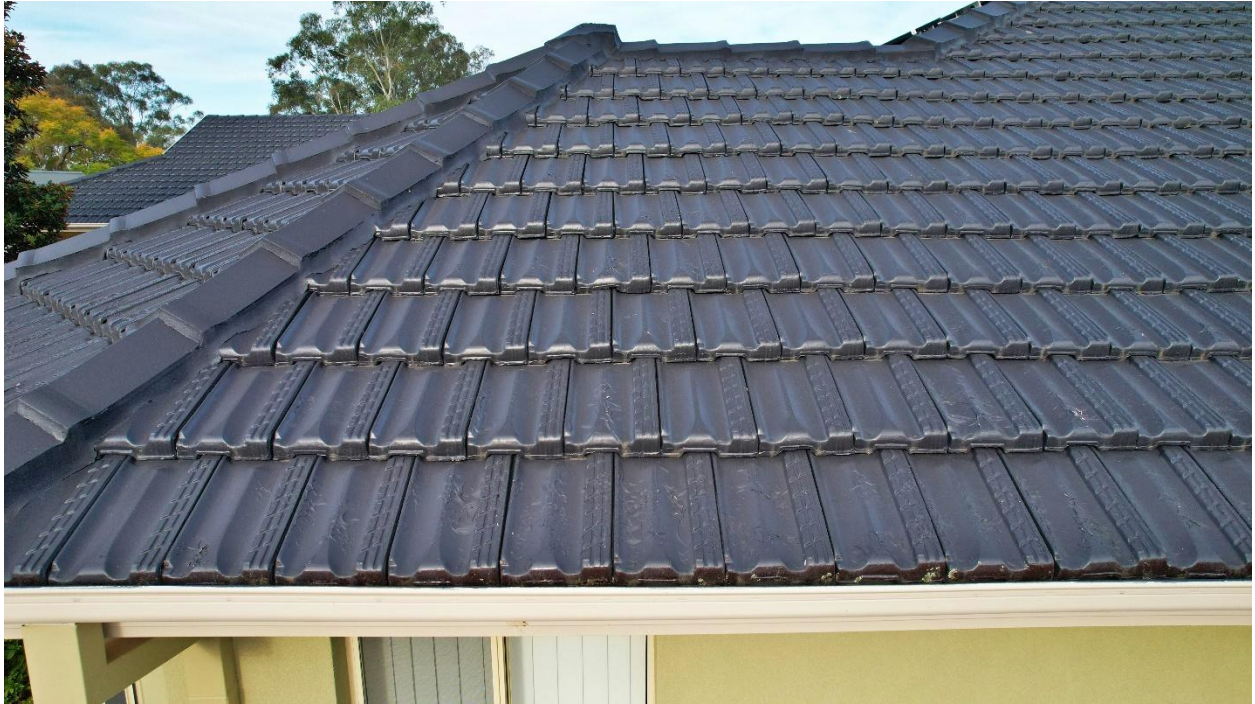
Photo 2 - Close up of roof section along the gutter line, showing peeling, bubbling and cracking paint

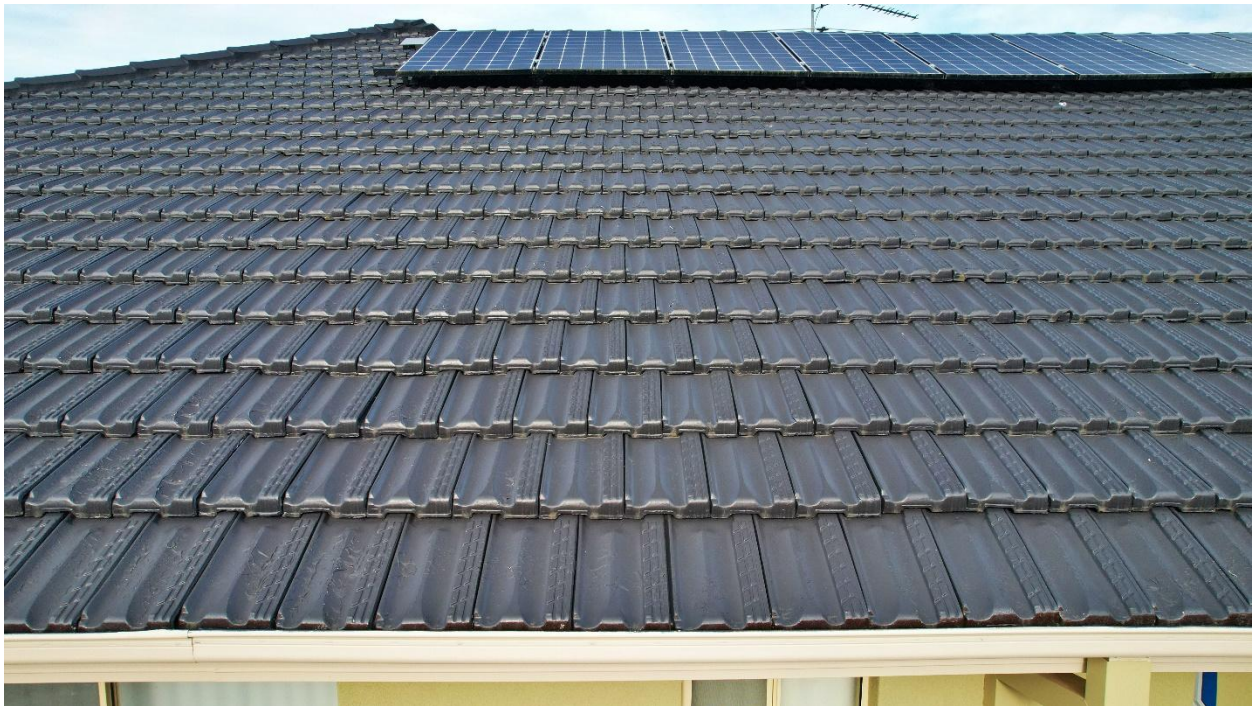
Photo 3 - Close up of roof section along the gutter line, showing bubbling and cracking paint which extends from the gutter to solar panels

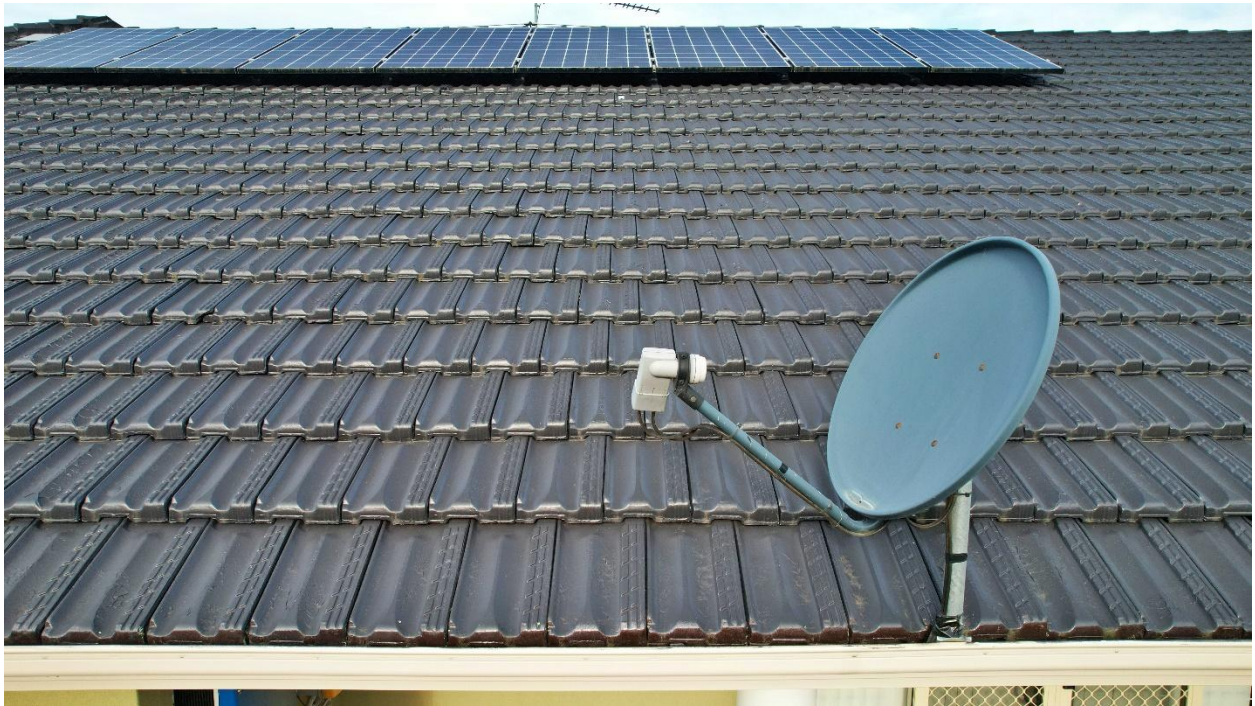
Photo 4 - Close up of roof section along the gutter line, showing peeling, bubbling and cracking paint which extends from the gutter to solar panels

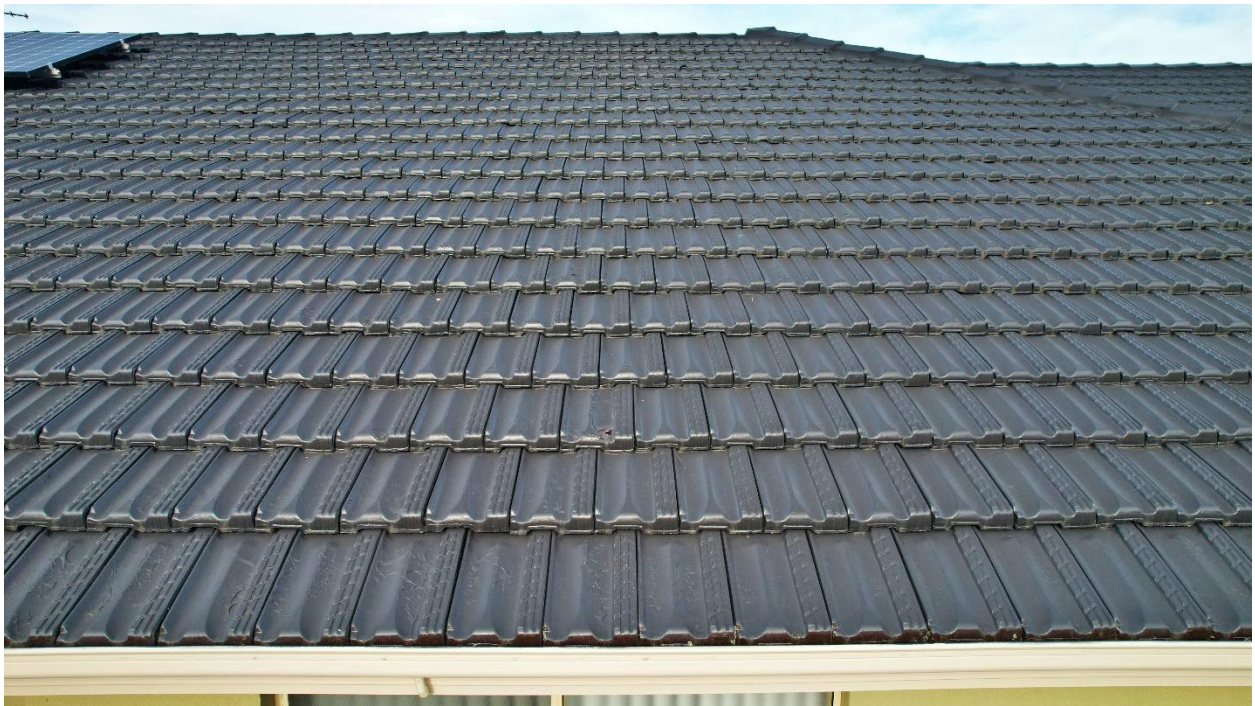
Photo 5 - Close up of roof section along the gutter line, showing peeling, bubbling and cracking paint which extends from the gutter to solar panels

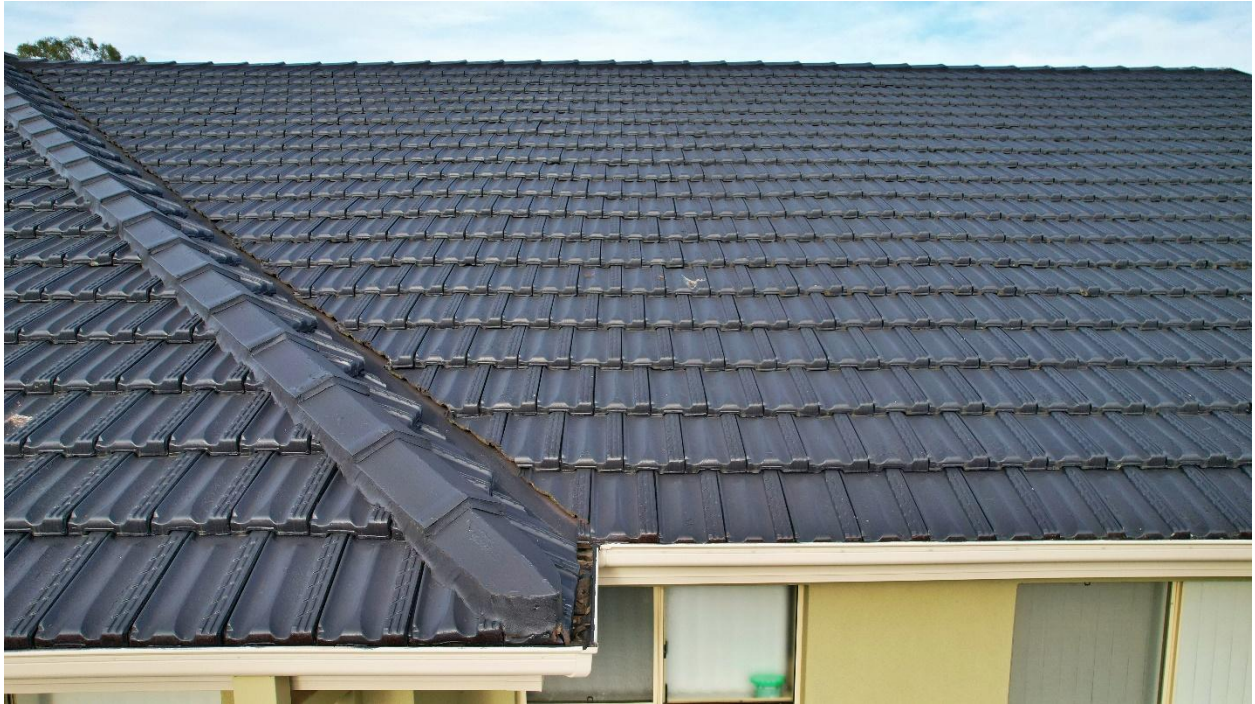
Photo 6 – Whilst less prevalent on this section, there is slight peeling and cracking paint along the ridge cap

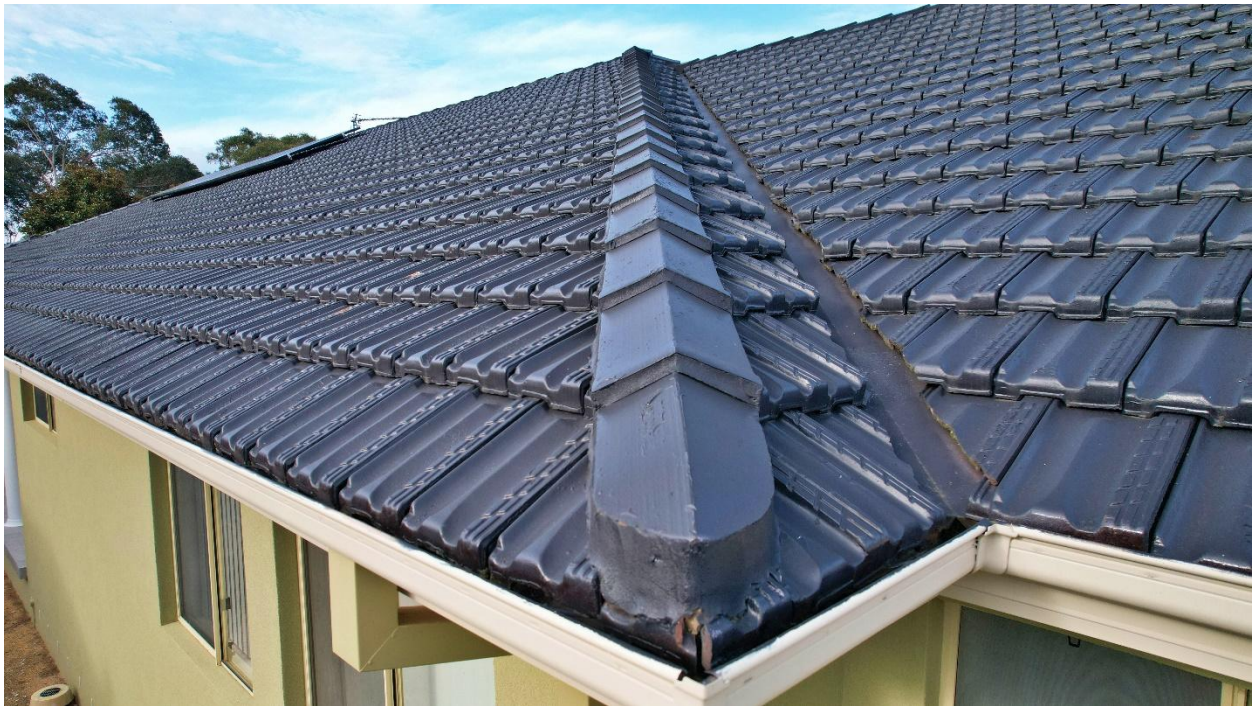
Photo 7 – Whilst less prevalent on this section, there is slight peeling and cracking paint starting to form on the ridge cap and tiles up to the flashing

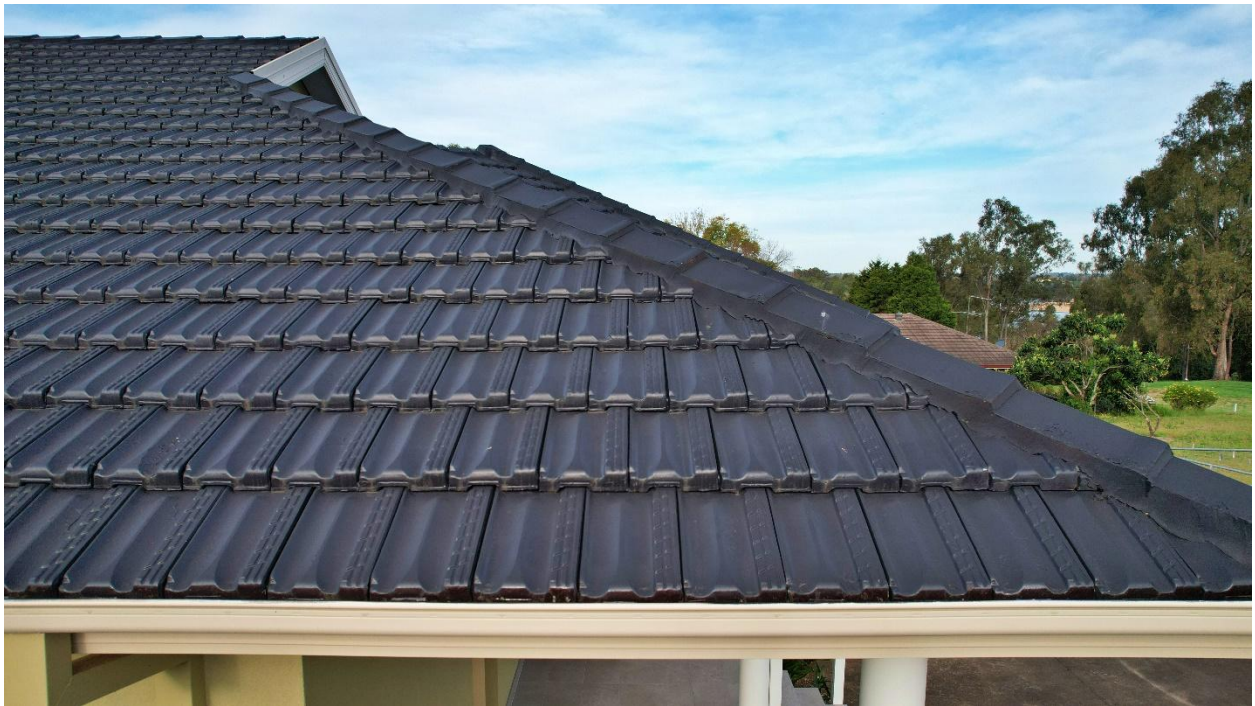
Photo 9 – Whilst less prevalent on this section, there is slight peeling, bubbling and cracking paint starting to form along the ridge cap

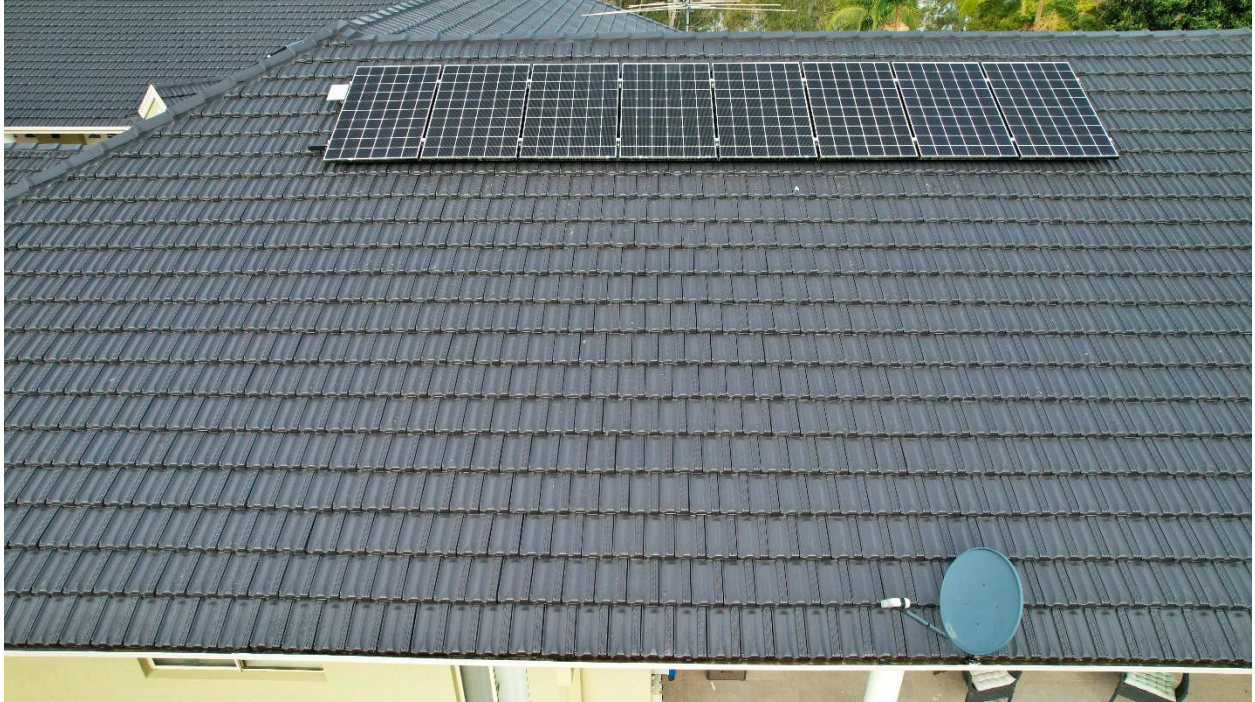
Photo 10 – Top down overview of photos 1-5 showing the paint damage and degradation. Whilst not as damaged as roof section D, degradations are starting to form and become apparent.

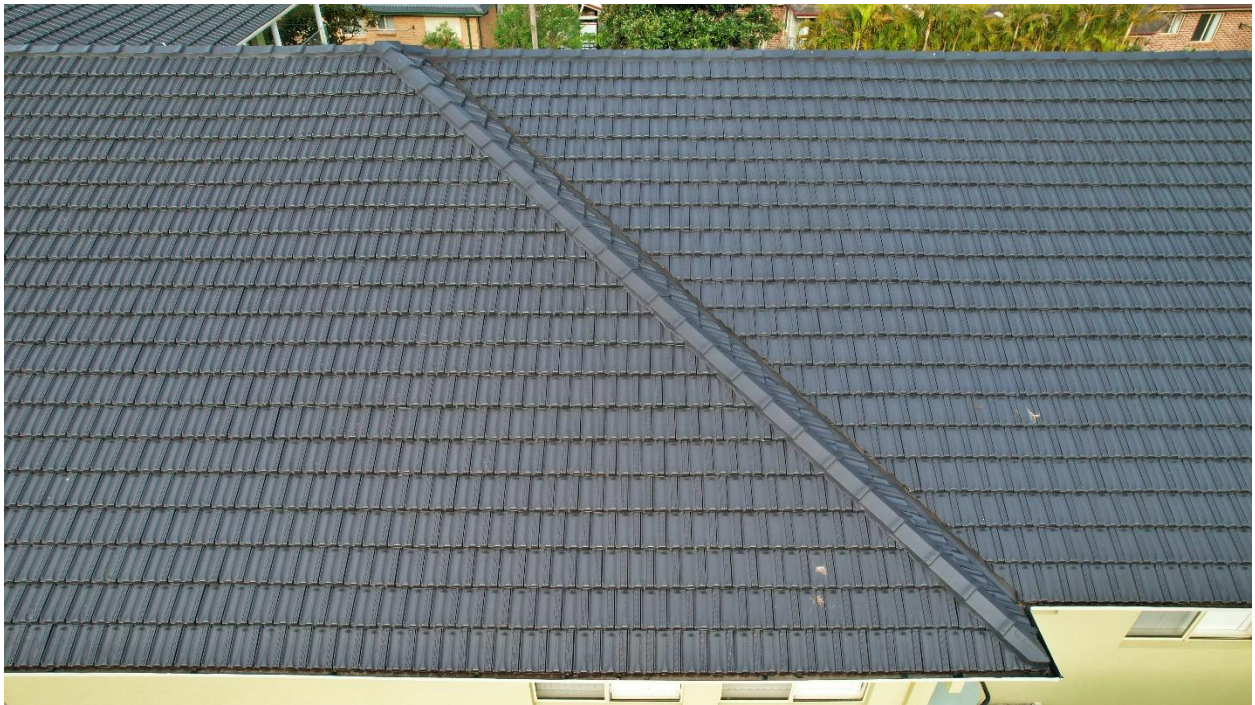
Photo 11 – Top down overview of photos 6-9 showing the paint damage and degradation.

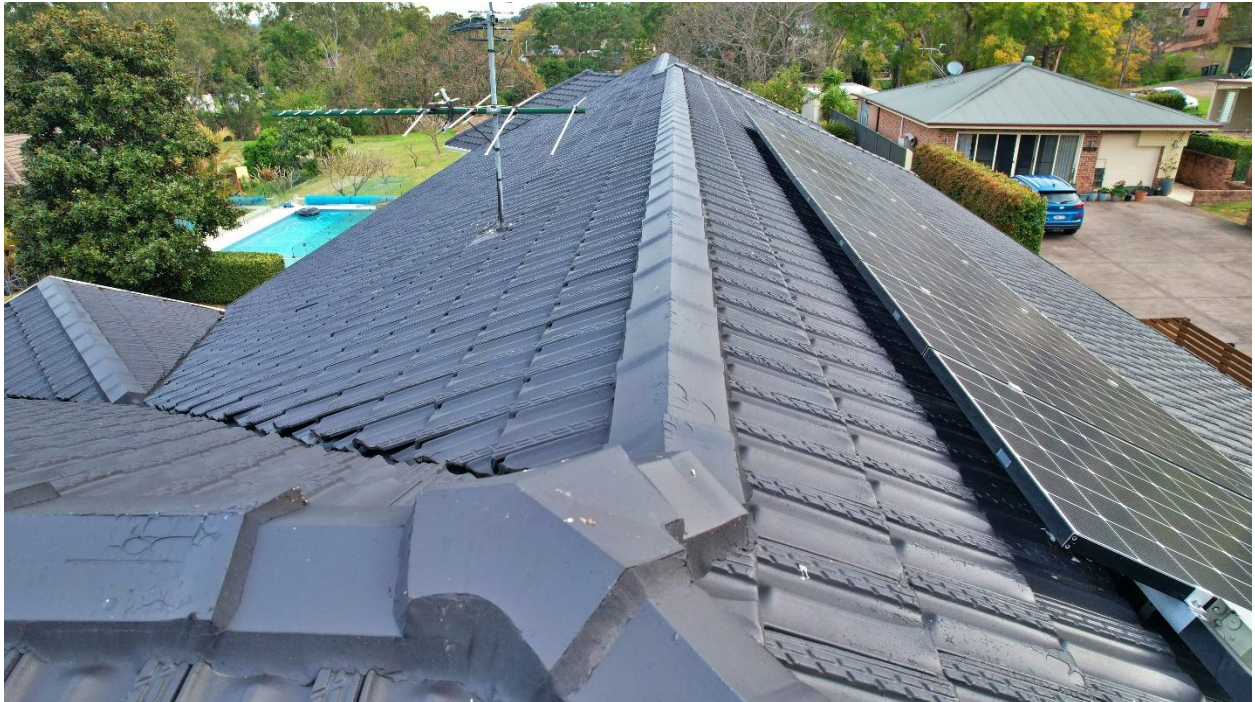
Photo 1 – Paint bubbling, peeling and cracking is present along the ridge cap along this section of roof

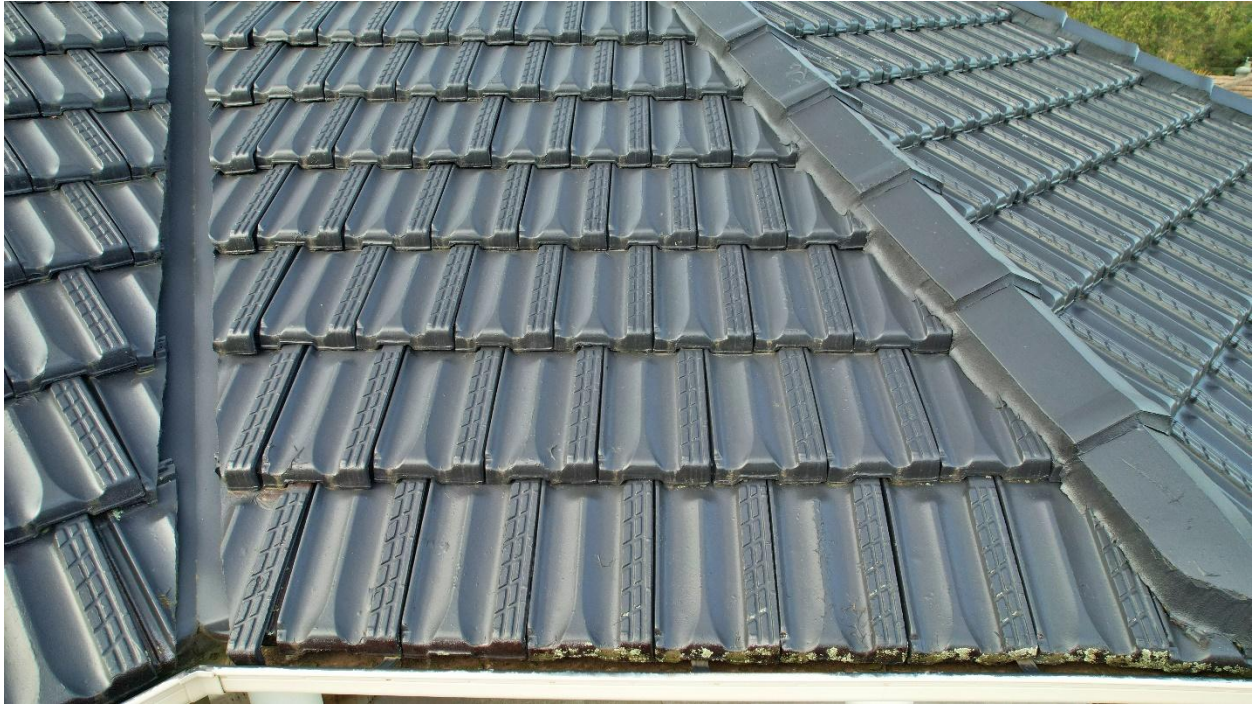
Photo 2 – Whilst less prevalent on this section, there is slight peeling, bubbling and cracking paint starting to form along the gutter line

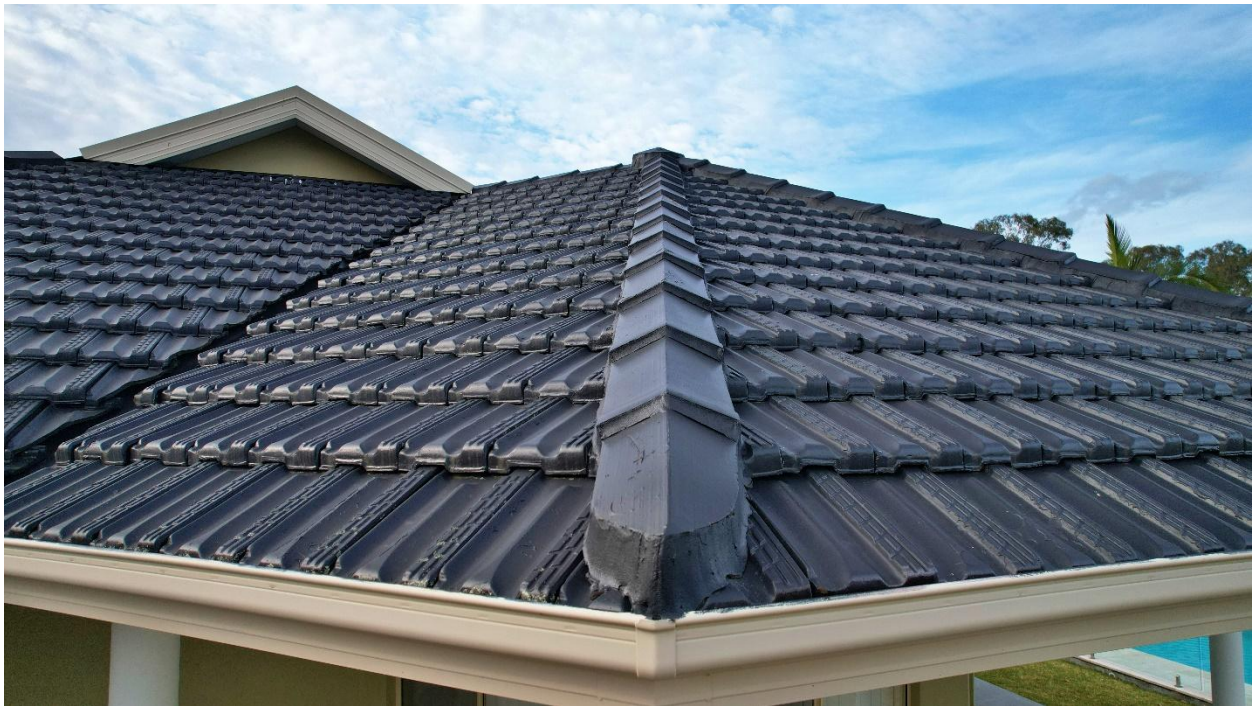
Photo 3 – Whilst less prevalent on this section, there is slight peeling, bubbling and cracking paint starting to form along the ridge cap

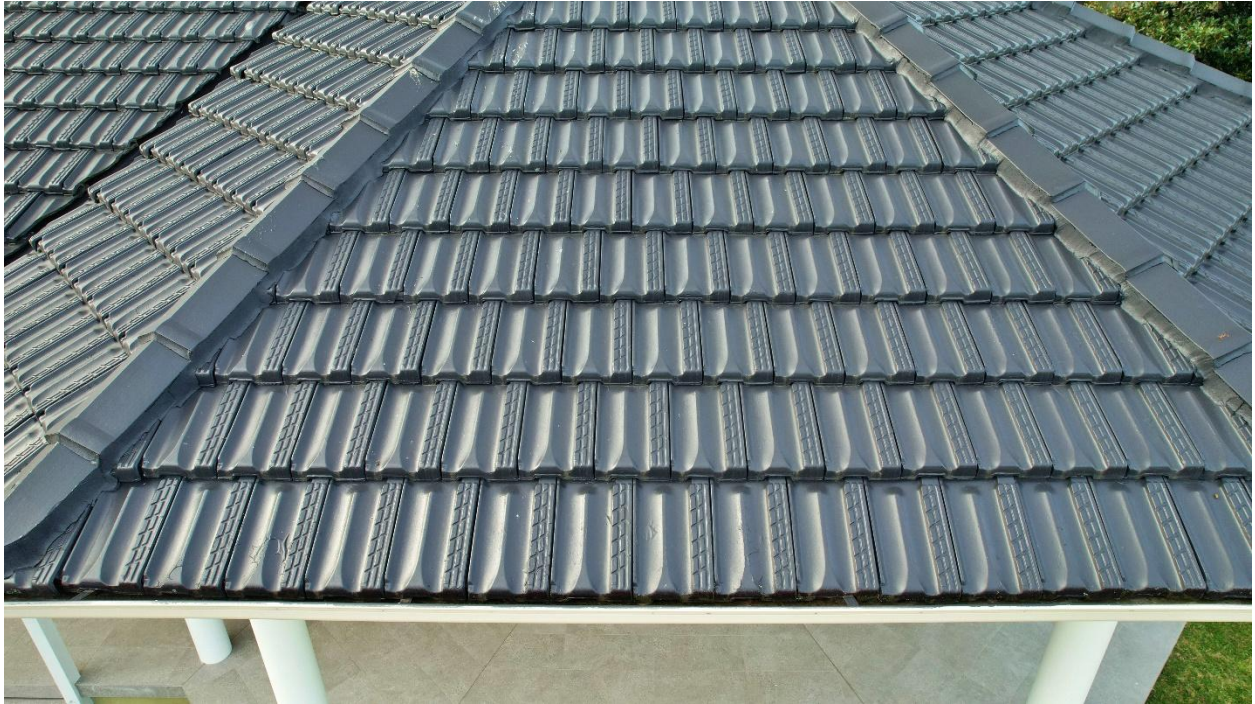
Photo 4 – Close up of the gutterline and ridge cap. Peeling, bubbling and cracking is quite present of this section of the roof

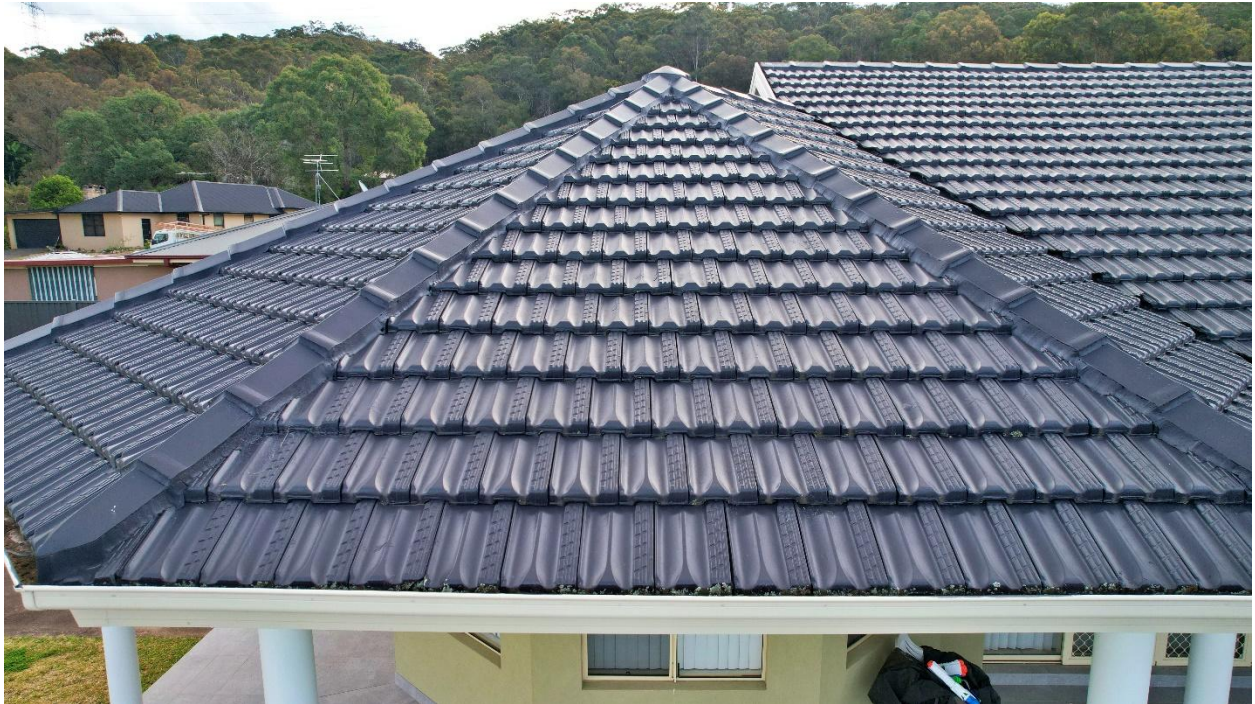
Photo 5 – Whilst less prevalent on this section, there is slight peeling, bubbling and cracking paint starting to form along the ridge cap

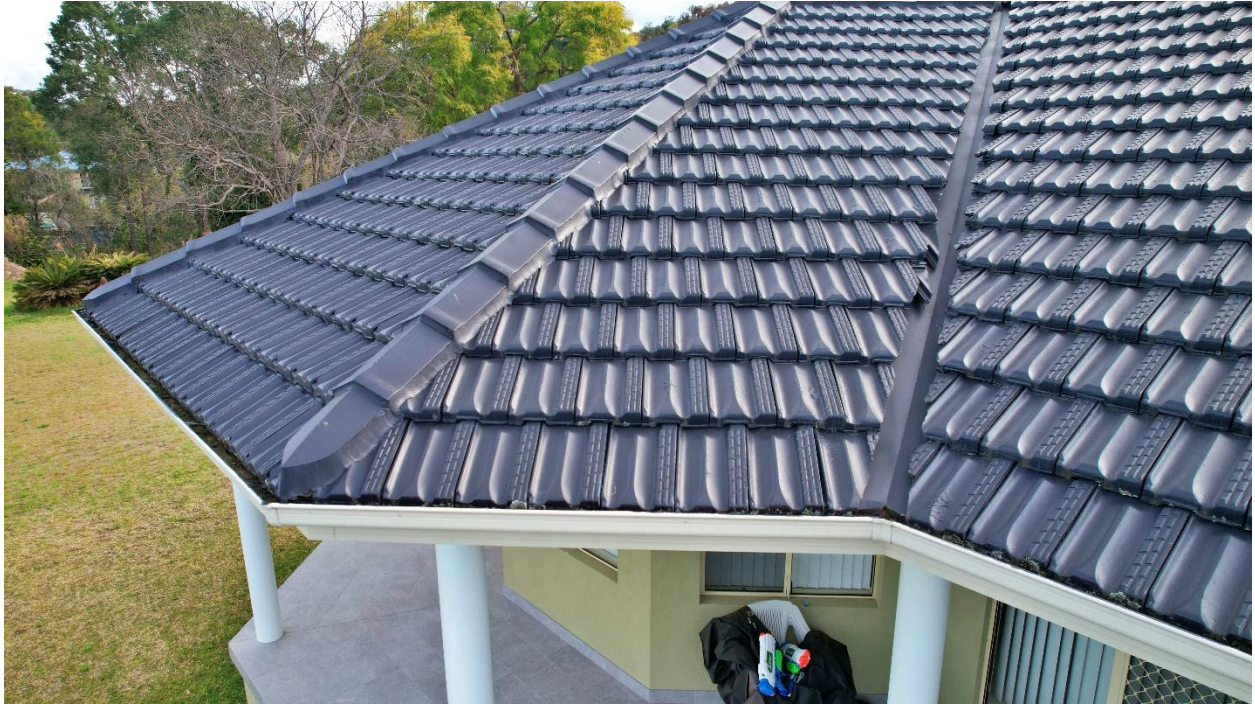
Photo 6 – Whilst less prevalent on this section, there is slight peeling, bubbling and cracking paint starting to form along the ridge cap

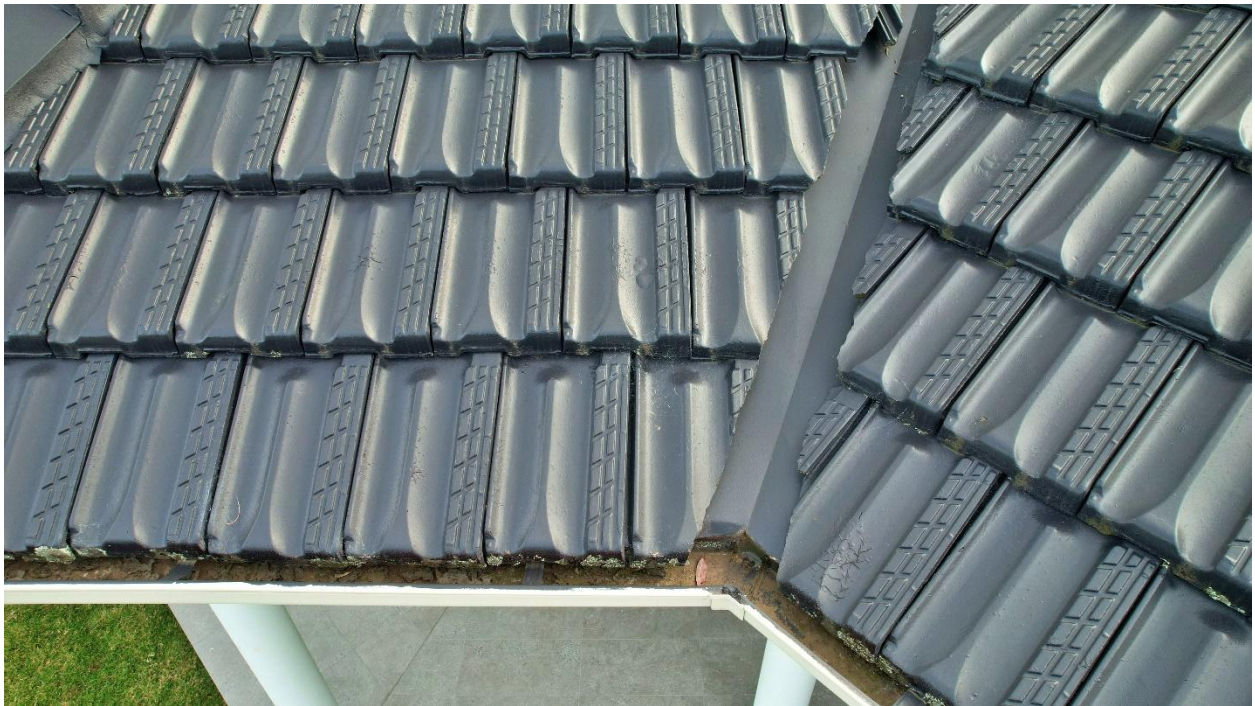
Photo 7 – Close up of roof section along the gutter line, showing peeling, bubbling and cracking paint

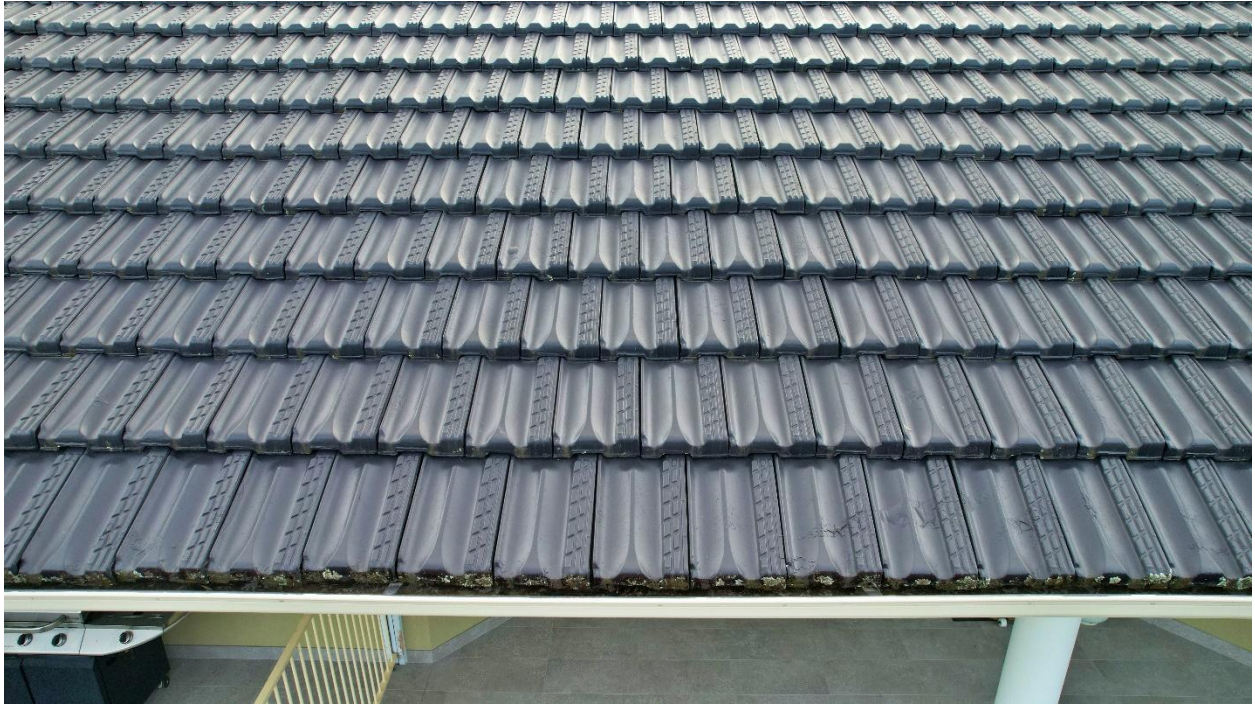
Photo 2 – Whilst less prevalent on this section, there is slight peeling, bubbling and cracking paint starting to form along the gutter line

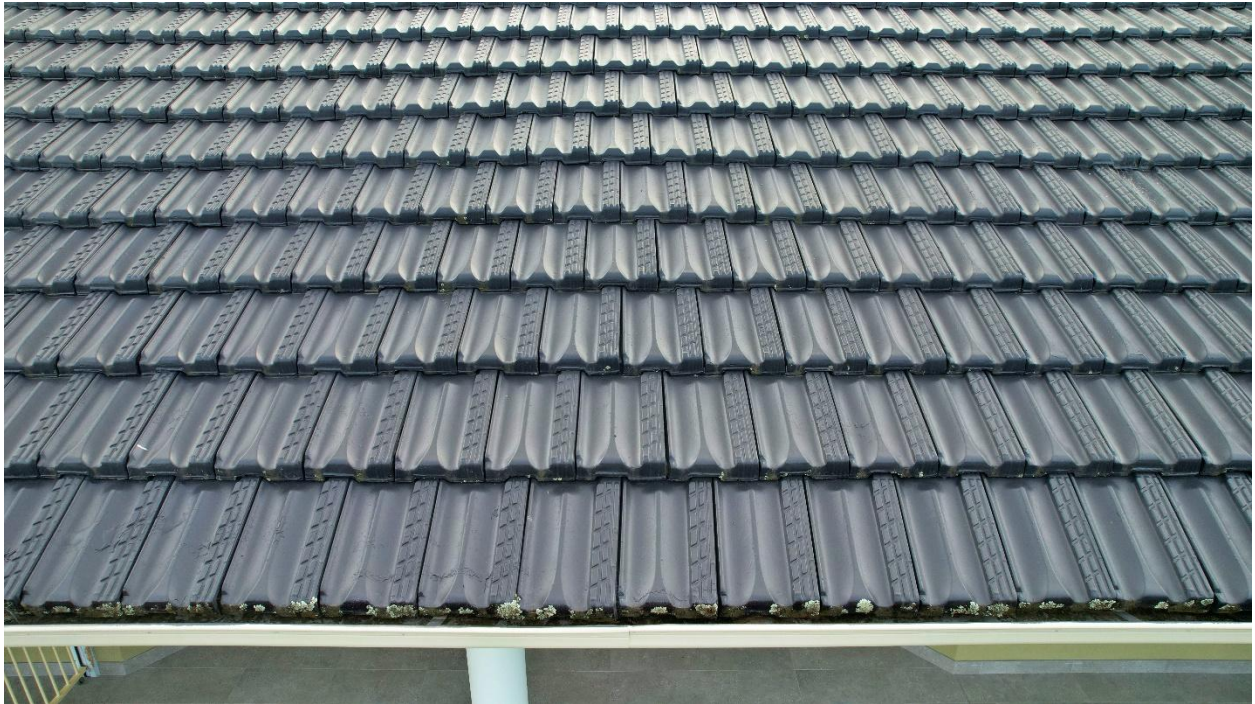
Photo 3 – Whilst less prevalent on this section, there is slight peeling, bubbling and cracking paint starting to form along the gutter line

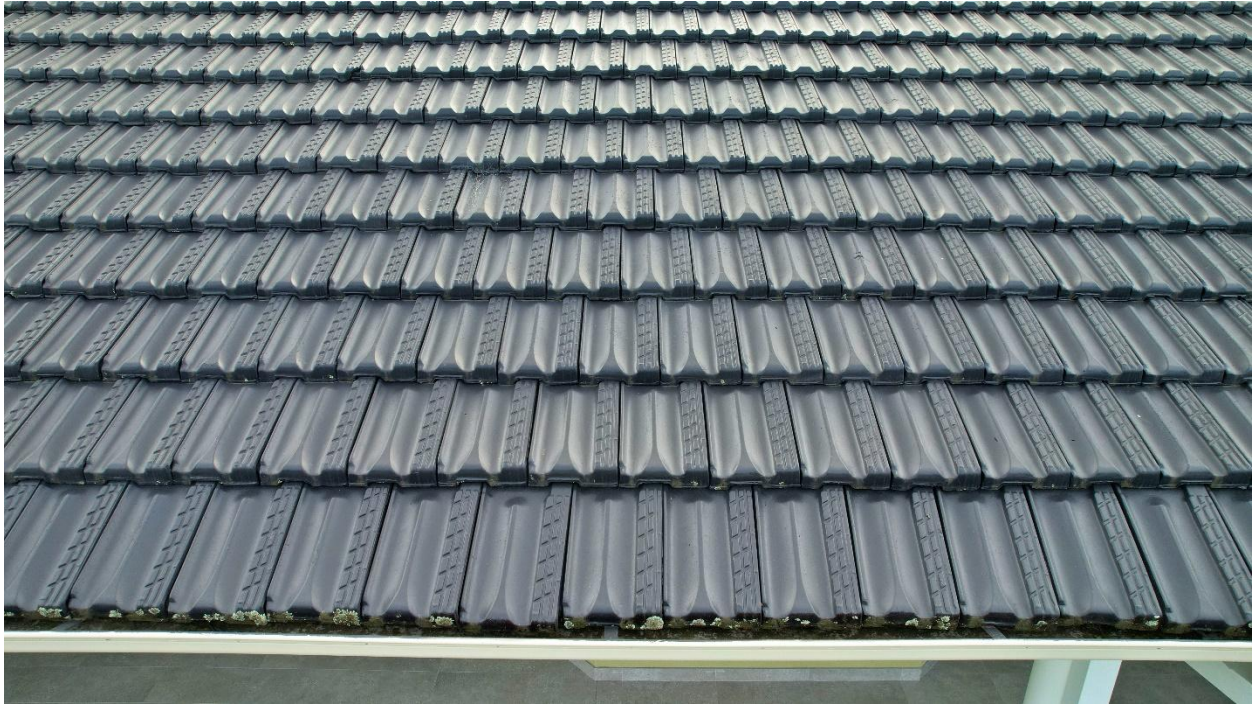
Photo 4 – Whilst less prevalent on this section, there is slight peeling, bubbling and cracking paint starting to form along the gutter line

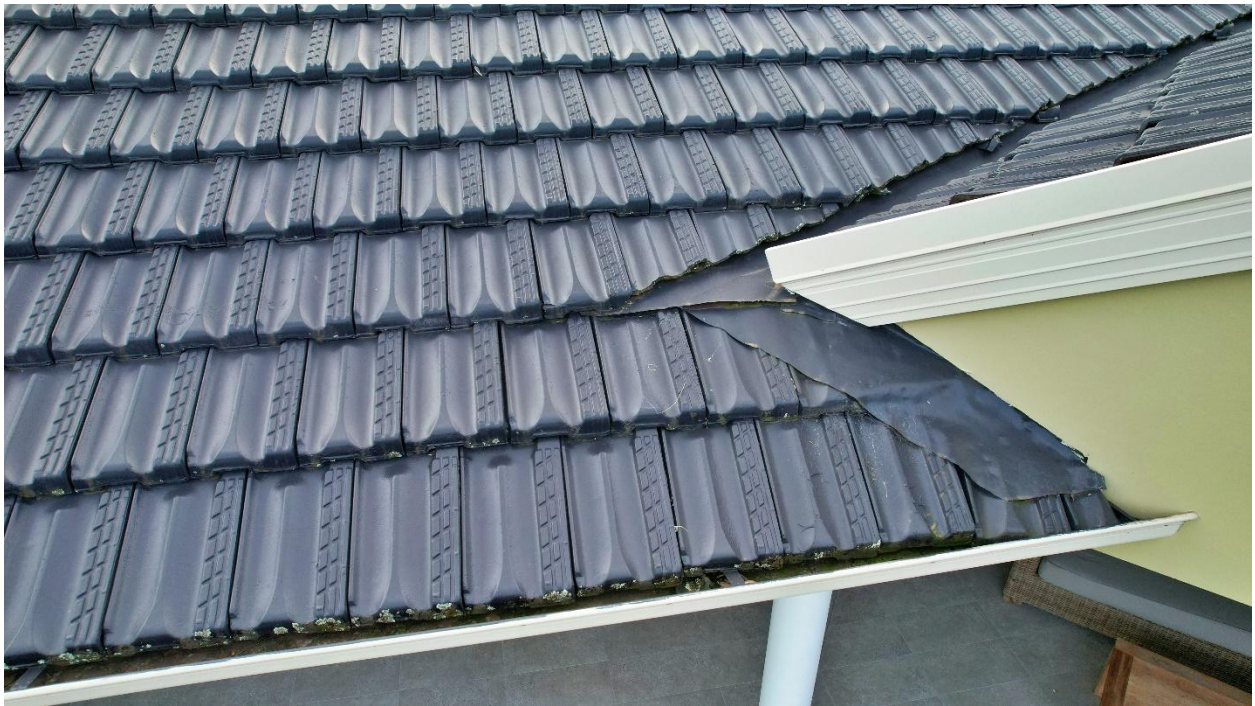
Photo 5 – Whilst less prevalent on this section, there is slight peeling, bubbling and cracking paint starting to form along the gutter line
