INSPECTION DATE - 8 SEPTEMBER 2024

# ROOF INSPECTION REPORT

8 RIVERTOP CLOSE, EMU HEIGHTS, NSW, 2750

REPORT PREPARED BY JIM MCGRATH

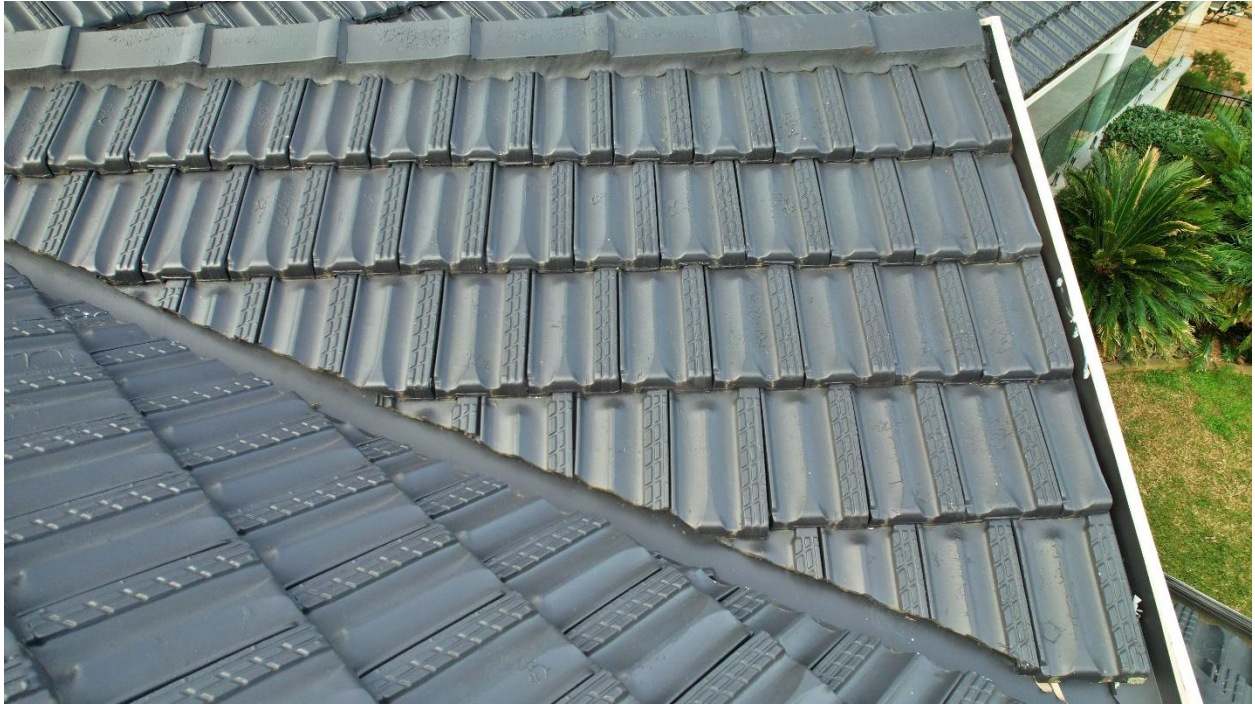
Photo 6 – Close up of roof section along the flashing, showing peeling, bubbling and cracking paint on tiles and the ridge capping

3. Roof Sections E–I exhibit comparatively lower levels of deterioration than Sections A–D, J, and K; however, early-stage defects are clearly visible. These include minor coating breakdown, initial cracking, and localised peeling, which are developing in a similar pattern to those observed in the more affected sections and may progress over time without appropriate maintenance or intervention.

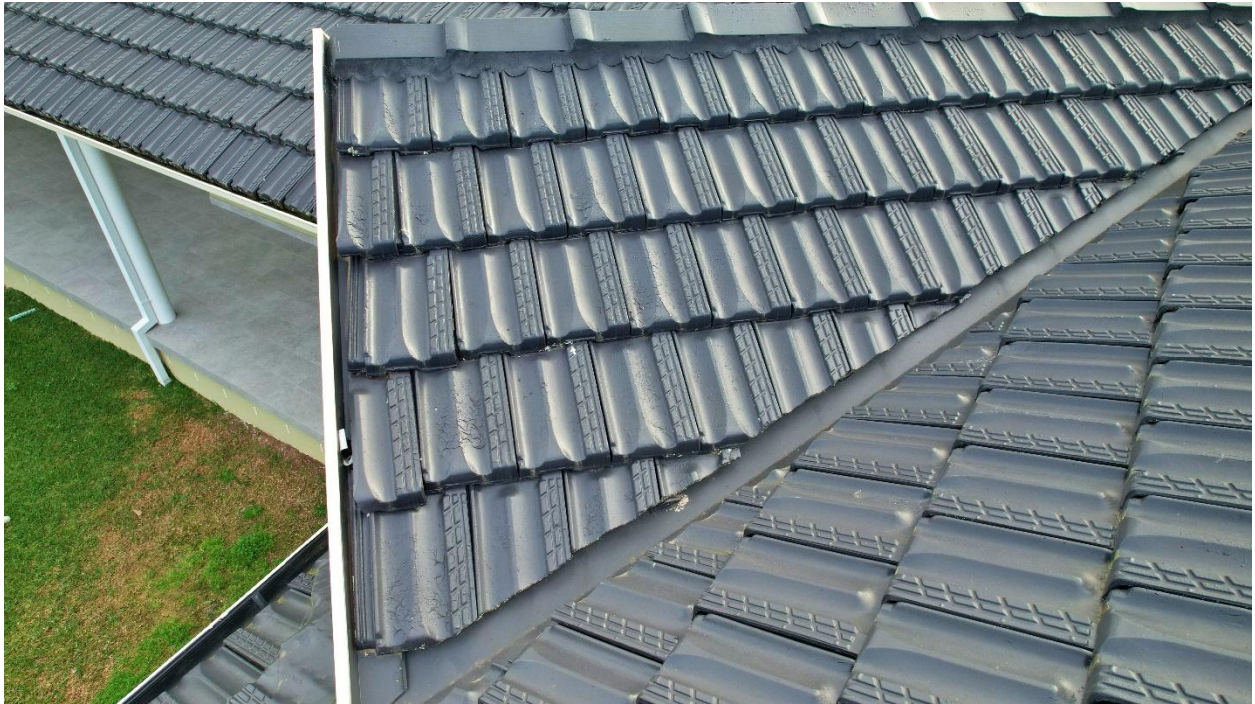
Photo 7 – Close up of roof section along the flashing, showing peeling, bubbling and cracking paint on tiles and the ridge capping

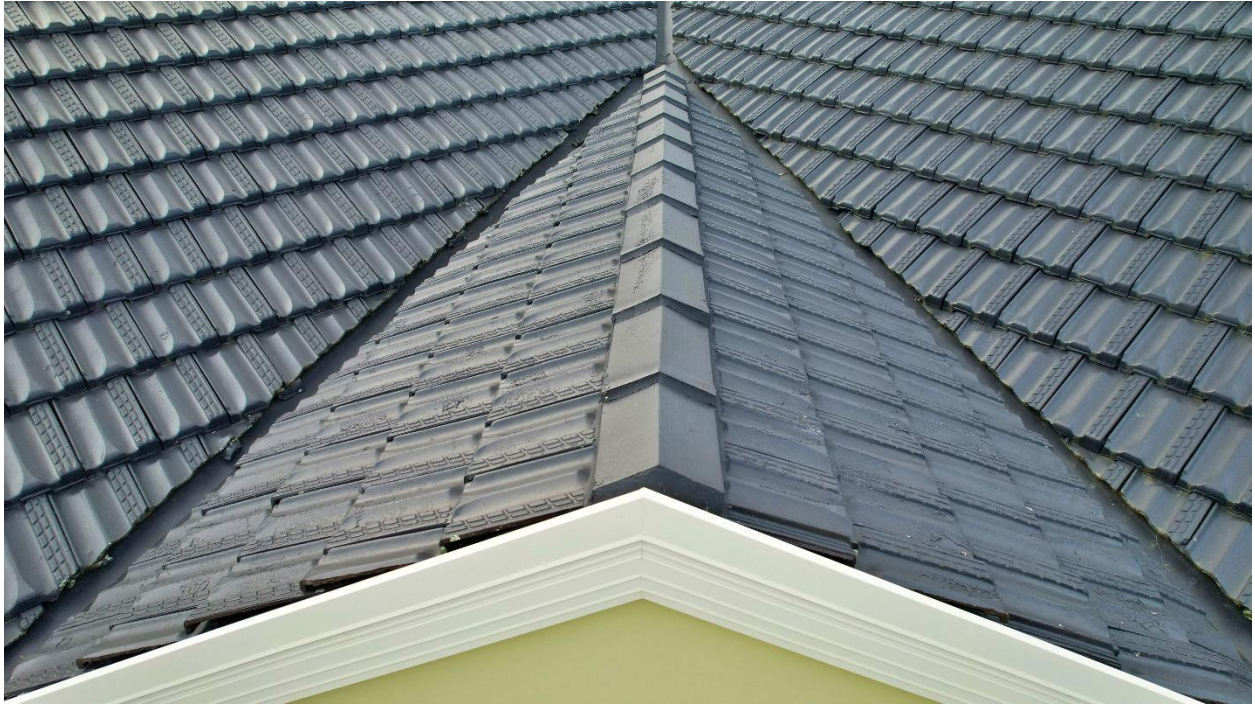
Photo 8 – Close up of roof section along the flashing, showing peeling, bubbling and cracking paint on tiles and the ridge capping

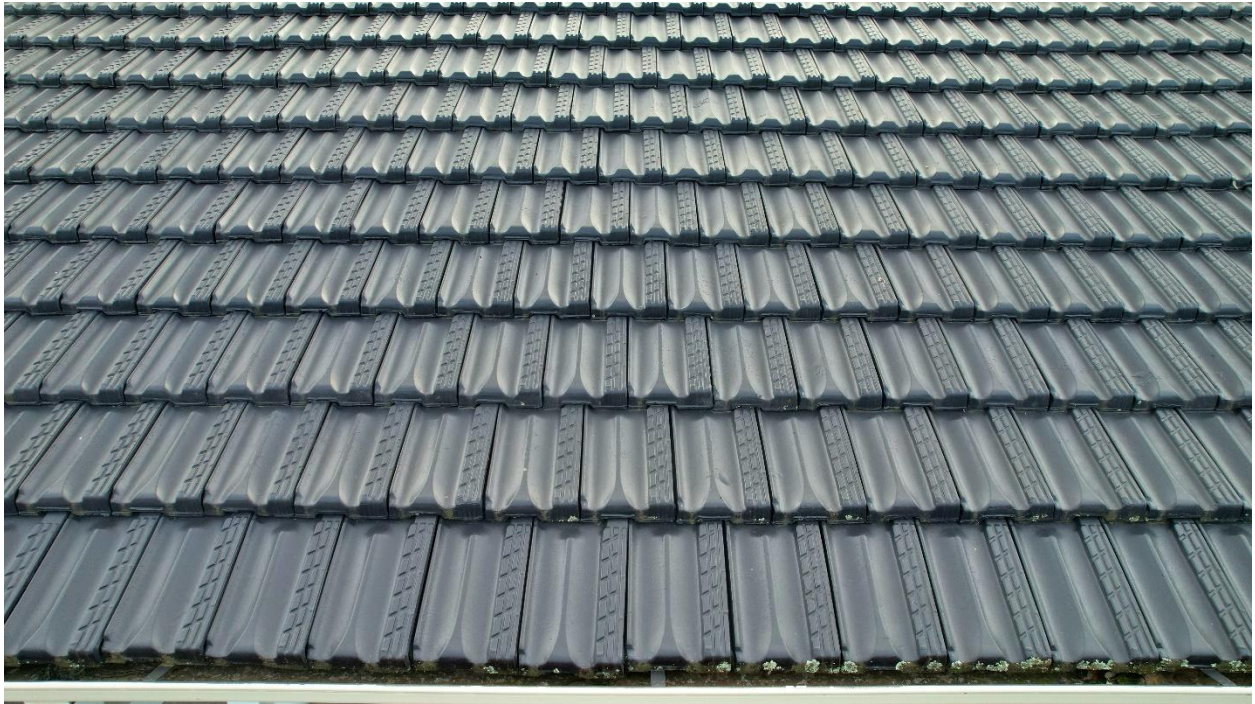
Photo 9 – Whilst less prevalent on this section, there is slight peeling, bubbling and cracking paint starting to form along the gutter line

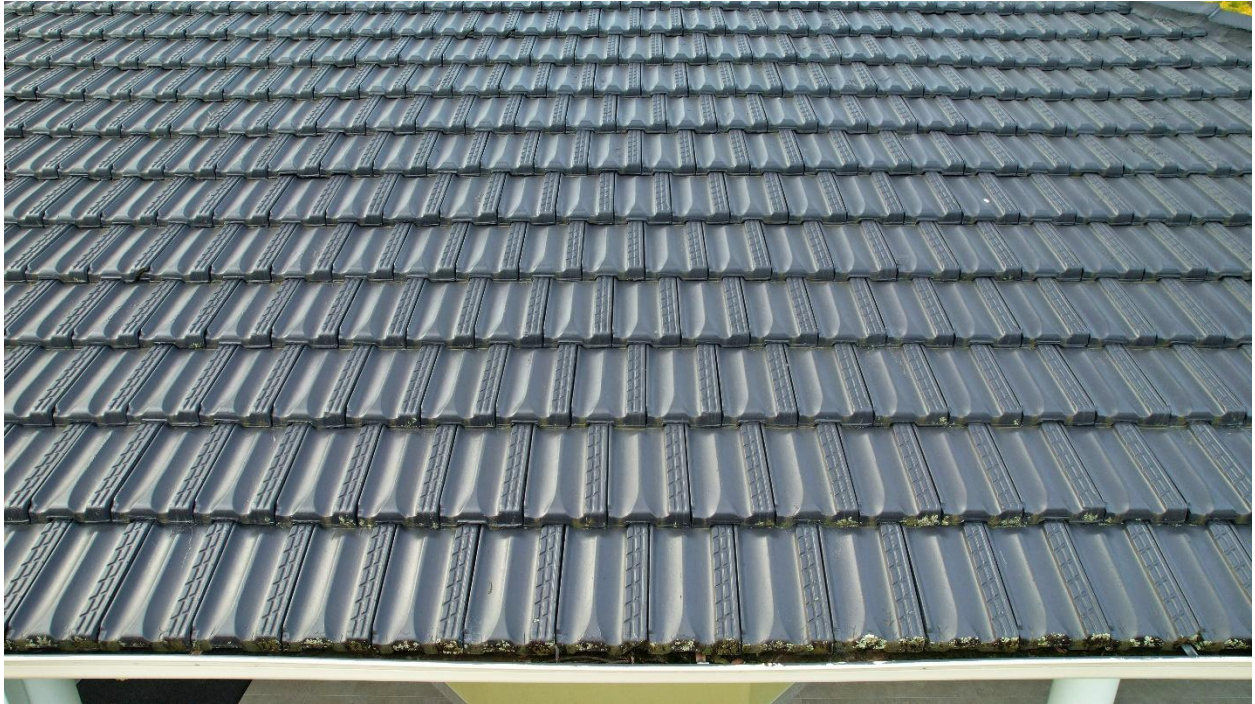
Photo 2 – Whilst less prevalent on this section, there is slight peeling, bubbling and cracking paint starting to form along the gutter line

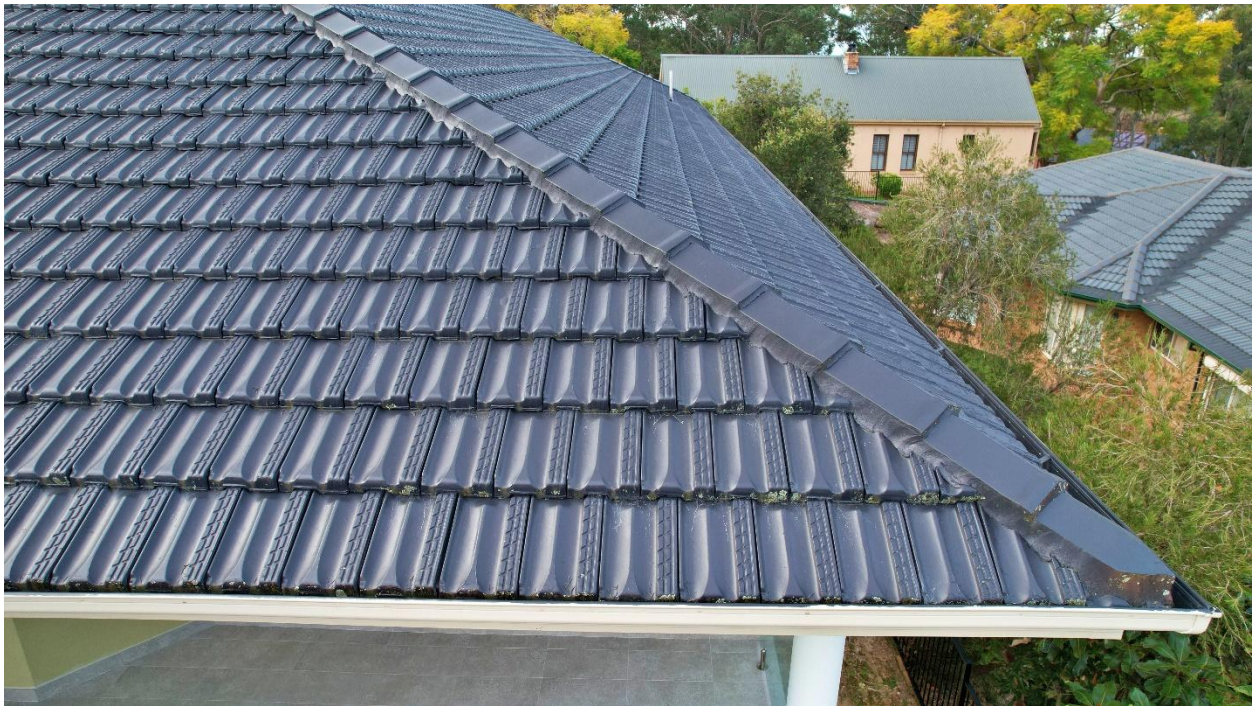
Photo 3 – Whilst less prevalent on this section, there is slight peeling, bubbling and cracking paint starting to form along the gutter line

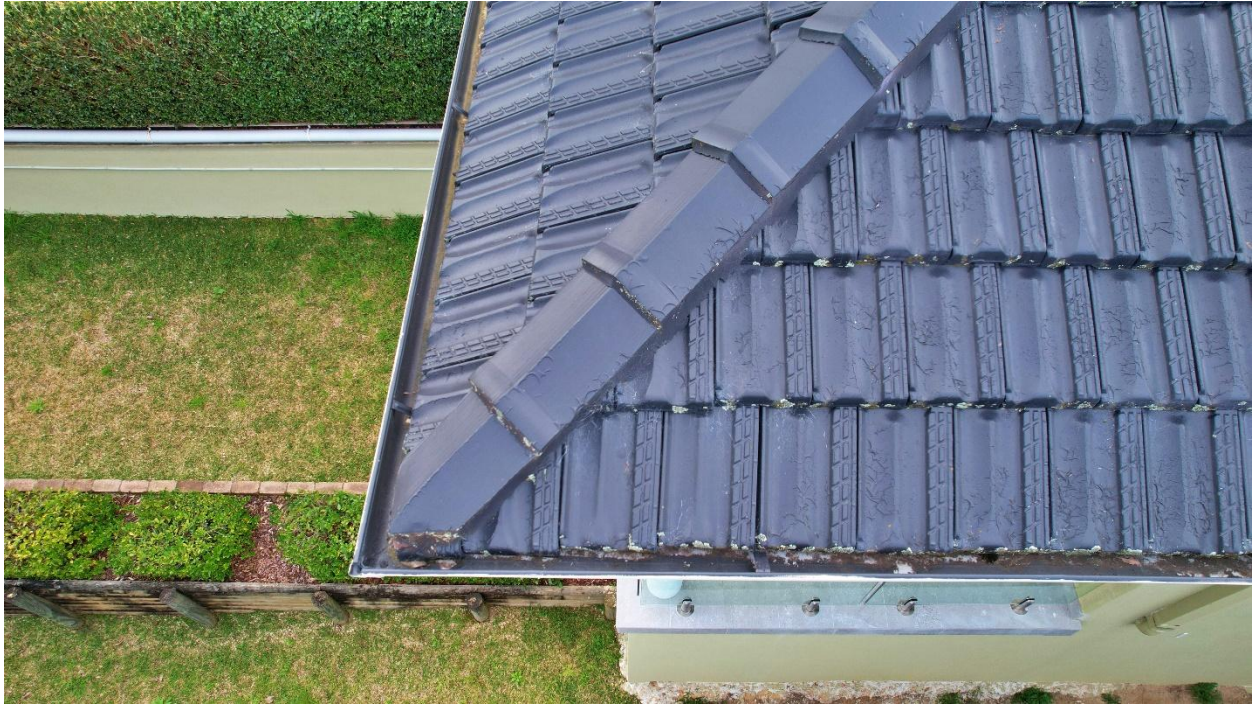
Photo 2 - Close up of roof section along the flashing, showing peeling, bubbling and cracking paint on tiles and the ridge capping

1. Roof Sections A–D and J present the most significant levels of deterioration across the property. Large portions of the roofing system display widespread coating failure, including bubbling, peeling, and cracking across numerous tiles. These defects indicate advanced weathering and prolonged exposure, which may compromise the protective coating and accelerate further degradation if left unaddressed.

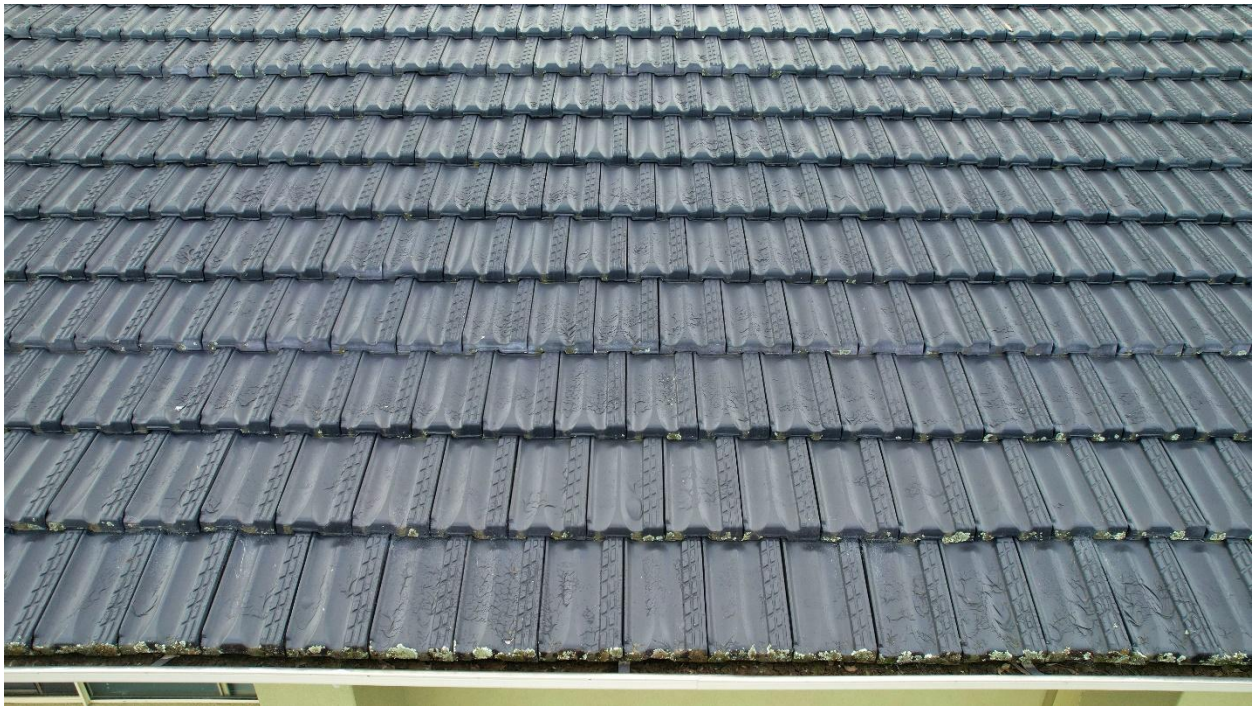
Photo 3 - Close up of roof section along the gutter line, showing peeling, bubbling and cracking paint

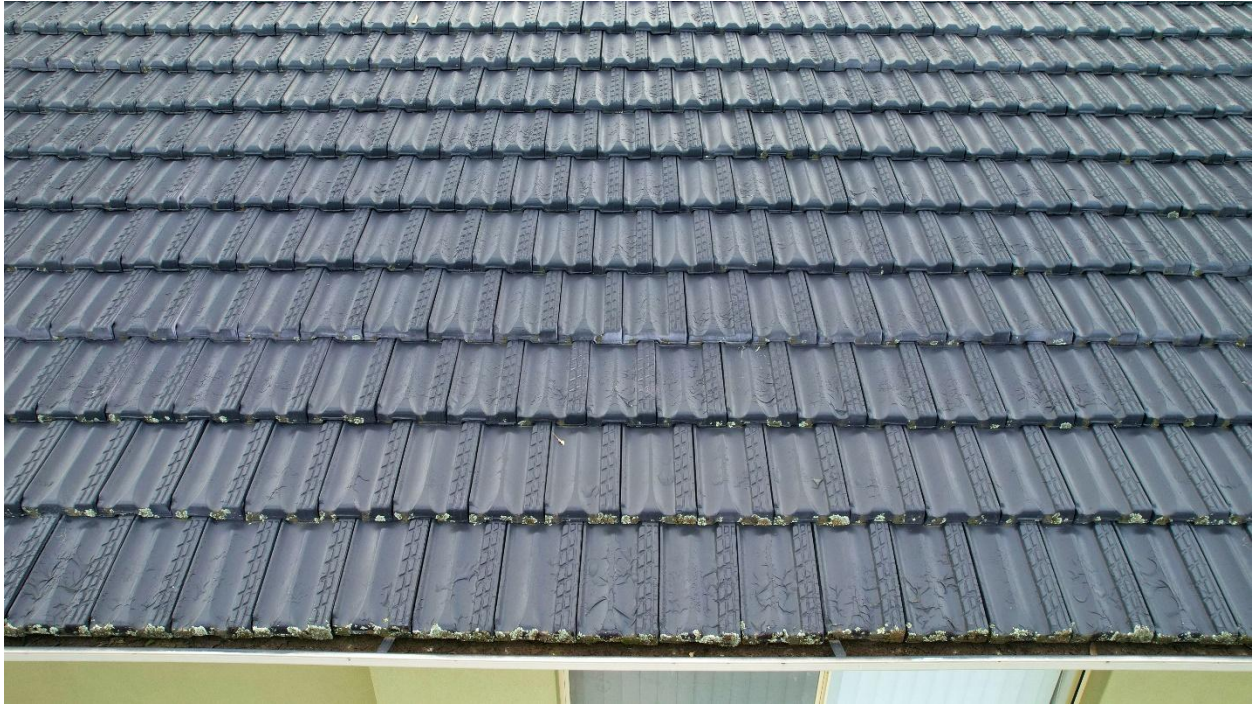
Photo 4 - Close up of roof section along the gutter line, showing peeling, bubbling and cracking paint

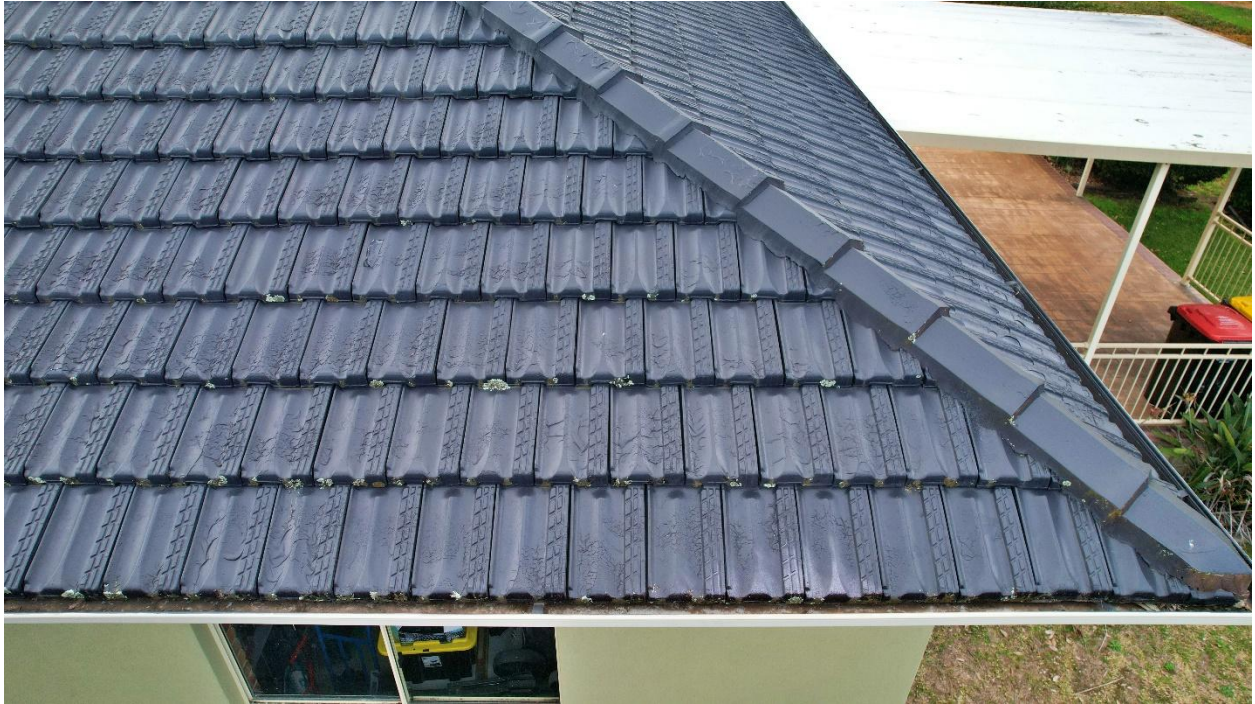
Photo 8 - Close up of roof section along the flashing, showing peeling, bubbling and cracking paint on tiles and the ridge capping

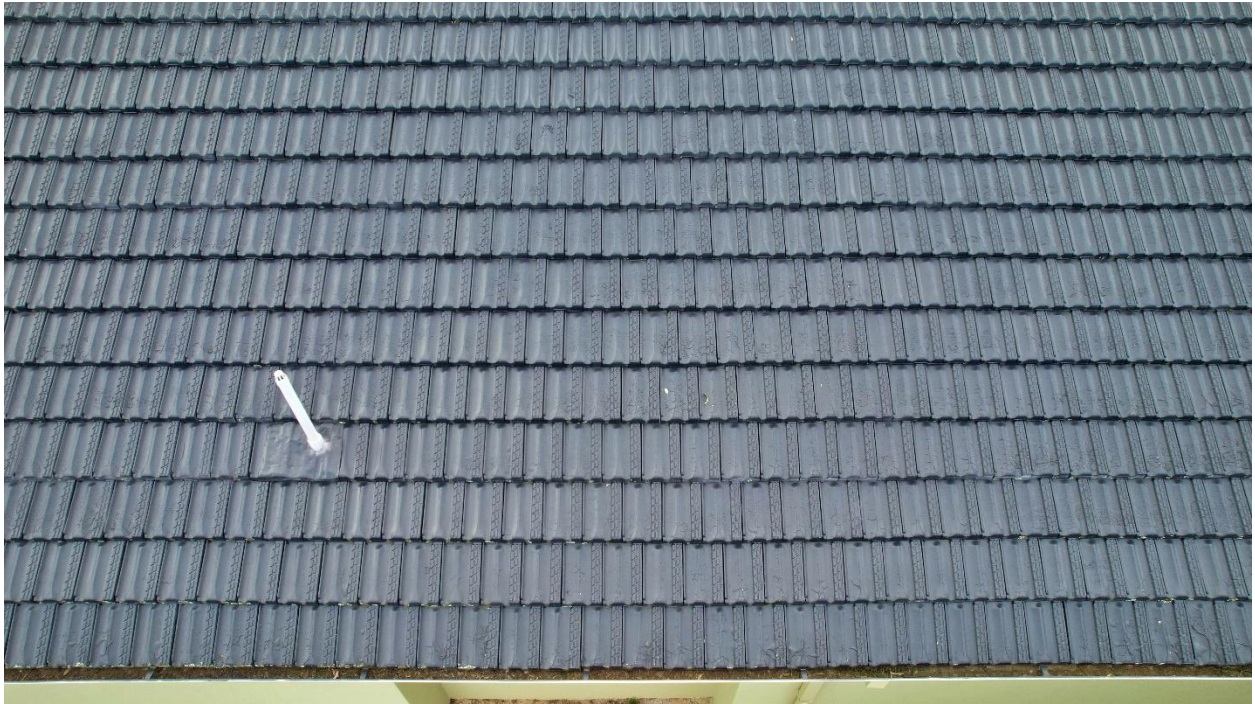
Photo 9 - Top down overview of photos 4-6 showing the extensive paint damage and degradation. This section appears to be quite damaged

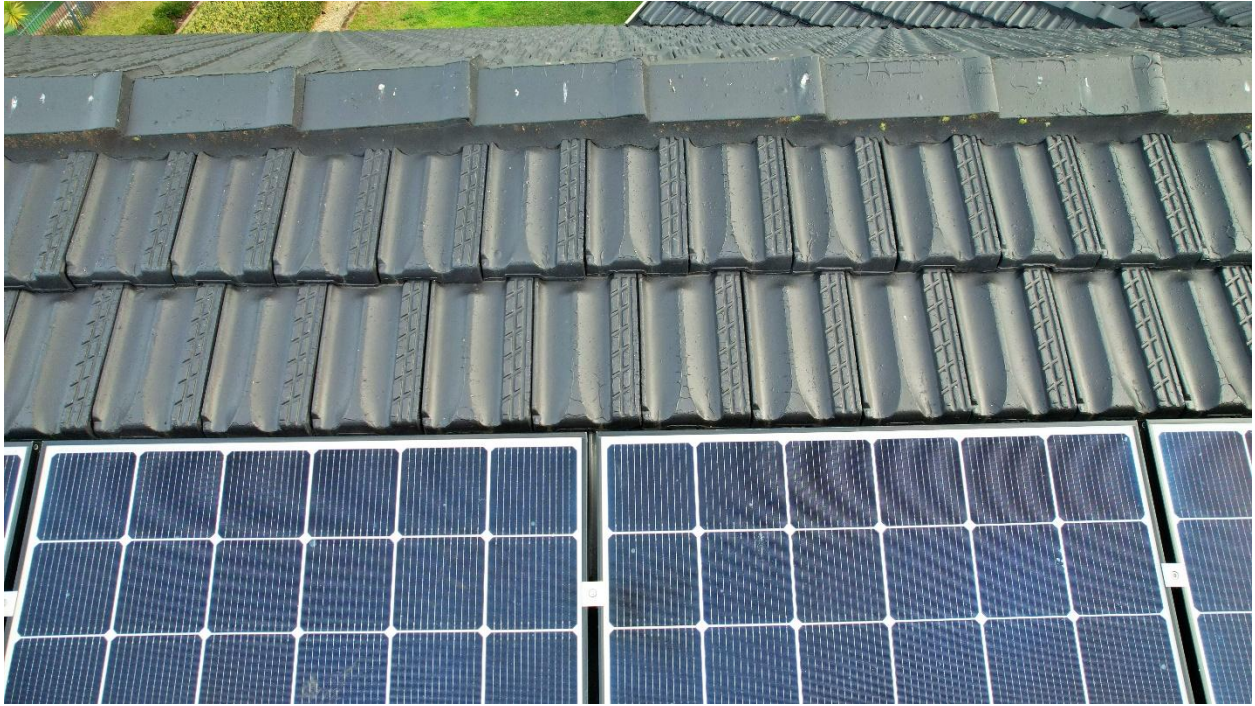
Photo 2 - Close up of roof section along the solar panel and ridge capping, showing peeling, bubbling and cracking paint on tiles is extensive

2. Roof Section K also demonstrates extensive coating deterioration across the majority of its surface area. The most notable defects are concentrated around the ridge capping and in areas surrounding the solar panel installations, where environmental exposure and runoff appear to have contributed to accelerated wear and breakdown of the coating system.

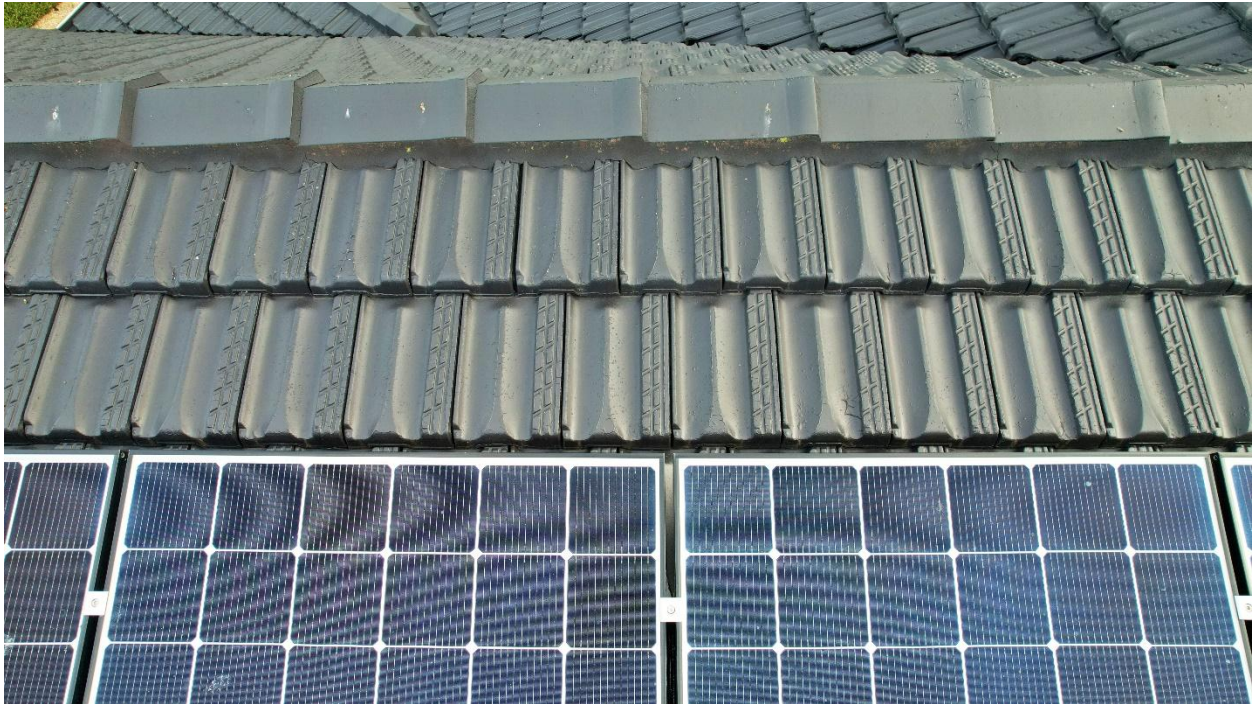
Photo 3 - Close up of roof section along the solar panel and ridge capping, showing peeling, bubbling and cracking paint on tiles is extensive

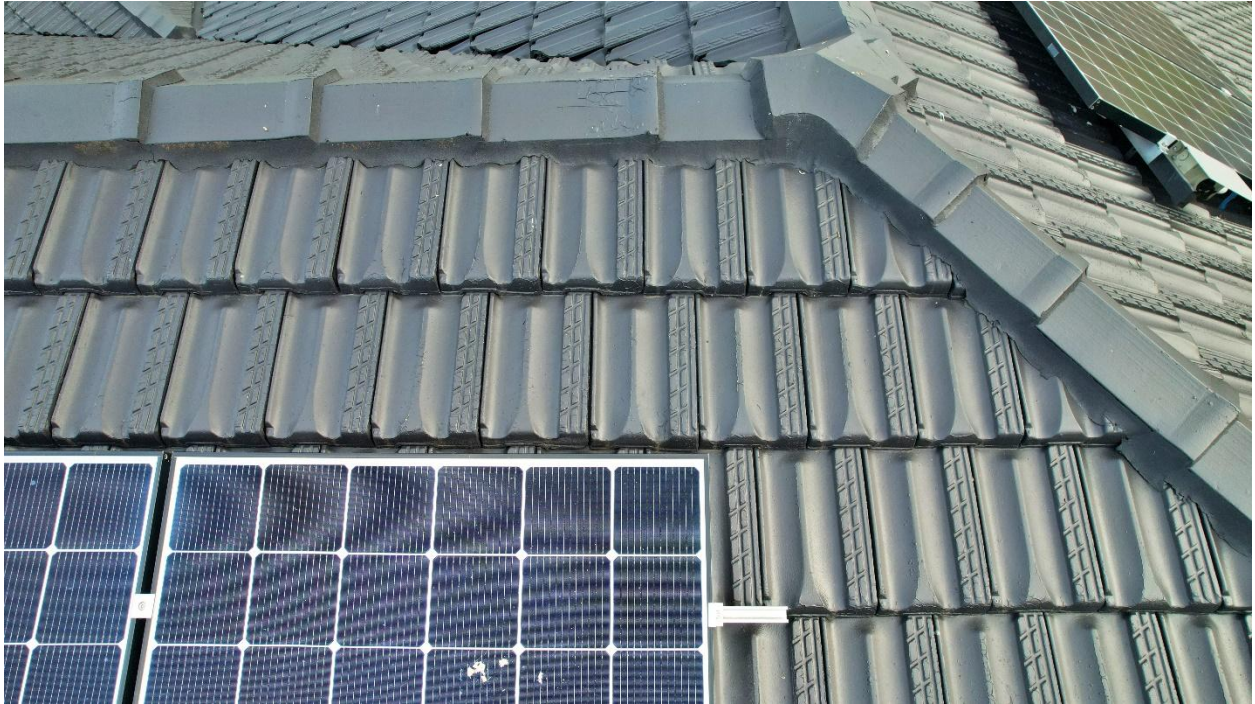
Photo 4 - Close up of roof section along the solar panel and ridge capping, showing bubbling and cracking paint on tiles is extensive

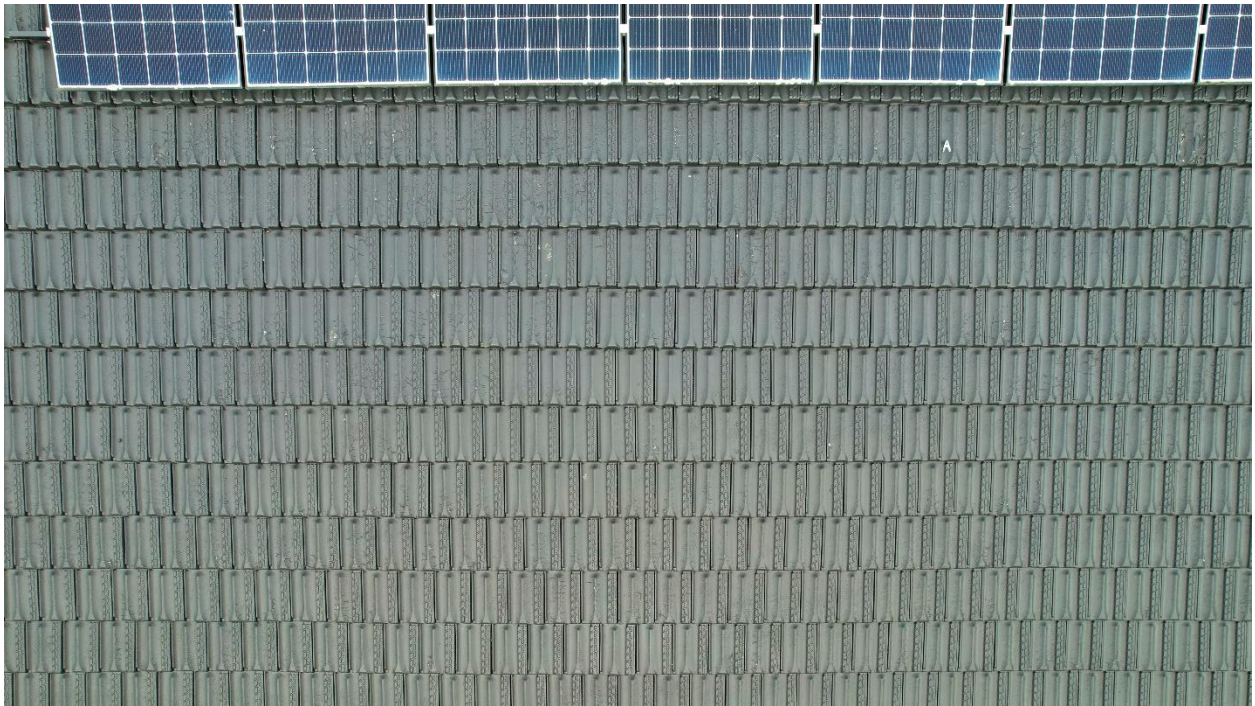
Photo 5 - Top down overview of photos 1-4 showing the extensive paint damage and degradation. This section appears to be the worst on the roof
