INSPECTION DATE - 8 SEPTEMBER 2024

# ROOF INSPECTION REPORT

8 RIVERTOP CLOSE, EMU HEIGHTS, NSW, 2750

REPORT PREPARED BY JIM MCGRATH

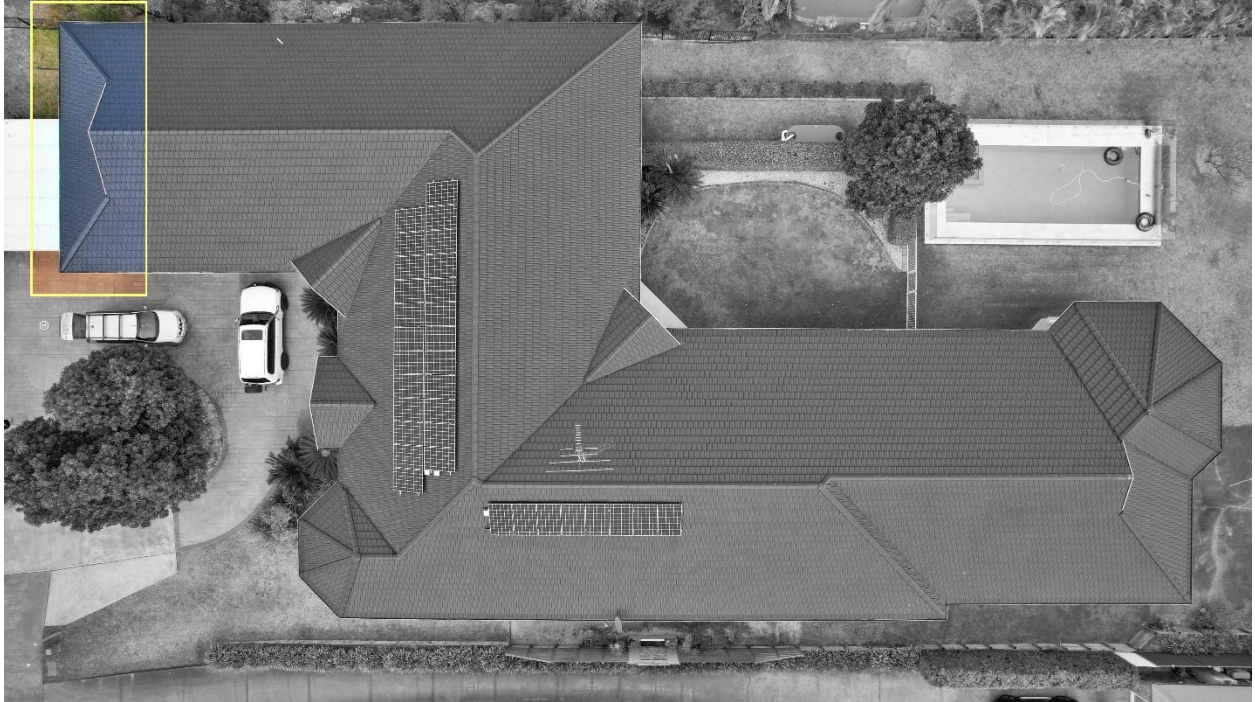
Photo 1 - Paint bubbling, peeling and cracking is present along the entire side of the roof section, from gutter to gable and ridge capping.

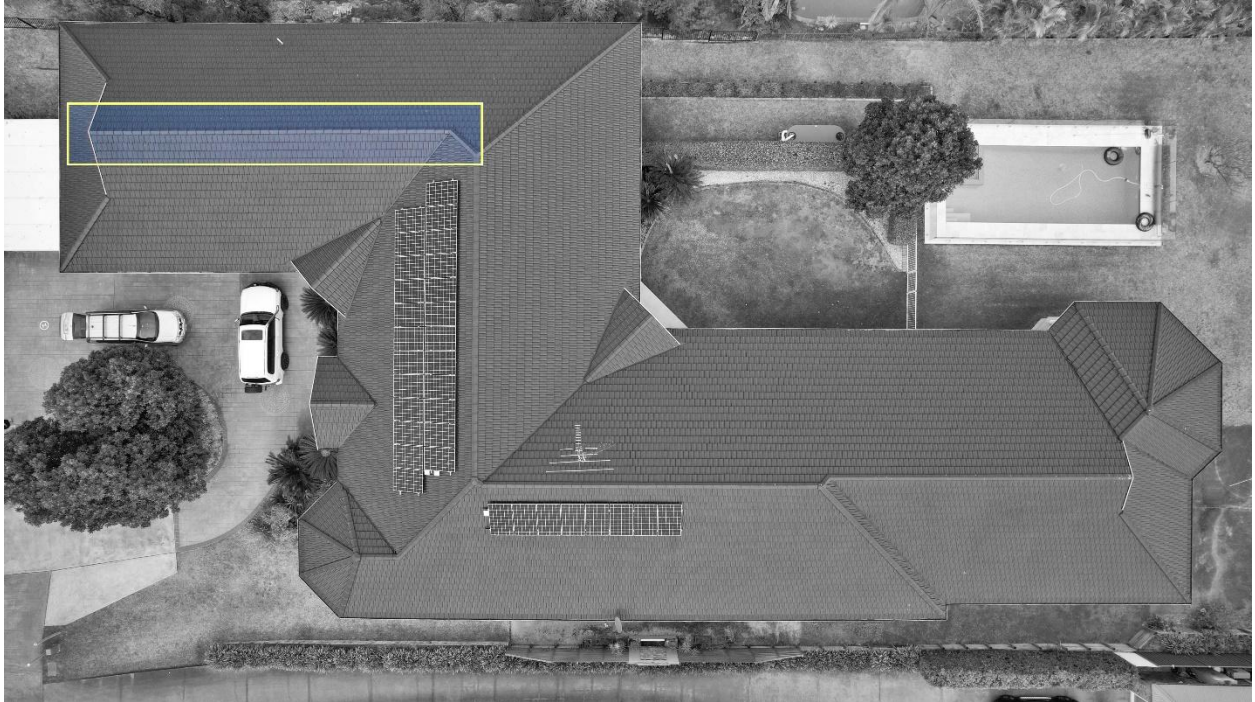
Photo 1 – Paint peeling and cracking is present along the ridge cap along this section of roof

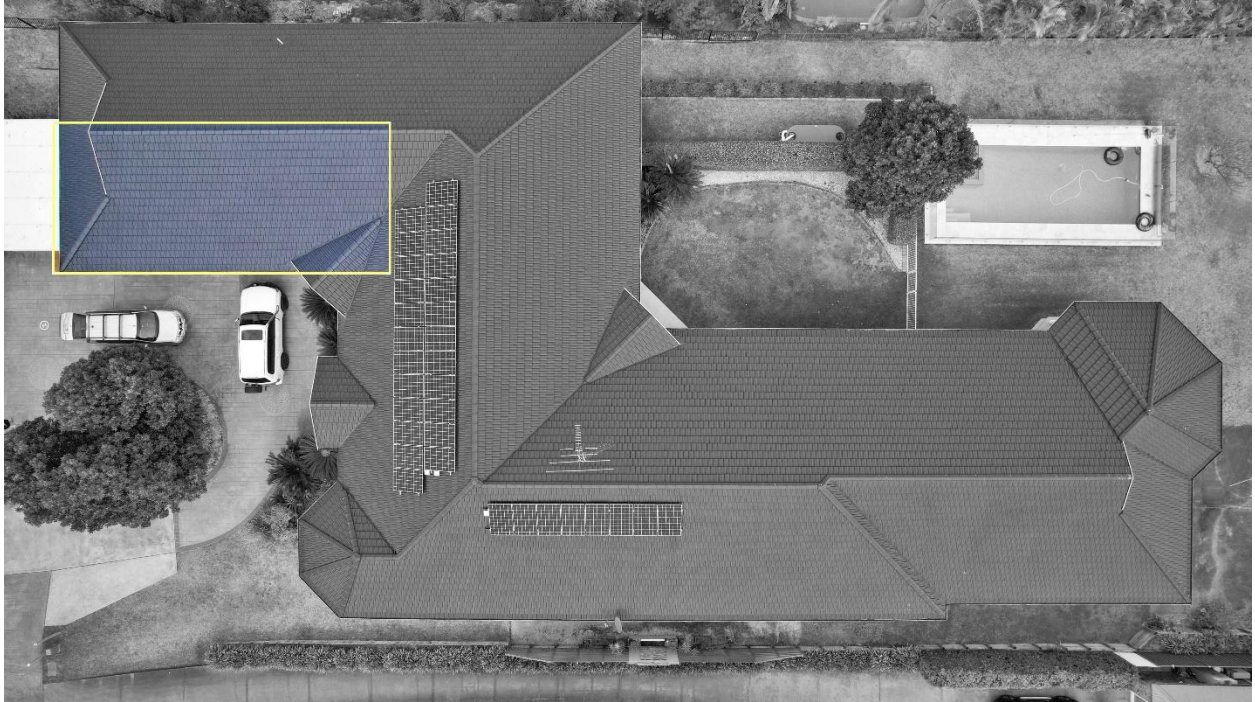
Photo 1 - Close up of roof section along the gutter line, showing peeling, bubbling and cracking paint

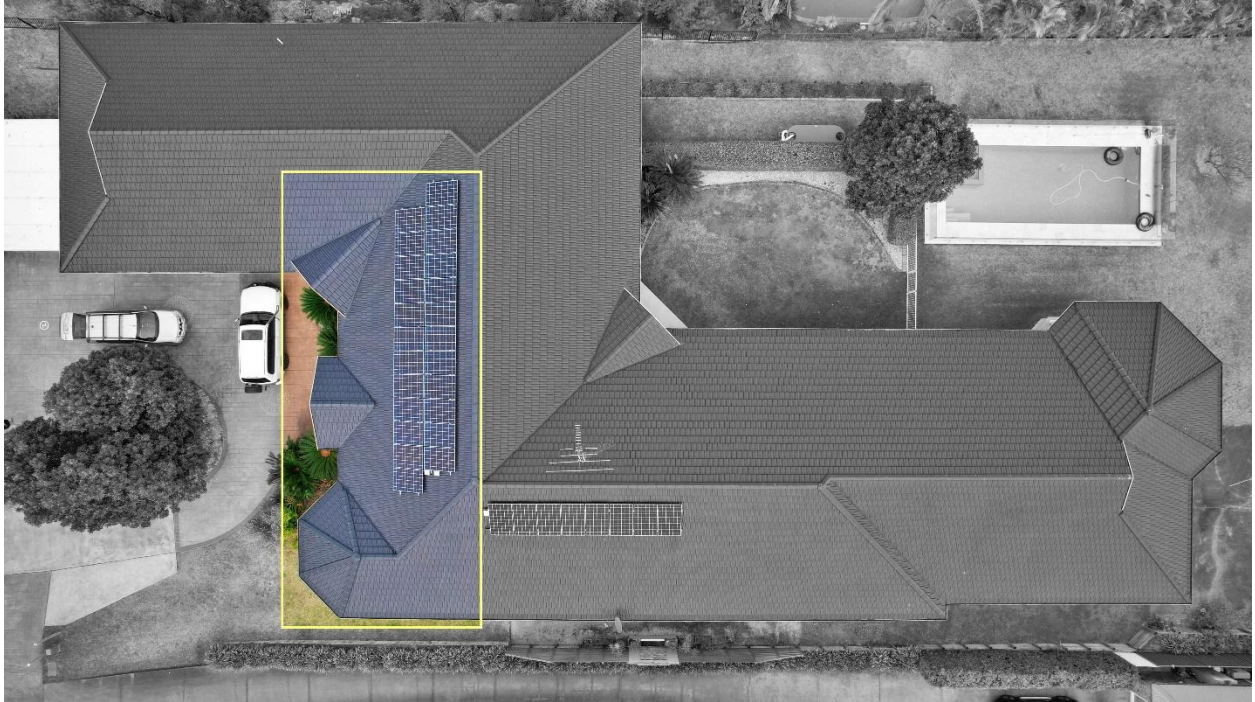
Photo 1 - Peeling, bubbling and cracking paint can be observed along the ridge cap and most tiles

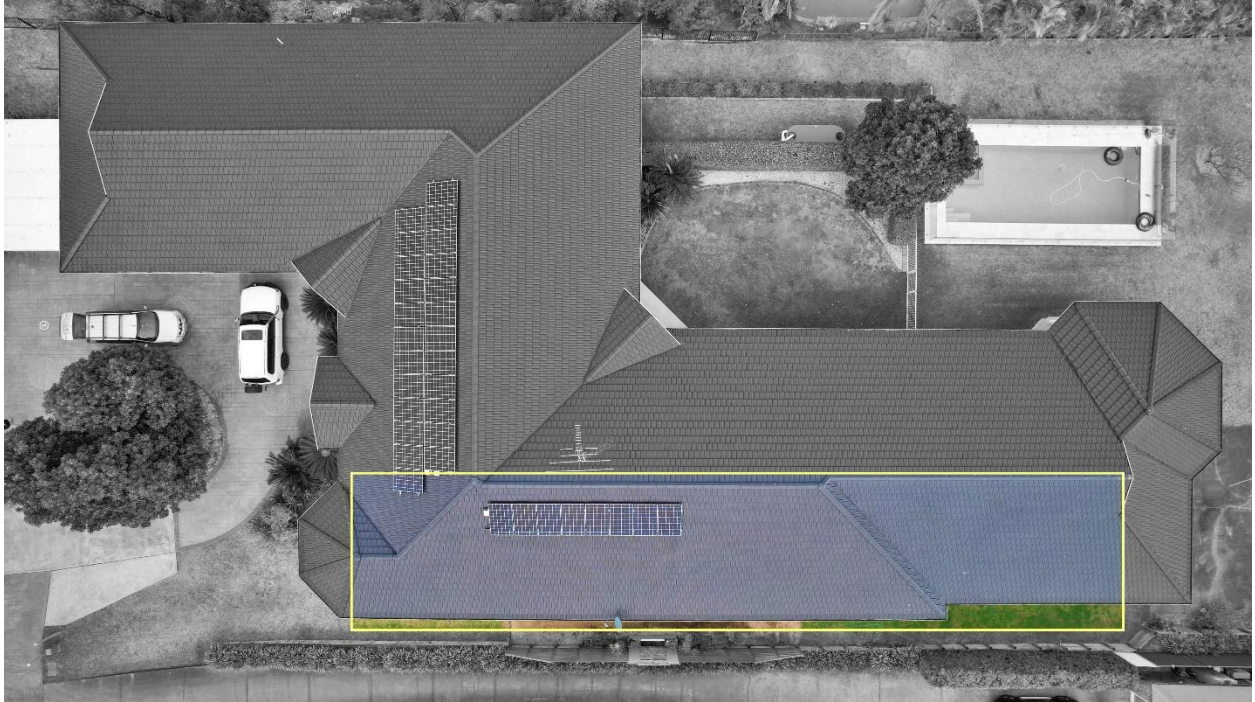
Photo 1 - Peeling, bubbling and cracking paint can be observed along part of the ridge cap and gutter line

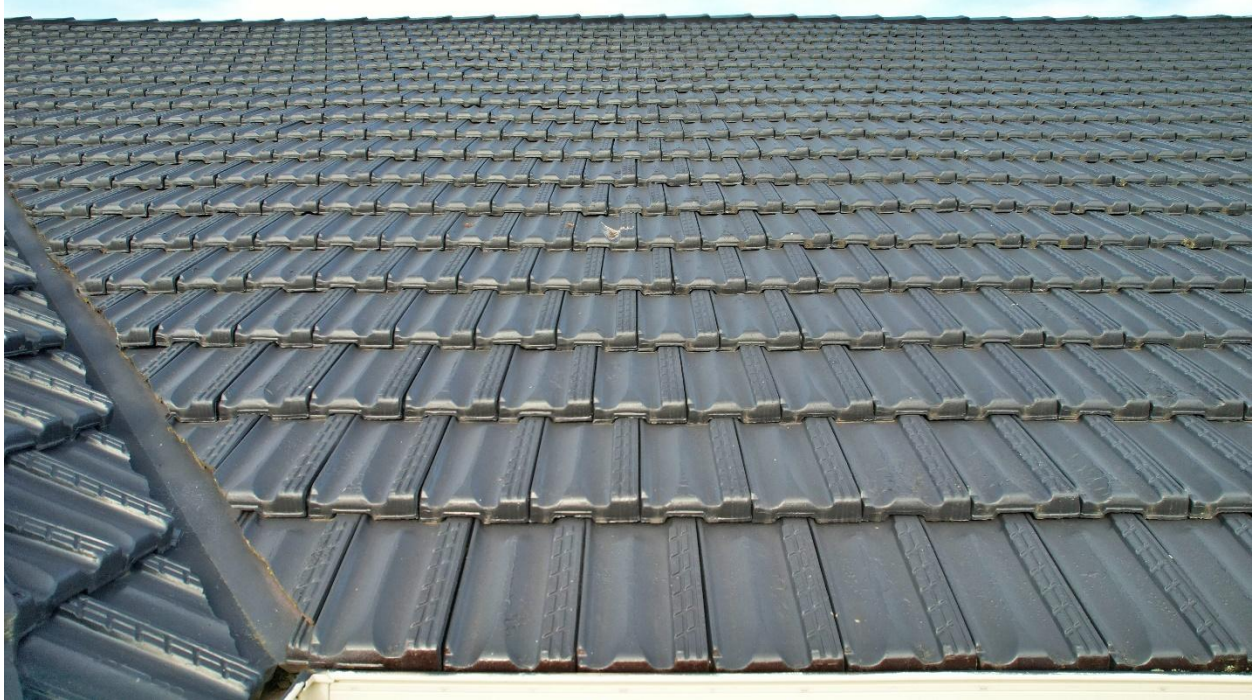
Photo 9 – Whilst less prevalent on this section, there is slight peeling, bubbling and cracking paint starting to form along the ridge cap

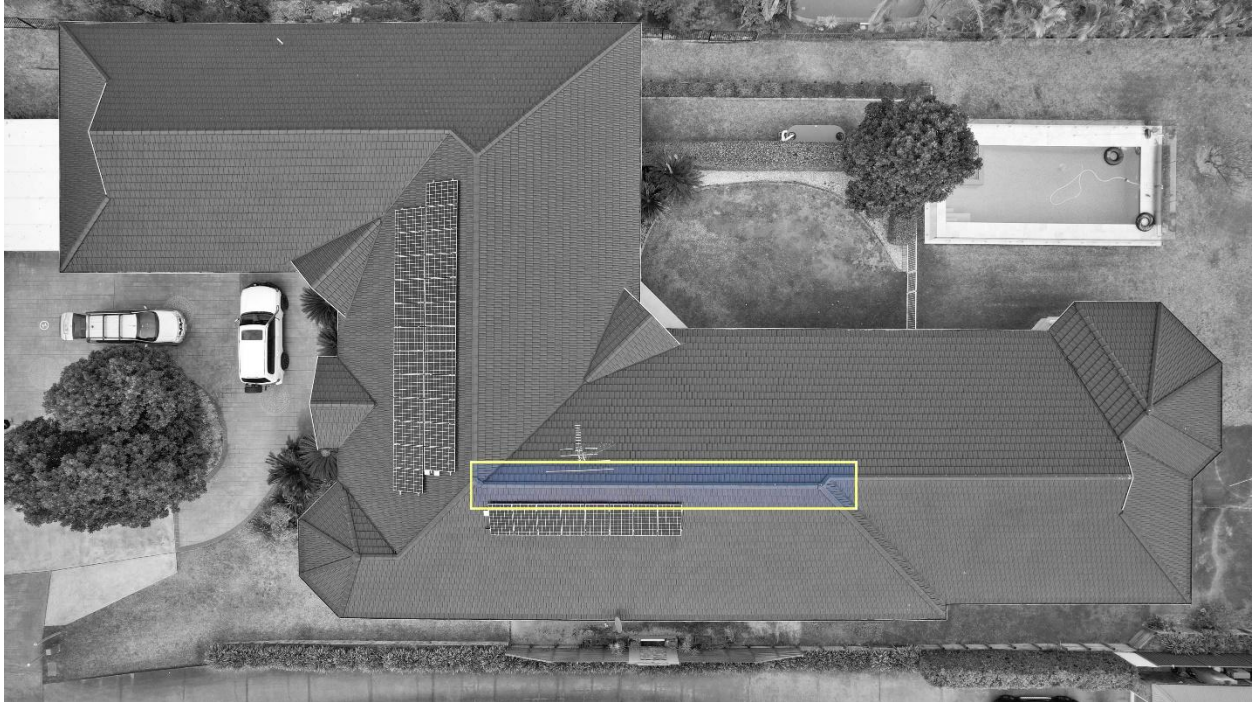
Photo 1 – Paint bubbling, peeling and cracking is present along the ridge cap along this section of roof

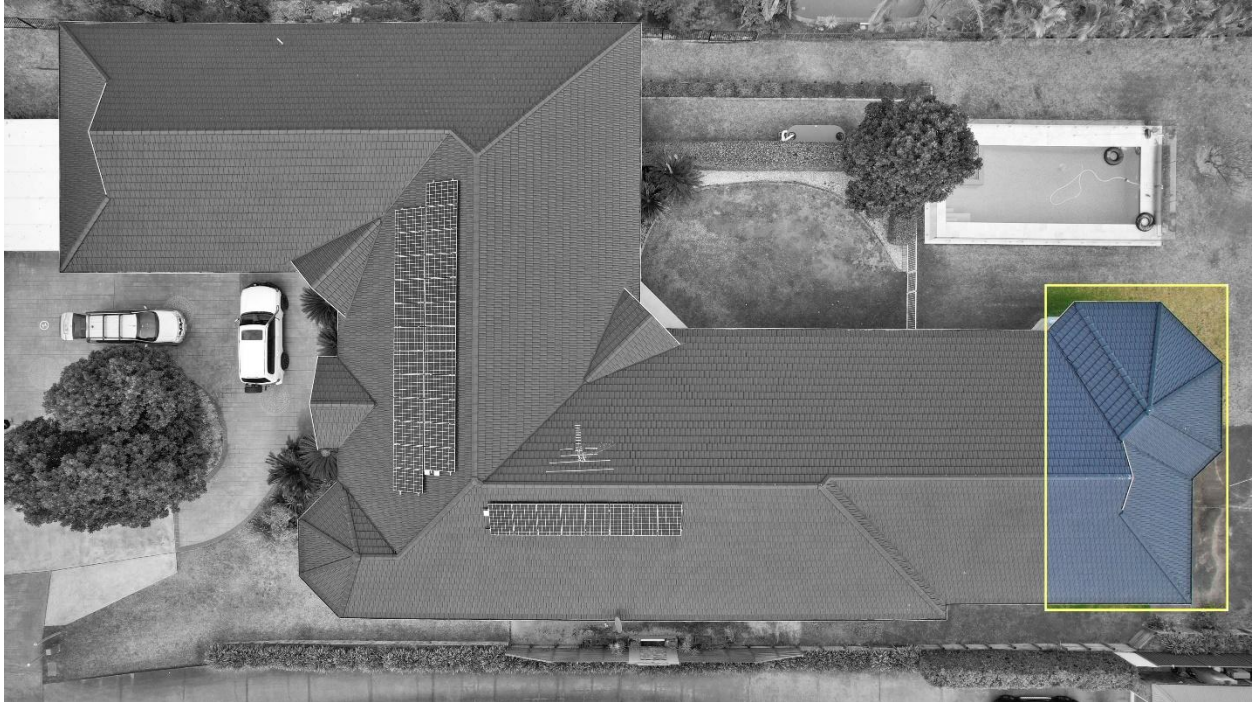
Photo 1 – Whilst less prevalent on this section, there is slight peeling, bubbling and cracking paint starting to form along the ridge cap

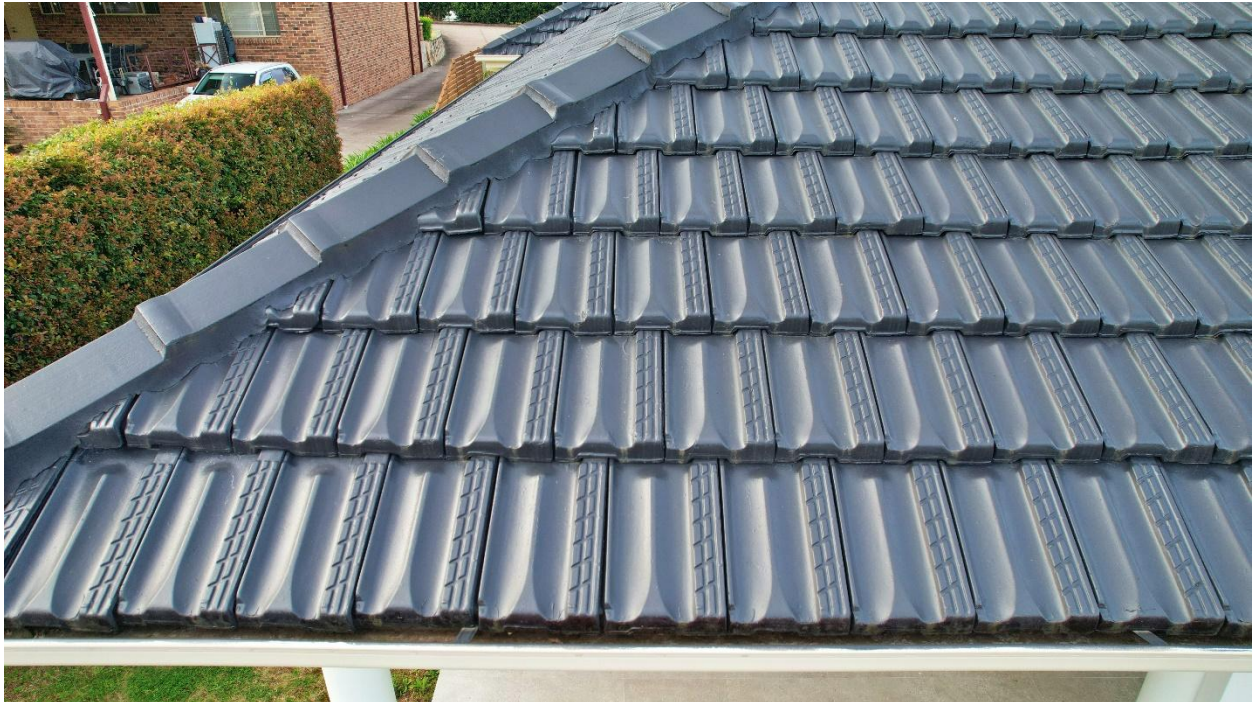
Photo 2 – Whilst less prevalent on this section, there is slight peeling, bubbling and cracking paint starting to form along the gutter line

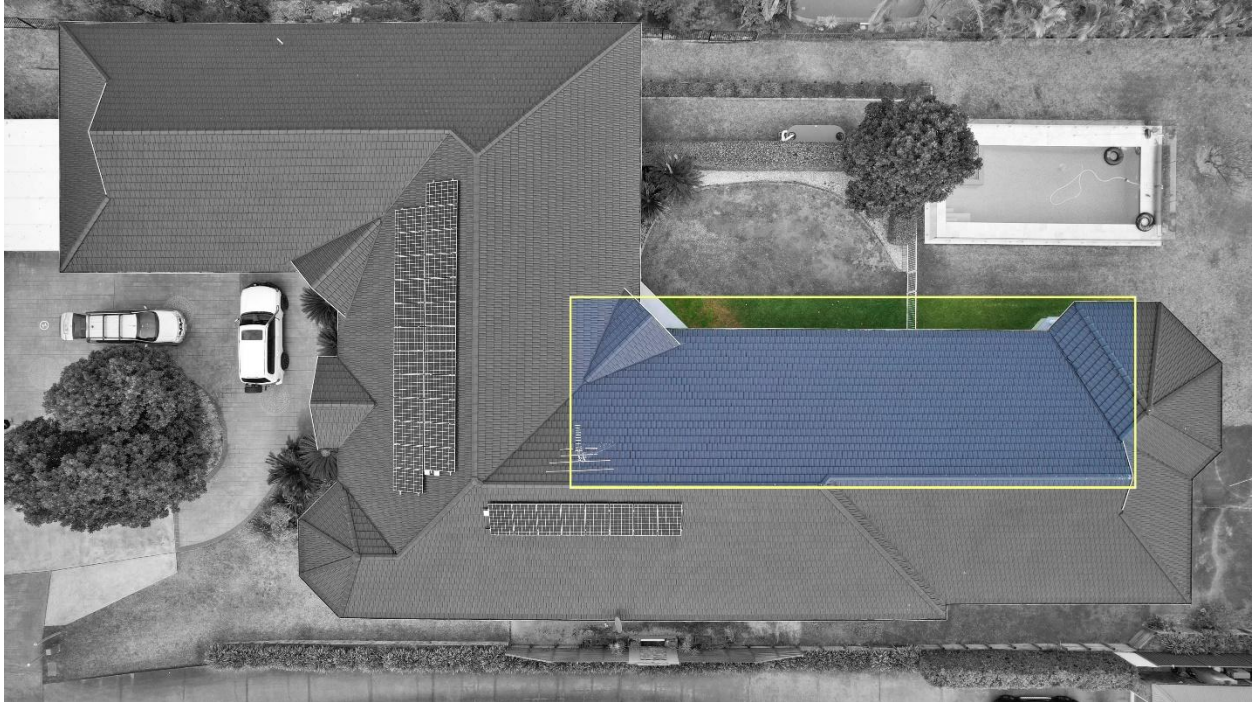
Photo 1 – Whilst less prevalent on this section, there is slight peeling, bubbling and cracking paint starting to form

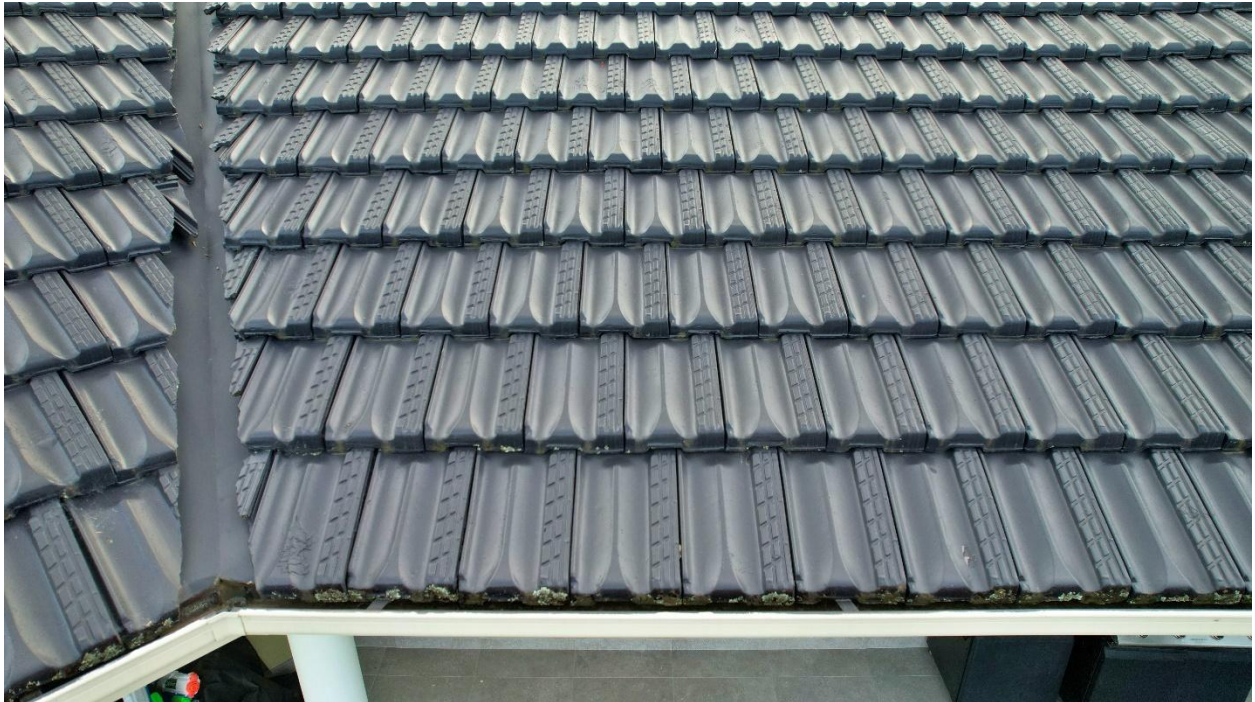
Photo 2 – Whilst less prevalent on this section, there is slight peeling, bubbling and cracking paint starting to form along the gutter line

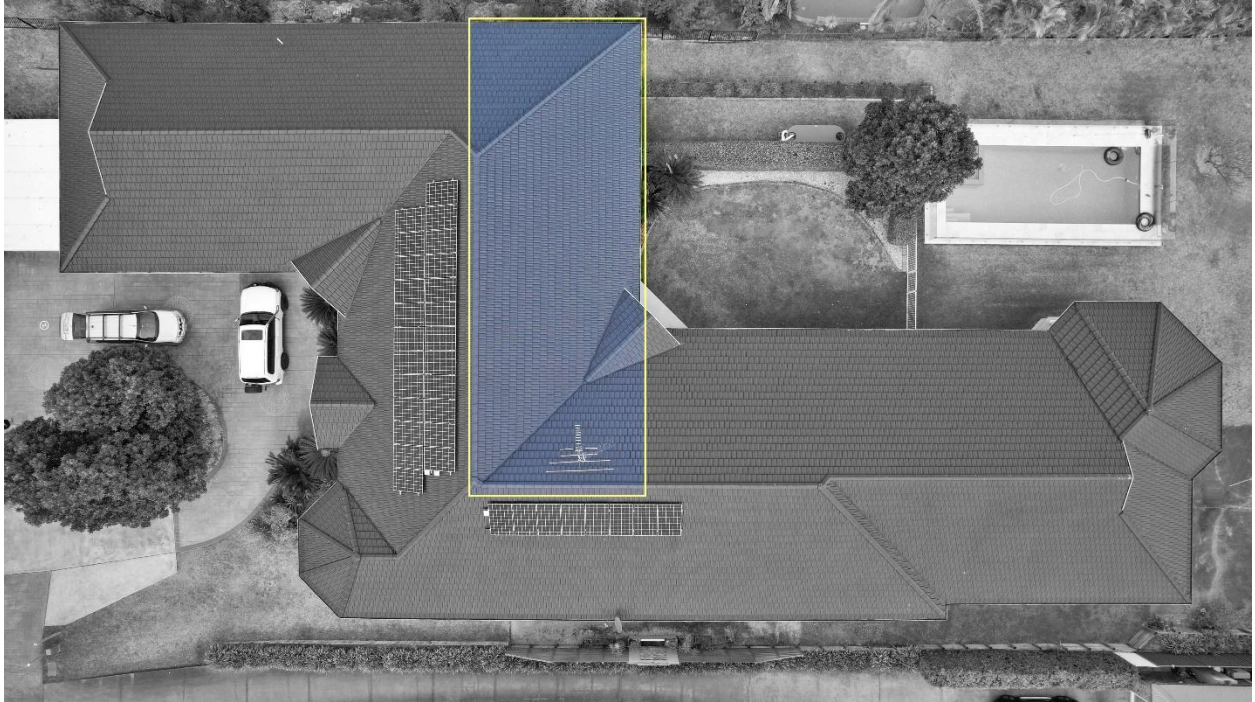
Photo 1 – Whilst less prevalent on this section, there is slight peeling, bubbling and cracking paint starting to form along the gutter line

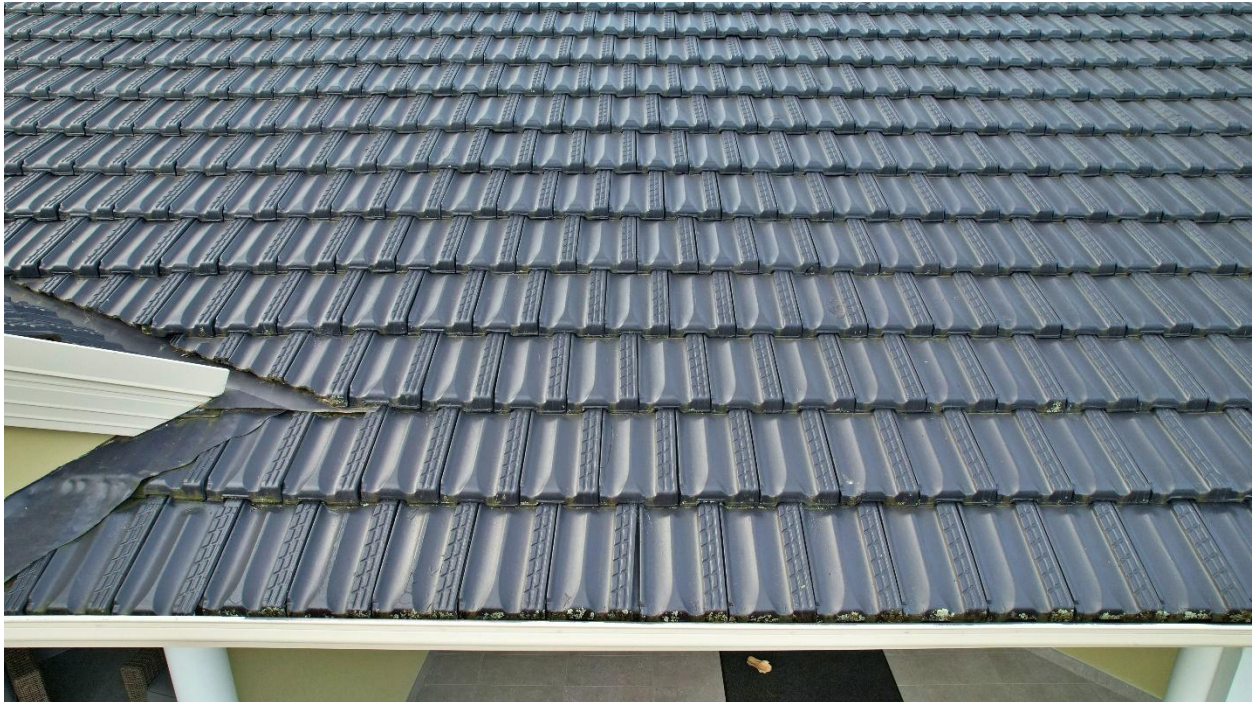
Photo 2 – Whilst less prevalent on this section, there is slight peeling, bubbling and cracking paint starting to form along the gutter line

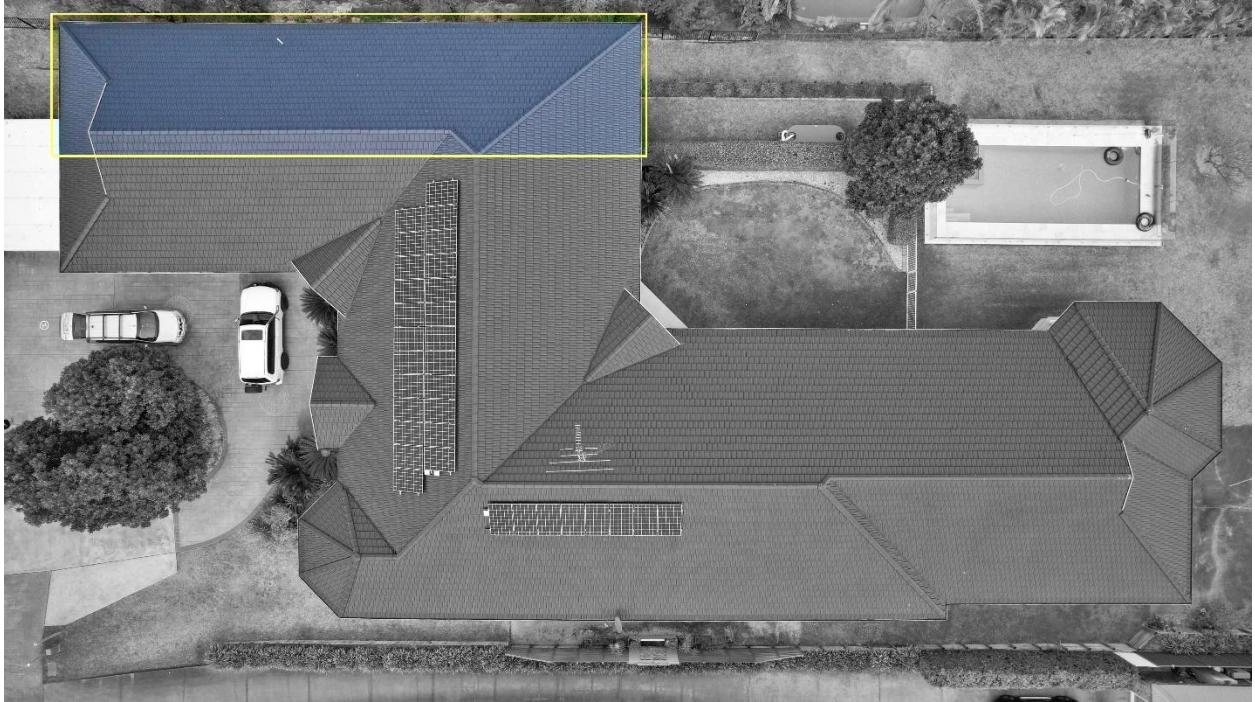
Photo 1 - Peeling, bubbling and cracking paint can be observed along the ridge cap and most tiles. Damage is quite heavy and extensive

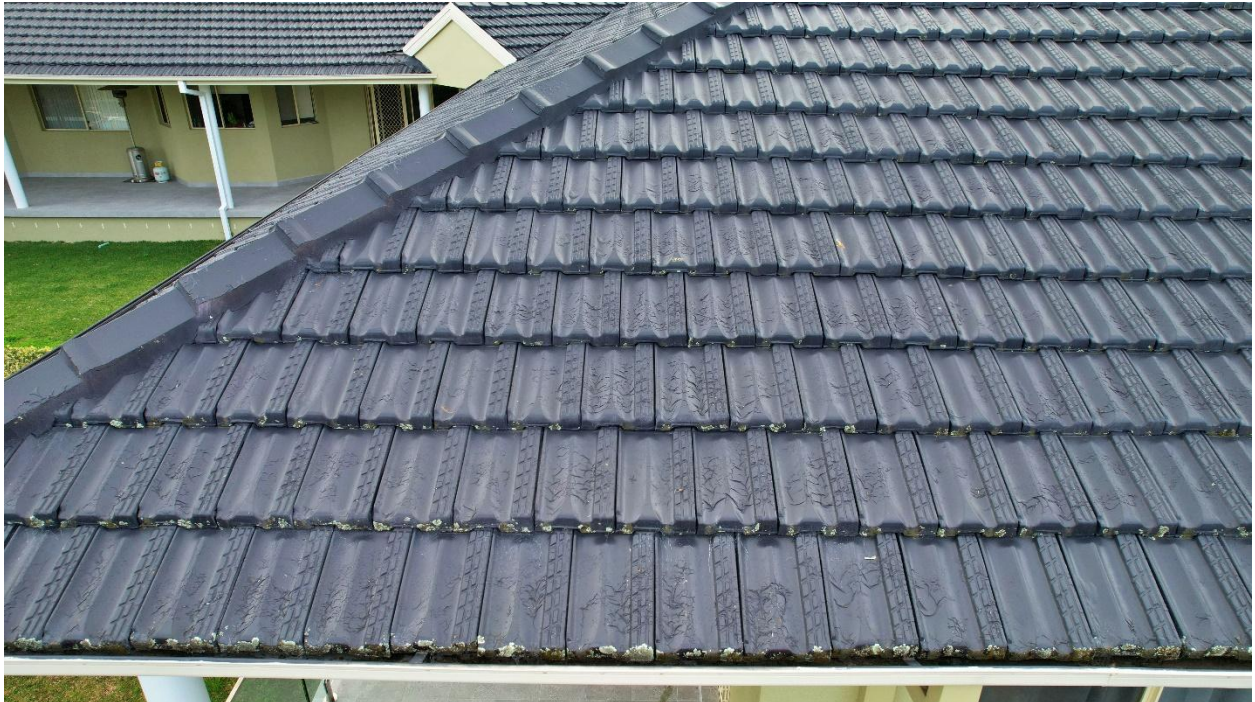
Photo 2 - Close up of roof section along the flashing, showing peeling, bubbling and cracking paint on tiles and the ridge capping

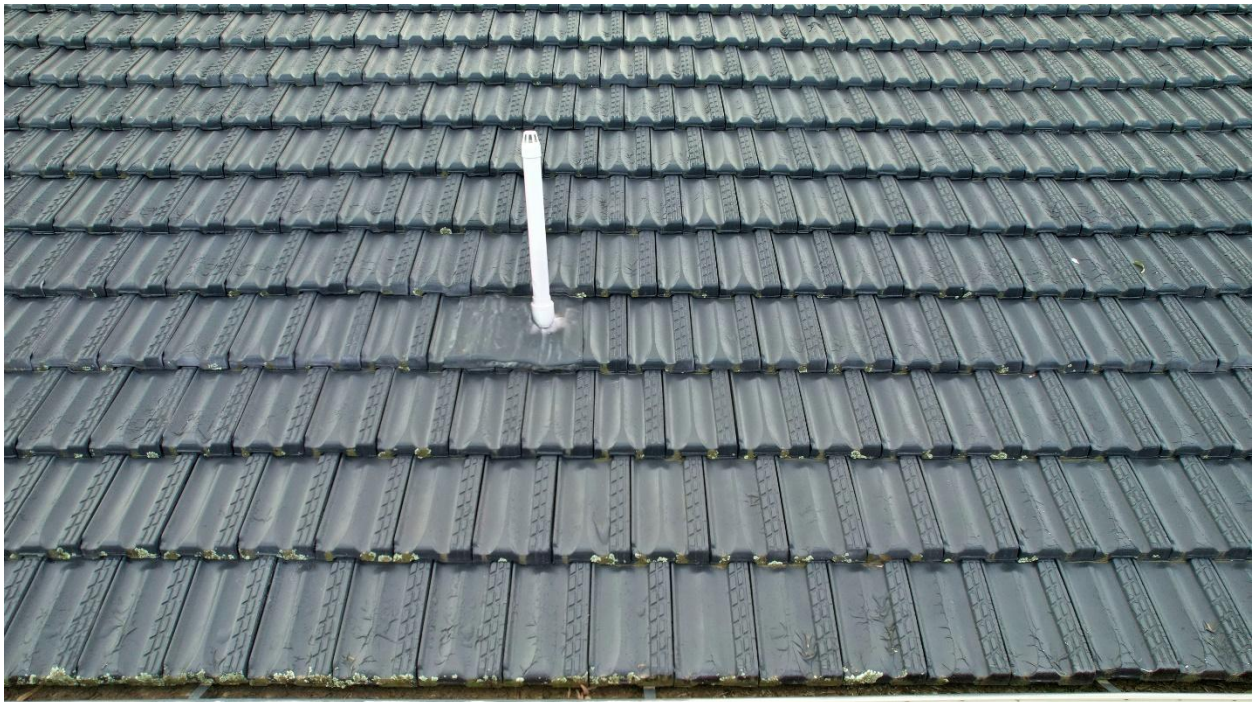
Photo 6 - Close up of roof section along the gutter line, showing peeling, bubbling and cracking paint

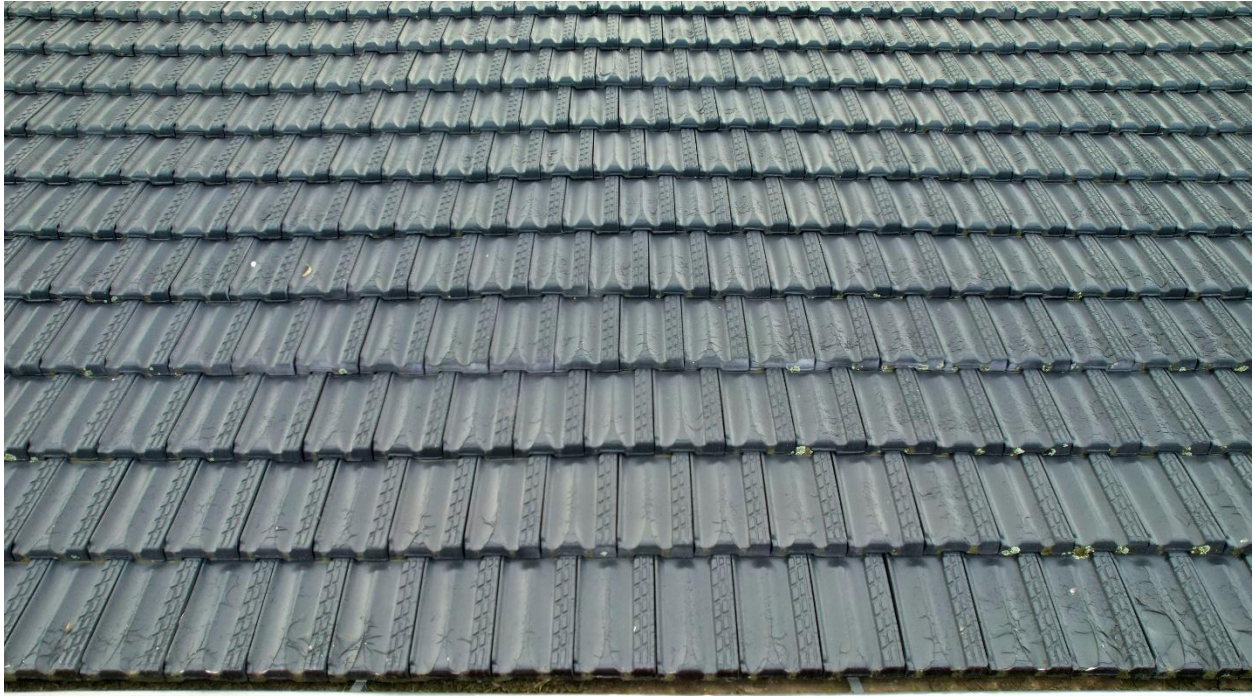
Photo 7 - Close up of roof section along the gutter line, showing peeling, bubbling and cracking paint

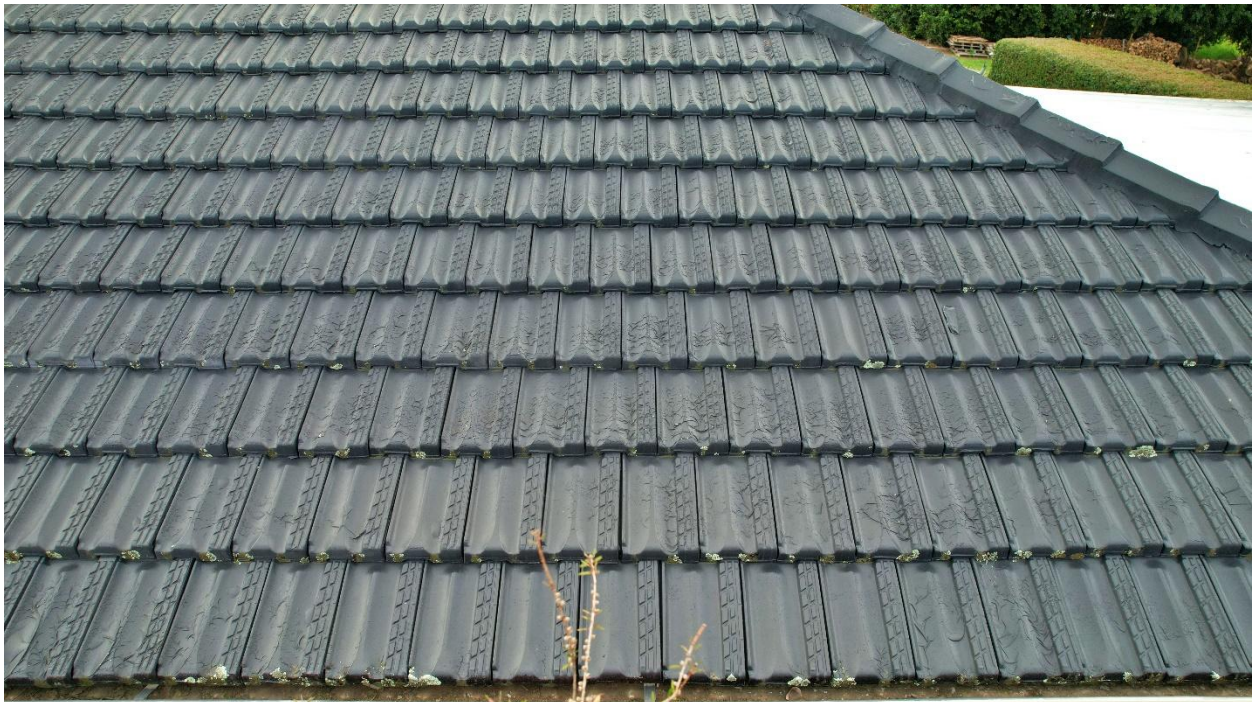
Photo 8 - Close up of roof section along the flashing, showing peeling, bubbling and cracking paint on tiles and the ridge capping

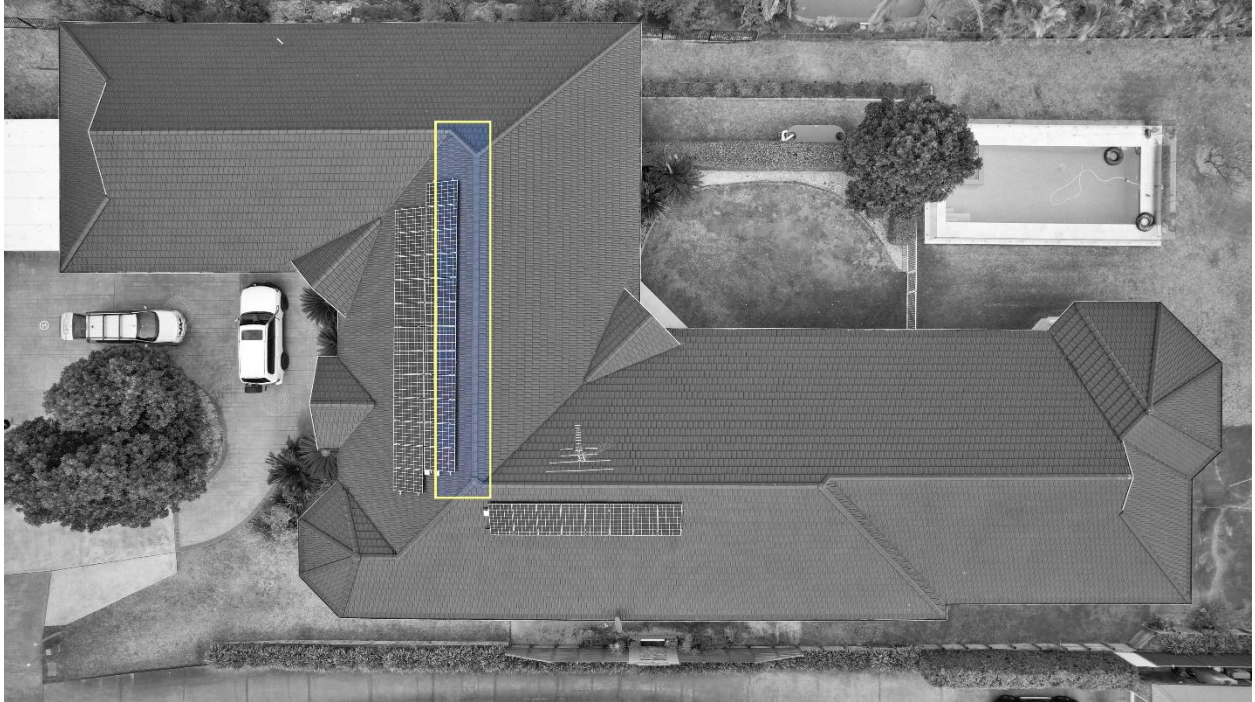
Photo 1 - Close up of roof section along the solar panel and ridge capping, showing peeling, bubbling and cracking paint on tiles is extensive

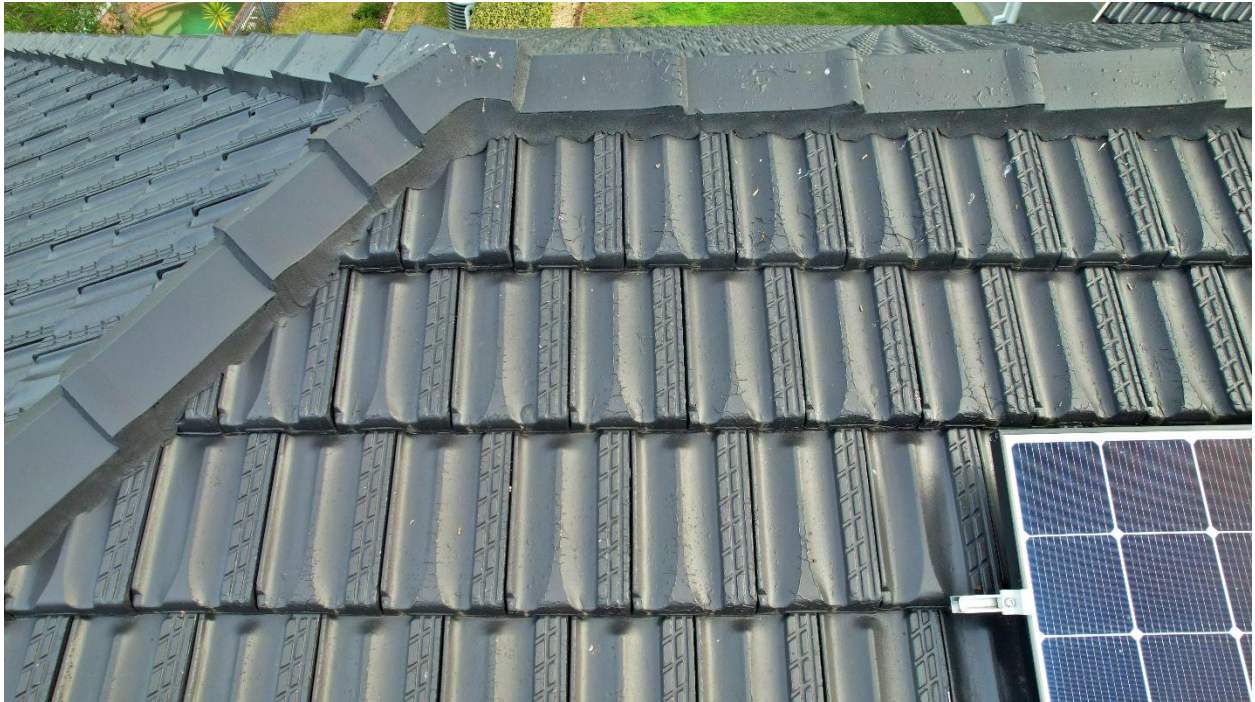
Photo 2 - Close up of roof section along the solar panel and ridge capping, showing peeling, bubbling and cracking paint on tiles is extensive
